Client: Town of Addison Date: 1/2/18
 Program: ADA Self-Evaluation and Transition Plan Prepared By: CMP
 KHA No.: 063543021 Checked By: EPE

Corridor : Oaks N Dr GPS ID: 90106
 Project Name: Intersection of Oaks N Dr and driveway (Lat. 32.9516; Long. -96.8150)
 Town: Addison

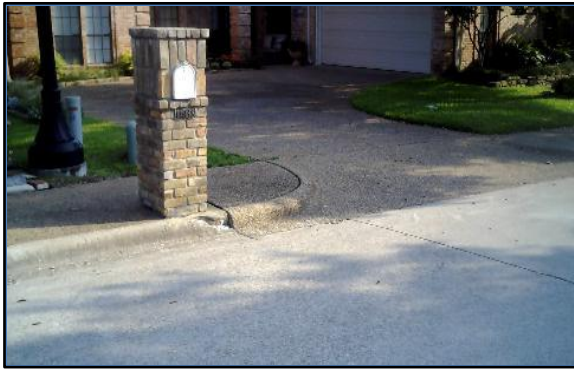
Curb Ramp Issues	Curb Ramp ID ('z' or 'i' in ramp label indicates no existing ramp)		Possible Solutions
	1z	2z	
Curb ramp does not exist and is needed	X	X	Install curb ramp; if median improvement, see shapefile
Curb ramp does not land in crosswalk			
No 4' x 4' clear space at base of curb ramp			
Curbed side is not 90° or has traversable adjacent surface			
Flare cross slope is greater than 10%			
Curb ramp running slope is greater than 8.3%			
Blended transition running slope is greater than 5%			
Cut-thru ramp running slope is greater than 5%			
Curb ramp cross slope is greater than 2%			
Cut-thru ramp cross slope is greater than 2%			
Curb ramp width is less than 48"			
Cut-thru ramp width is less than 60"			
Permanent obstruction (>0.25") in curb ramp/landing/flares			
Temporary obstruction (>0.25") in curb ramp/landing/flares			
No textured surface at base of curb ramp			
No color contrast at base of curb ramp

Corner 1 No Ramp (1z)

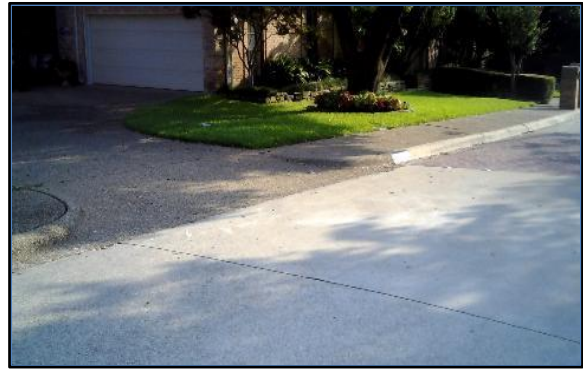
Corner 2 No Ramp (2z)
