Client: Town of Addison Date: 1/2/18
 Program: ADA Self-Evaluation and Transition Plan Prepared By: CMP
 KHA No.: 063543021 Checked By: EPE

Corridor : Oaks N Dr GPS ID: 90112
 Project Name: Intersection of Oaks N Dr and driveway (Lat. 32.9524; Long. -96.8143)
 Town: Addison

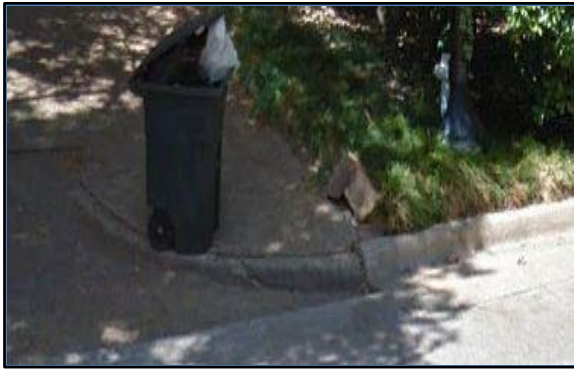
Curb Ramp Issues	Curb Ramp ID ('z' or 'l' in ramp label indicates no existing ramp)		Possible Solutions
	1z	4z	
Curb ramp does not exist and is needed		X	Install curb ramp; if median improvement, see shapefile
Curb ramp does not land in crosswalk			
No 4' x 4' clear space at base of curb ramp			
Curbed side is not 90° or has traversable adjacent surface			
Flare cross slope is greater than 10%			
Curb ramp running slope is greater than 8.3%			
Blended transition running slope is greater than 5%			
Cut-thru ramp running slope is greater than 5%			
Curb ramp cross slope is greater than 2%			
Cut-thru ramp cross slope is greater than 2%			
Curb ramp width is less than 48"			
Cut-thru ramp width is less than 60"			
Permanent obstruction (>0.25") in curb ramp/landing/flares			
Temporary obstruction (>0.25") in curb ramp/landing/flares			
No textured surface at base of curb ramp			
No color contrast at base of curb ramp

Corner 1 No Ramp (1z)

Item No.	Item Description	Quantity	Unit	Unit Price	Item Cost
TxDOT 110-6001	EXCAVATION (ROADWAY)	0	CY	\$ 10.00	\$ -
TxDOT 529-6002	CONC CURB (TY II)	0	LF	\$ 15.00	\$ -
TxDOT 531-6001	CONC SIDEWALKS (4")	0	SY	\$ 45.00	\$ -
TxDOT 531	CURB RAMPS	1	EA	\$ 1,500.00	\$ 1,500.00
TxDOT 5003-6002	RETROFIT DET WARN SURF (CAST IN PLACE)	0	SF	\$ 50.00	\$ -
TxDOT 104-6015	REMOVING CONC (SIDEWALKS)	0	SY	\$ 9.00	\$ -
TxDOT 677	ELIM EXT PAVE MRK & MRKS	0	LF	\$ 2.80	\$ -
TxDOT 666/678	REFL PAV MRK PREP TY I & TY II (W) 24" (SLD)	0	LF	\$ 8.50	\$ -
---	REPAVE ROADWAY	0	LS	\$ 5,000.00	\$ -
---	FIX PONDING	0	LS	\$ 2,000.00	\$ -
---	FIX CURB RAMP TRANSITION	0	LS	\$ 2,000.00	\$ -
---	MEDIAN NOSE MODIFICATION	0	LS	\$ 5,000.00	\$ -
---	REMOVE TEMPORARY OBSTRUCTION	0	LS	\$ 500.00	\$ -
---	FIX CURB RAMP COUNTER SLOPE	0	LS	\$ 2,000.00	\$ -

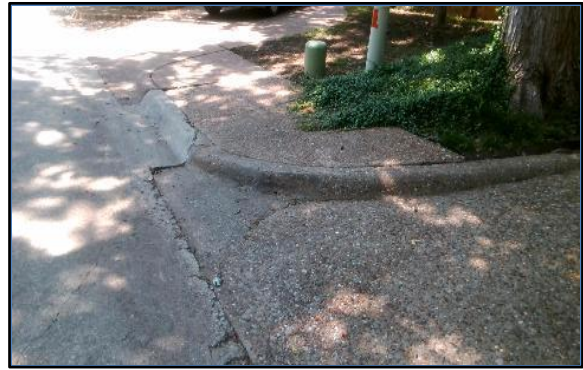
Corner 4 No Ramp (4z)
