Client: Town of Addison Date: 1/2/18
 Program: ADA Self-Evaluation and Transition Plan Prepared By: CMP
 KHA No.: 063543021 Checked By: EPE

Corridor : Les Lacs Ave GPS ID: 90058
 Project Name: Intersection of Les Lacs Ave and driveway (Lat. 32.9474; Long. -96.8536)
 Town: Addison

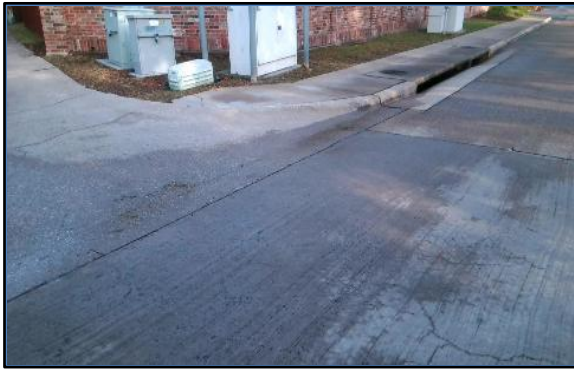
Curb Ramp Issues	Curb Ramp ID ('z' or 'l' in ramp label indicates no existing ramp)		Possible Solutions
	1z	4z	
Curb ramp does not exist and is needed	X	X	Install curb ramp; if median improvement, see shapefile
Curb ramp does not land in crosswalk			
No 4' x 4' clear space at base of curb ramp			
Curbed side is not 90° or has traversable adjacent surface			
Flare cross slope is greater than 10%			
Curb ramp running slope is greater than 8.3%			
Blended transition running slope is greater than 5%			
Cut-thru ramp running slope is greater than 5%			
Curb ramp cross slope is greater than 2%			
Cut-thru ramp cross slope is greater than 2%			
Curb ramp width is less than 48"			
Cut-thru ramp width is less than 60"			
Permanent obstruction (>0.25") in curb ramp/landing/flares			
Temporary obstruction (>0.25") in curb ramp/landing/flares			
No textured surface at base of curb ramp			
No color contrast at base of curb ramp

Corner 1 No Ramp (1z)

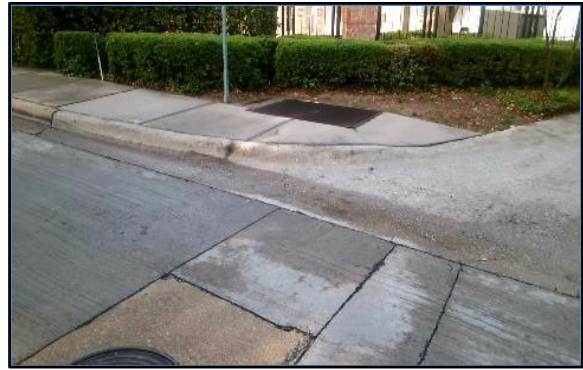
Corner 4 No Ramp (4z)
