LONG STAR BANK  
4650 Bellline Road  
Addicks, TX  
Project # 1804

S4.01

FRAMING DETAILS

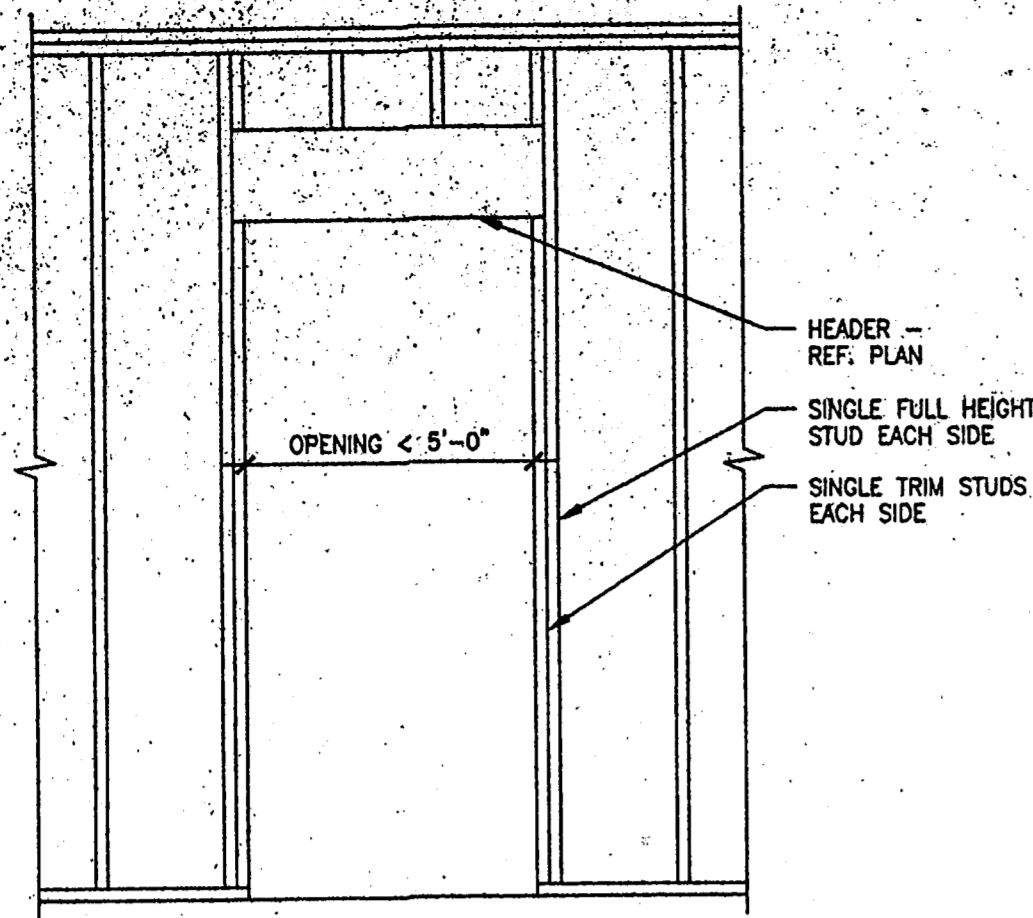
1 TYPICAL OPENING FRAMING AT  
2x STUD WALL - OPENING  $\le 5'-0''$   
NO SCALE

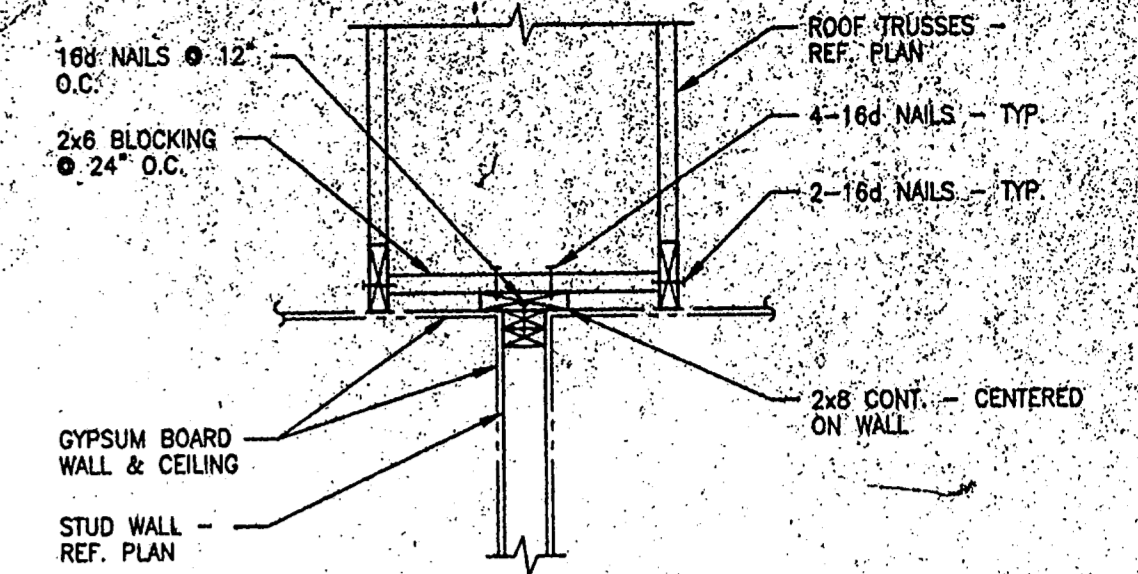
4 TYPICAL ROOF TRUSS TO  
INTERIOR SHEARWALL  
(ROOF TRUSS PARALLEL TO WALL)  
NO SCALE
