LONE STAR BANK
4650 Beltline Road
Addison, TX
Project # 1804

S4.01

FRAMING DETAILS

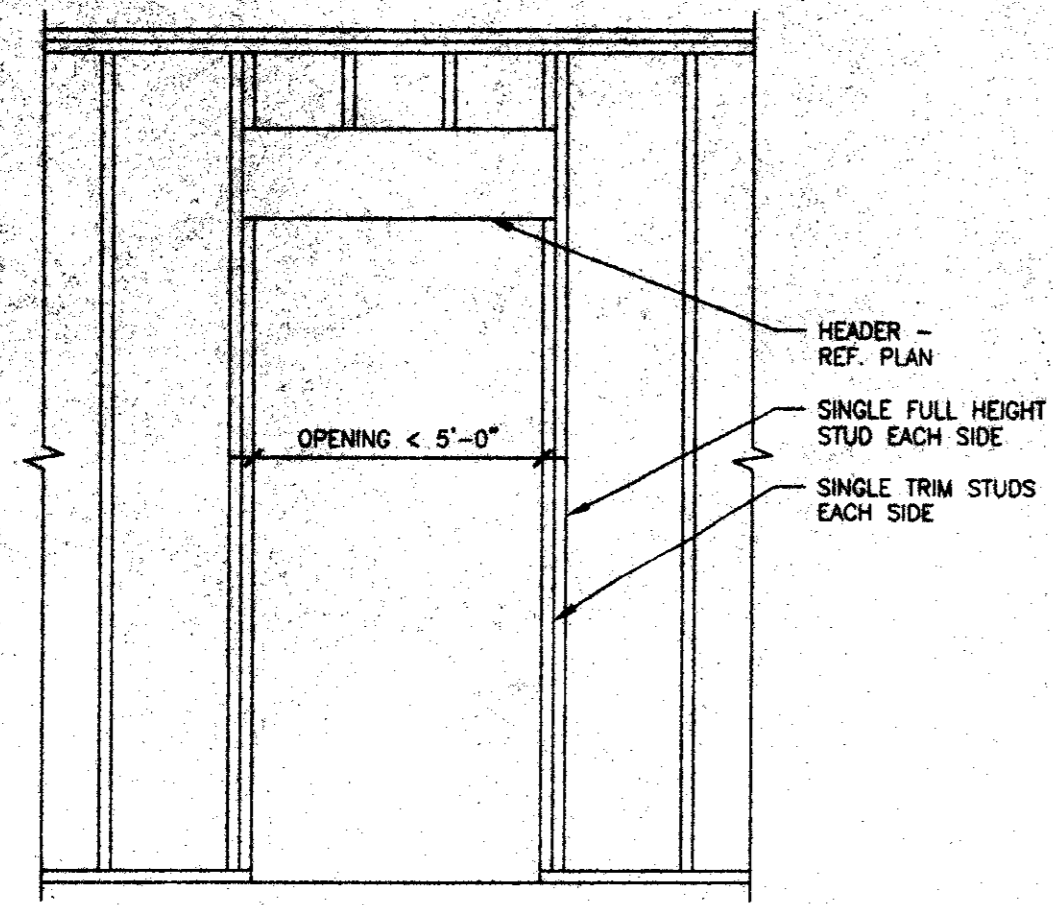
1
S4.01
TYPICAL OPENING FRAMING AT
2x STUD WALL - OPENING \leq 5'-0"
NO SCALE

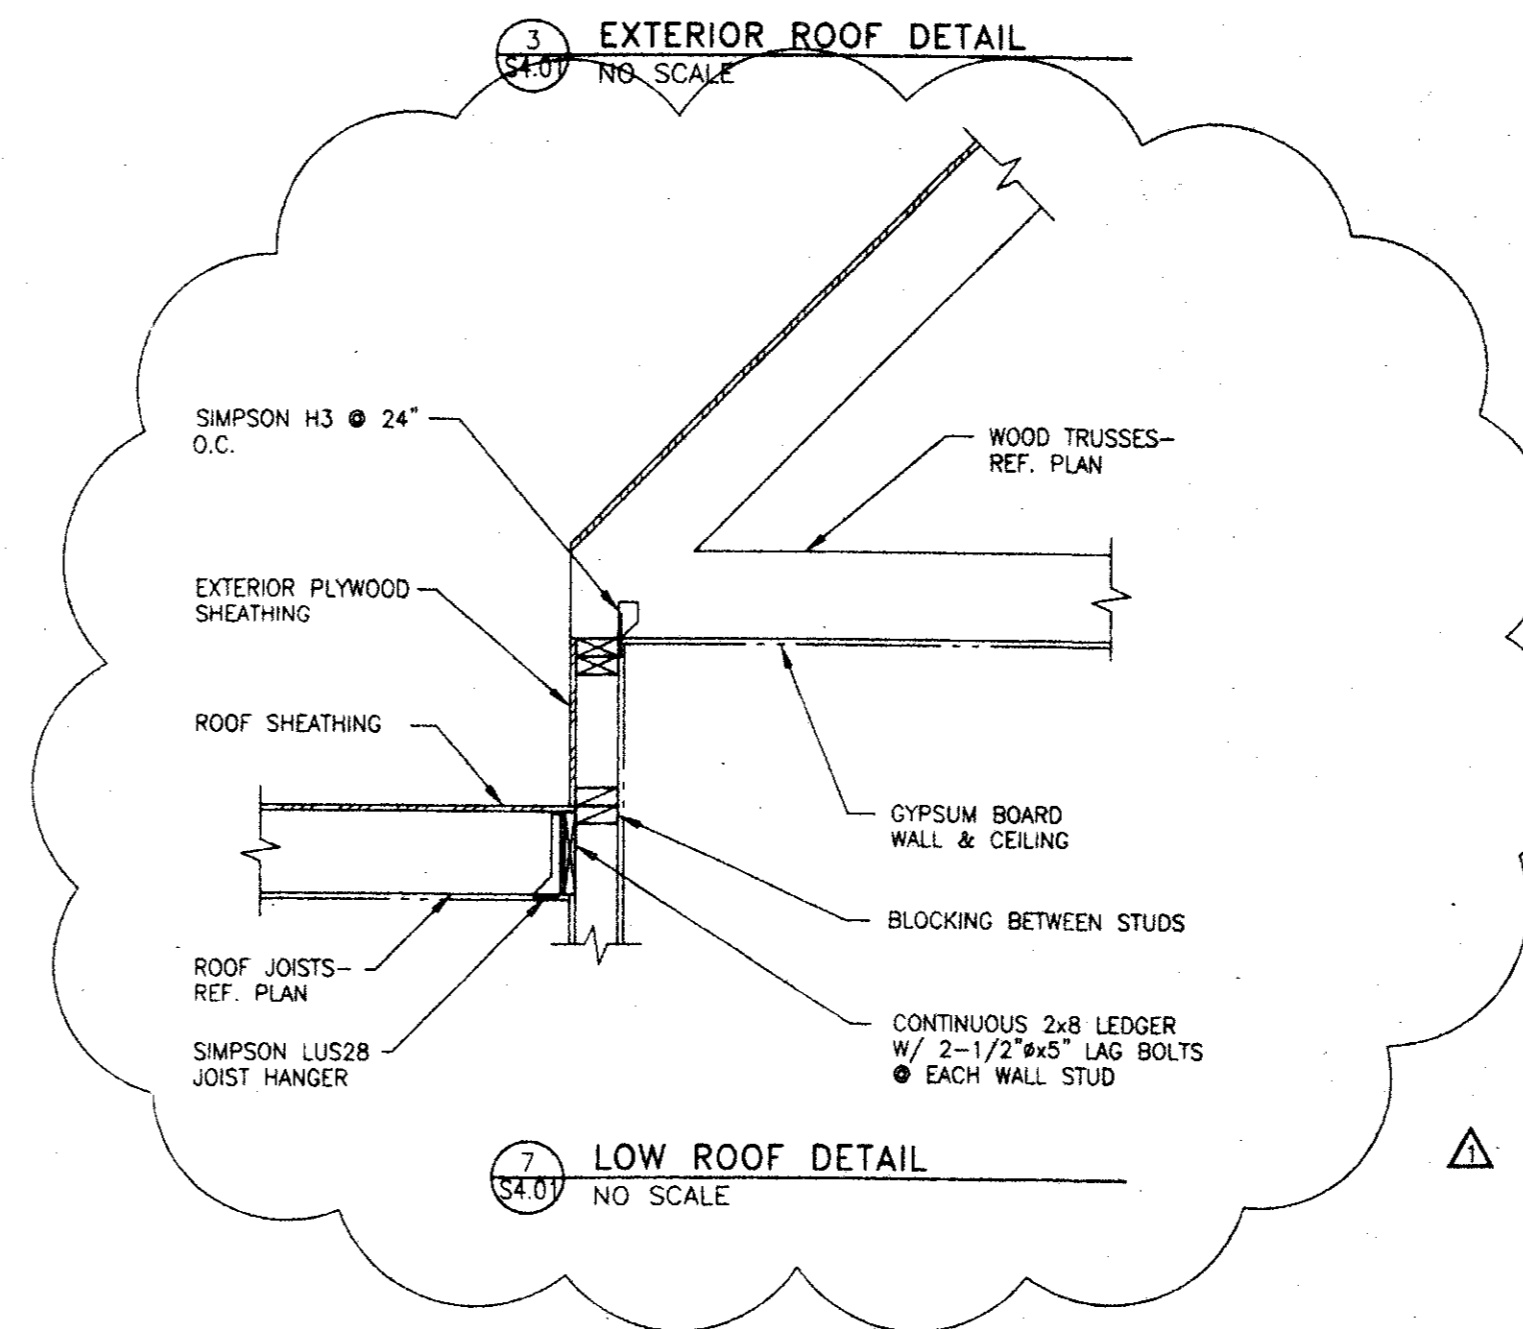
7
S4.01
LOW ROOF DETAIL
NO SCALE
