No.	Revision	By	Date
TOWN OF ADDISON DALLAS COUNTY, TEXAS CROSTOWN WATER LINE			
STA. 48+91 to 55+42			
GINN, INC. Consulting Engineers Dallas, Texas			
Designed - MP	Drawn - GAP	Date - NOVEMBER, 1984	Job No. - 216
Approved - HWG	Checked - GF	Scale - 1"=20'H/1"=5'V	Sheet 10 of 20

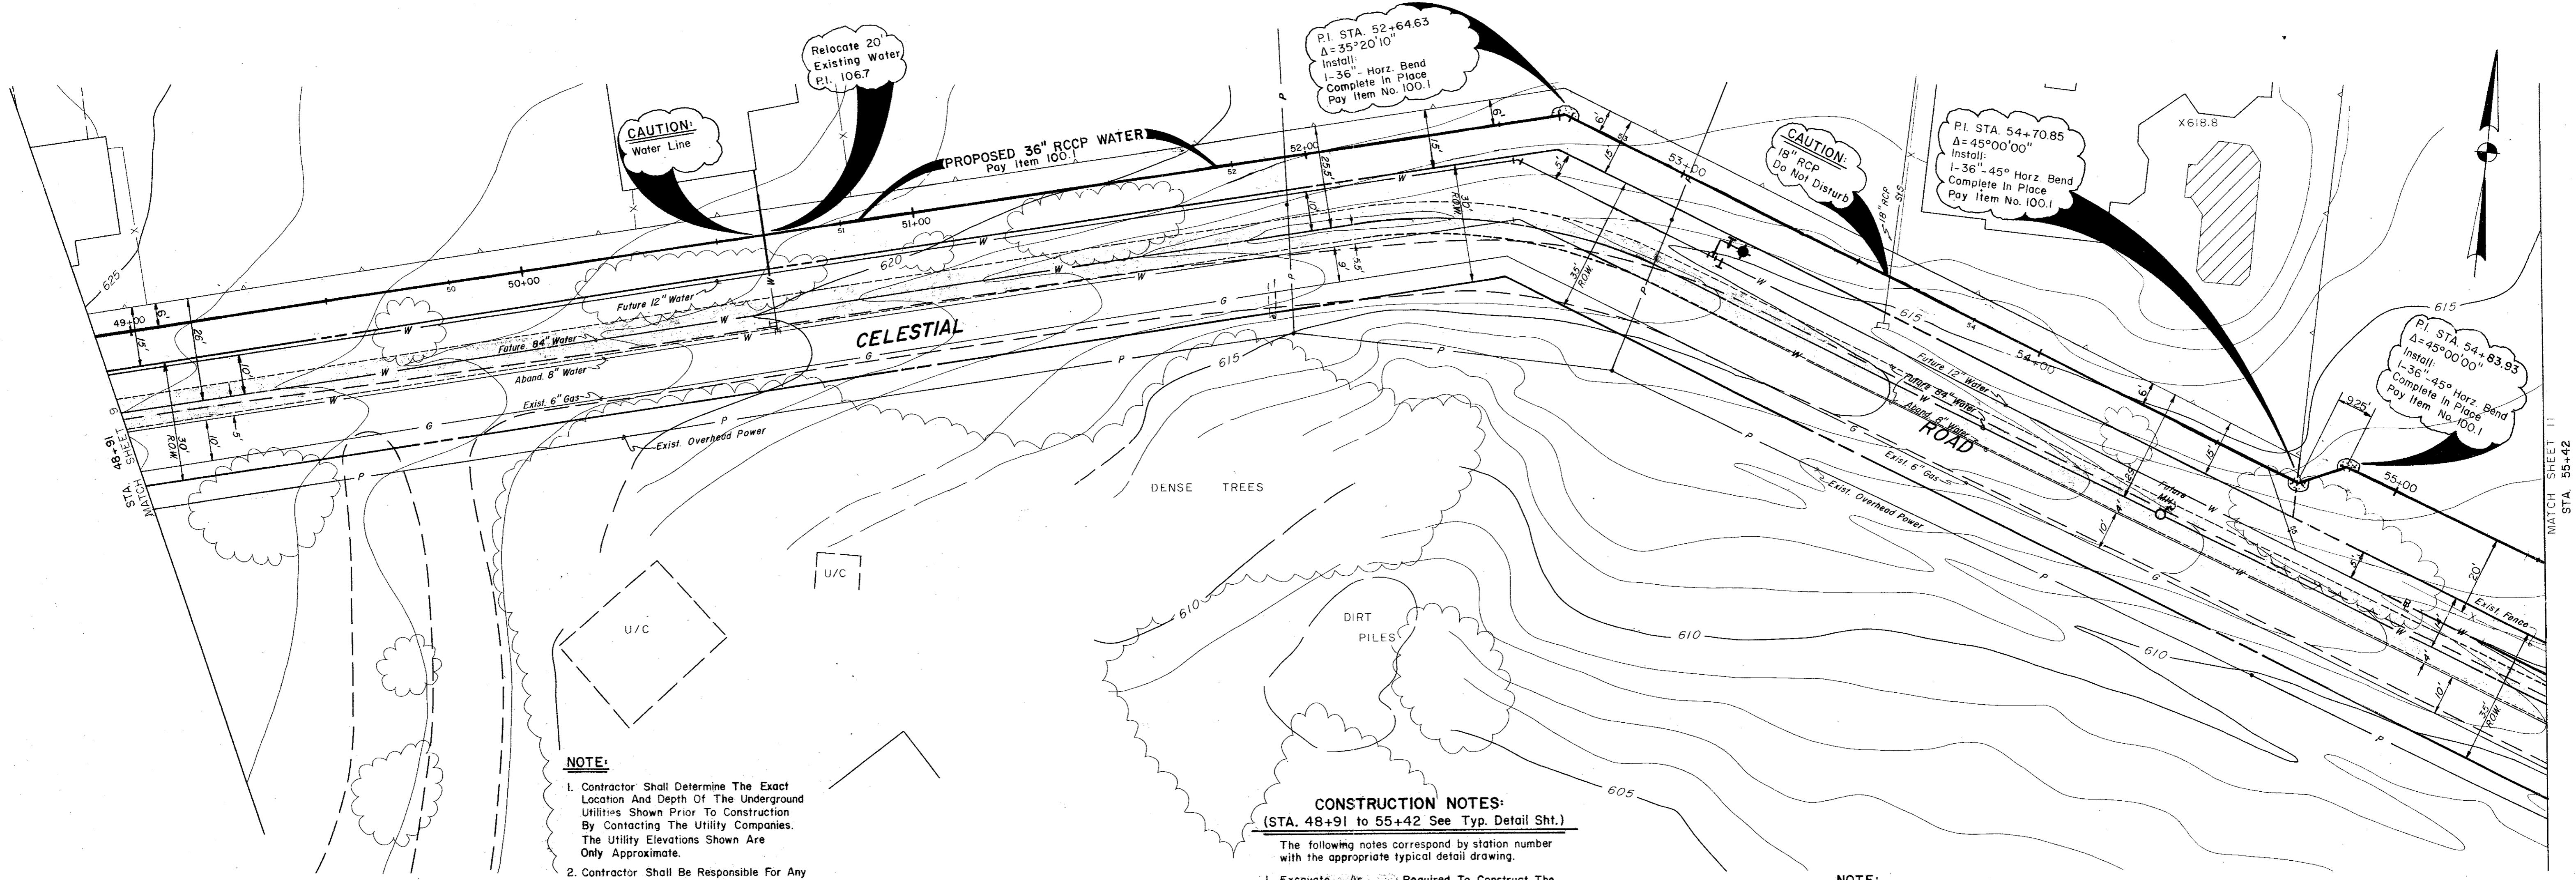
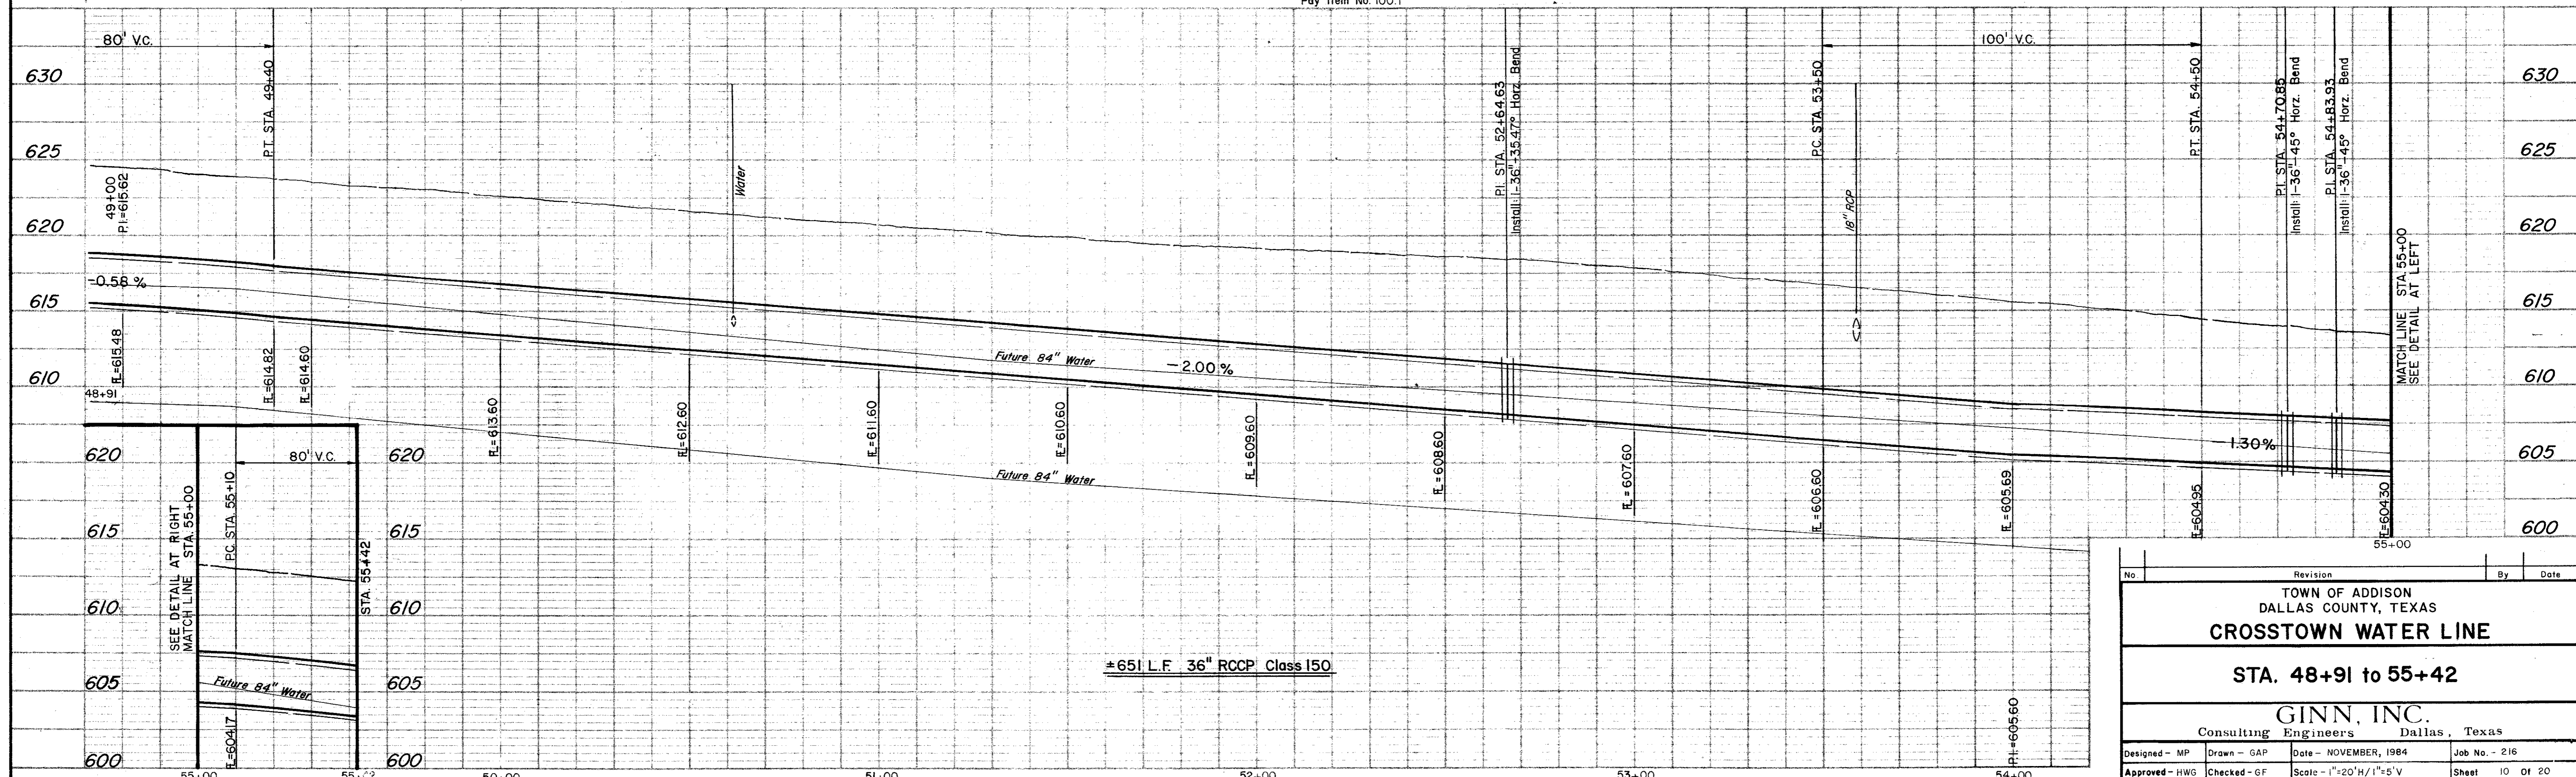
CONSTRUCTION NOTES:
(STA. 48+91 to 55+42 See Typ. Detail Sht.)

- Excavate As Required To Construct The Water Line With Appurtenances, As Shown With The Typical Detail Drawing.
- Replace With Fill Material To Match Existing Grades, As Shown With Typical Detail Drawing, Not A Separate Pay Item, Include in Pay Item No. 100.1

NOTE:
Block All Bends, Tees And Plugs As Required By Appurtenances. See Typical Detail Sheet.

B.M. "□" Plus Mark #19 At Sta. 55+28± On Celestial Rd. Elev. 614.37
