11129

S4.03

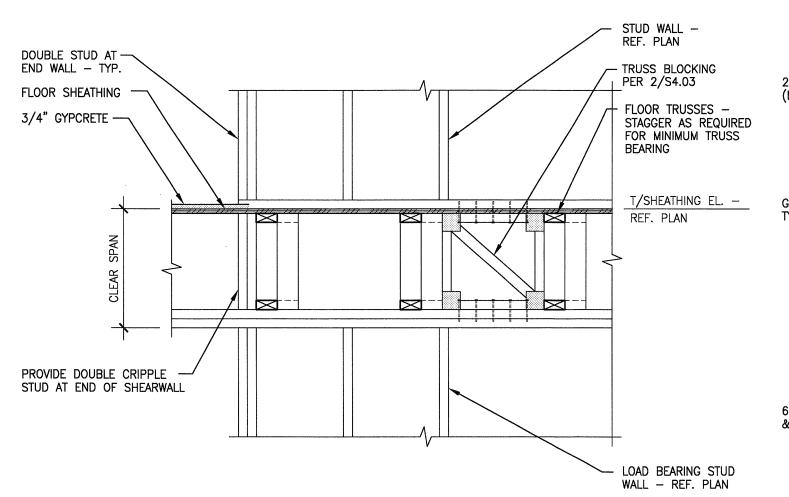
TYPICAL INTERIOR SHEARWALL DETAIL (TRUSSES PERPENDICULAR TO WALL) NO SCALE

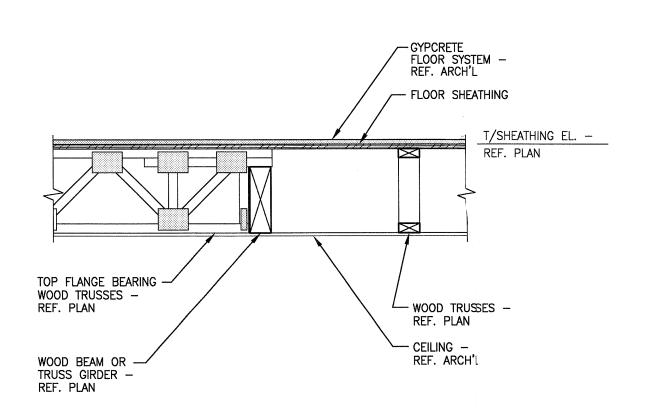
TYPICAL FLOOR TRUSS TO FLUSH BEAM CONNECTION S4.03 NO SCALE

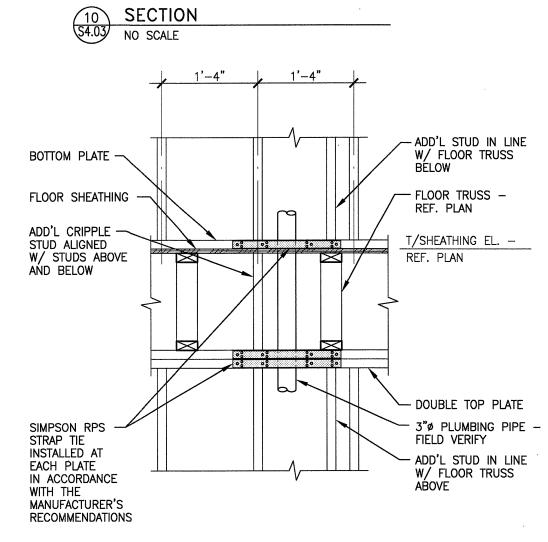
S4.03 NO SCALE

TYPICAL PLATE REPAIR DETAIL

AT PLUMBING PENETRATION

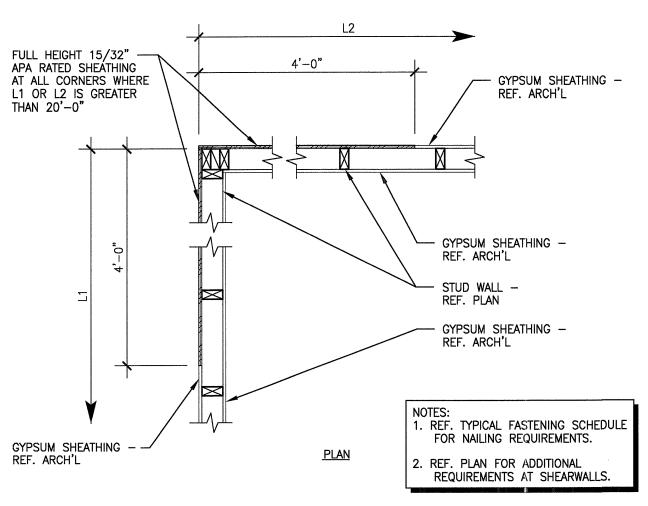
TYPICAL EXTERIOR

CORNER BRACING DETAIL

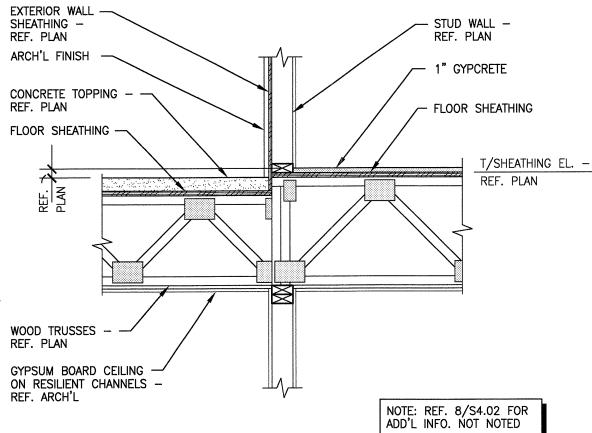
TYPICAL EXTERIOR
LOAD BEARING WALL DETAIL
(TRUSSES PERPENDICULAR TO WALL)
