KELLER SPRINGS LOFTS
LOFT APARTMENTS IN ADDISON, TEXAS

CONSTRUCTION ISSUE
10-17-2011

S3.01

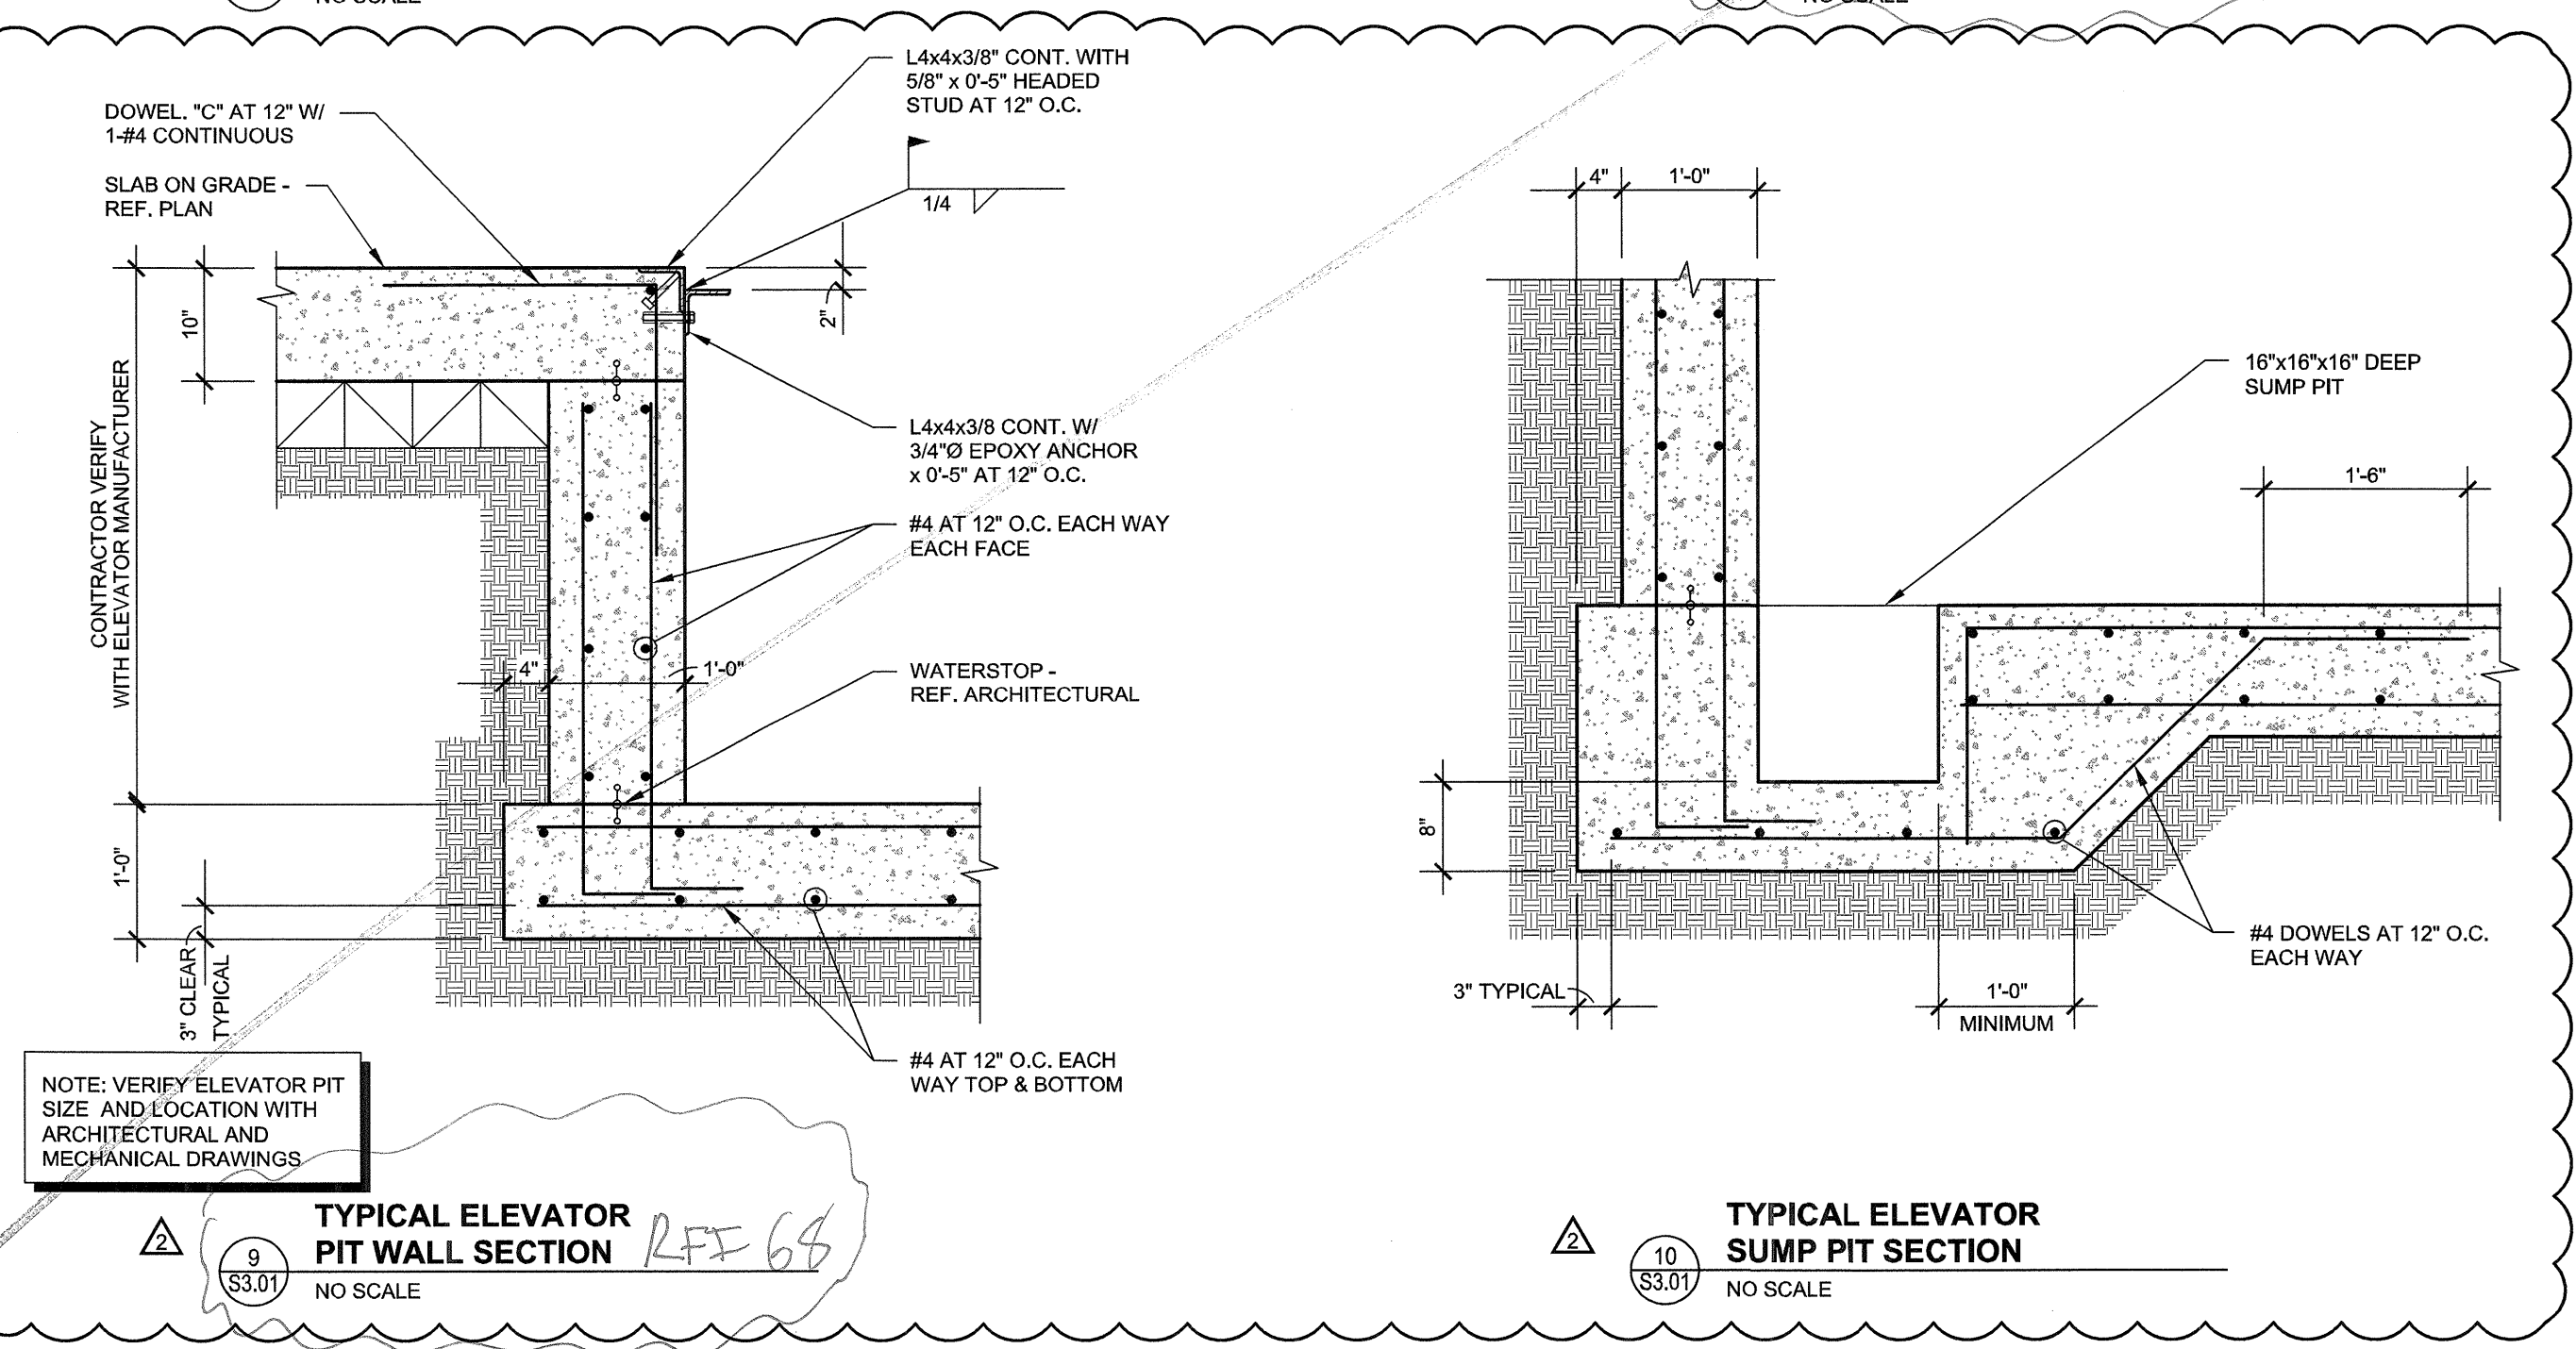
9 TYPICAL ELEVATOR PIT WALL SECTION
NO SCALE
RFI 68

10 TYPICAL ELEVATOR SUMP PIT SECTION
NO SCALE
