**SITE PLAN - PART "BB"**  
**GRADING & DRAINAGE**

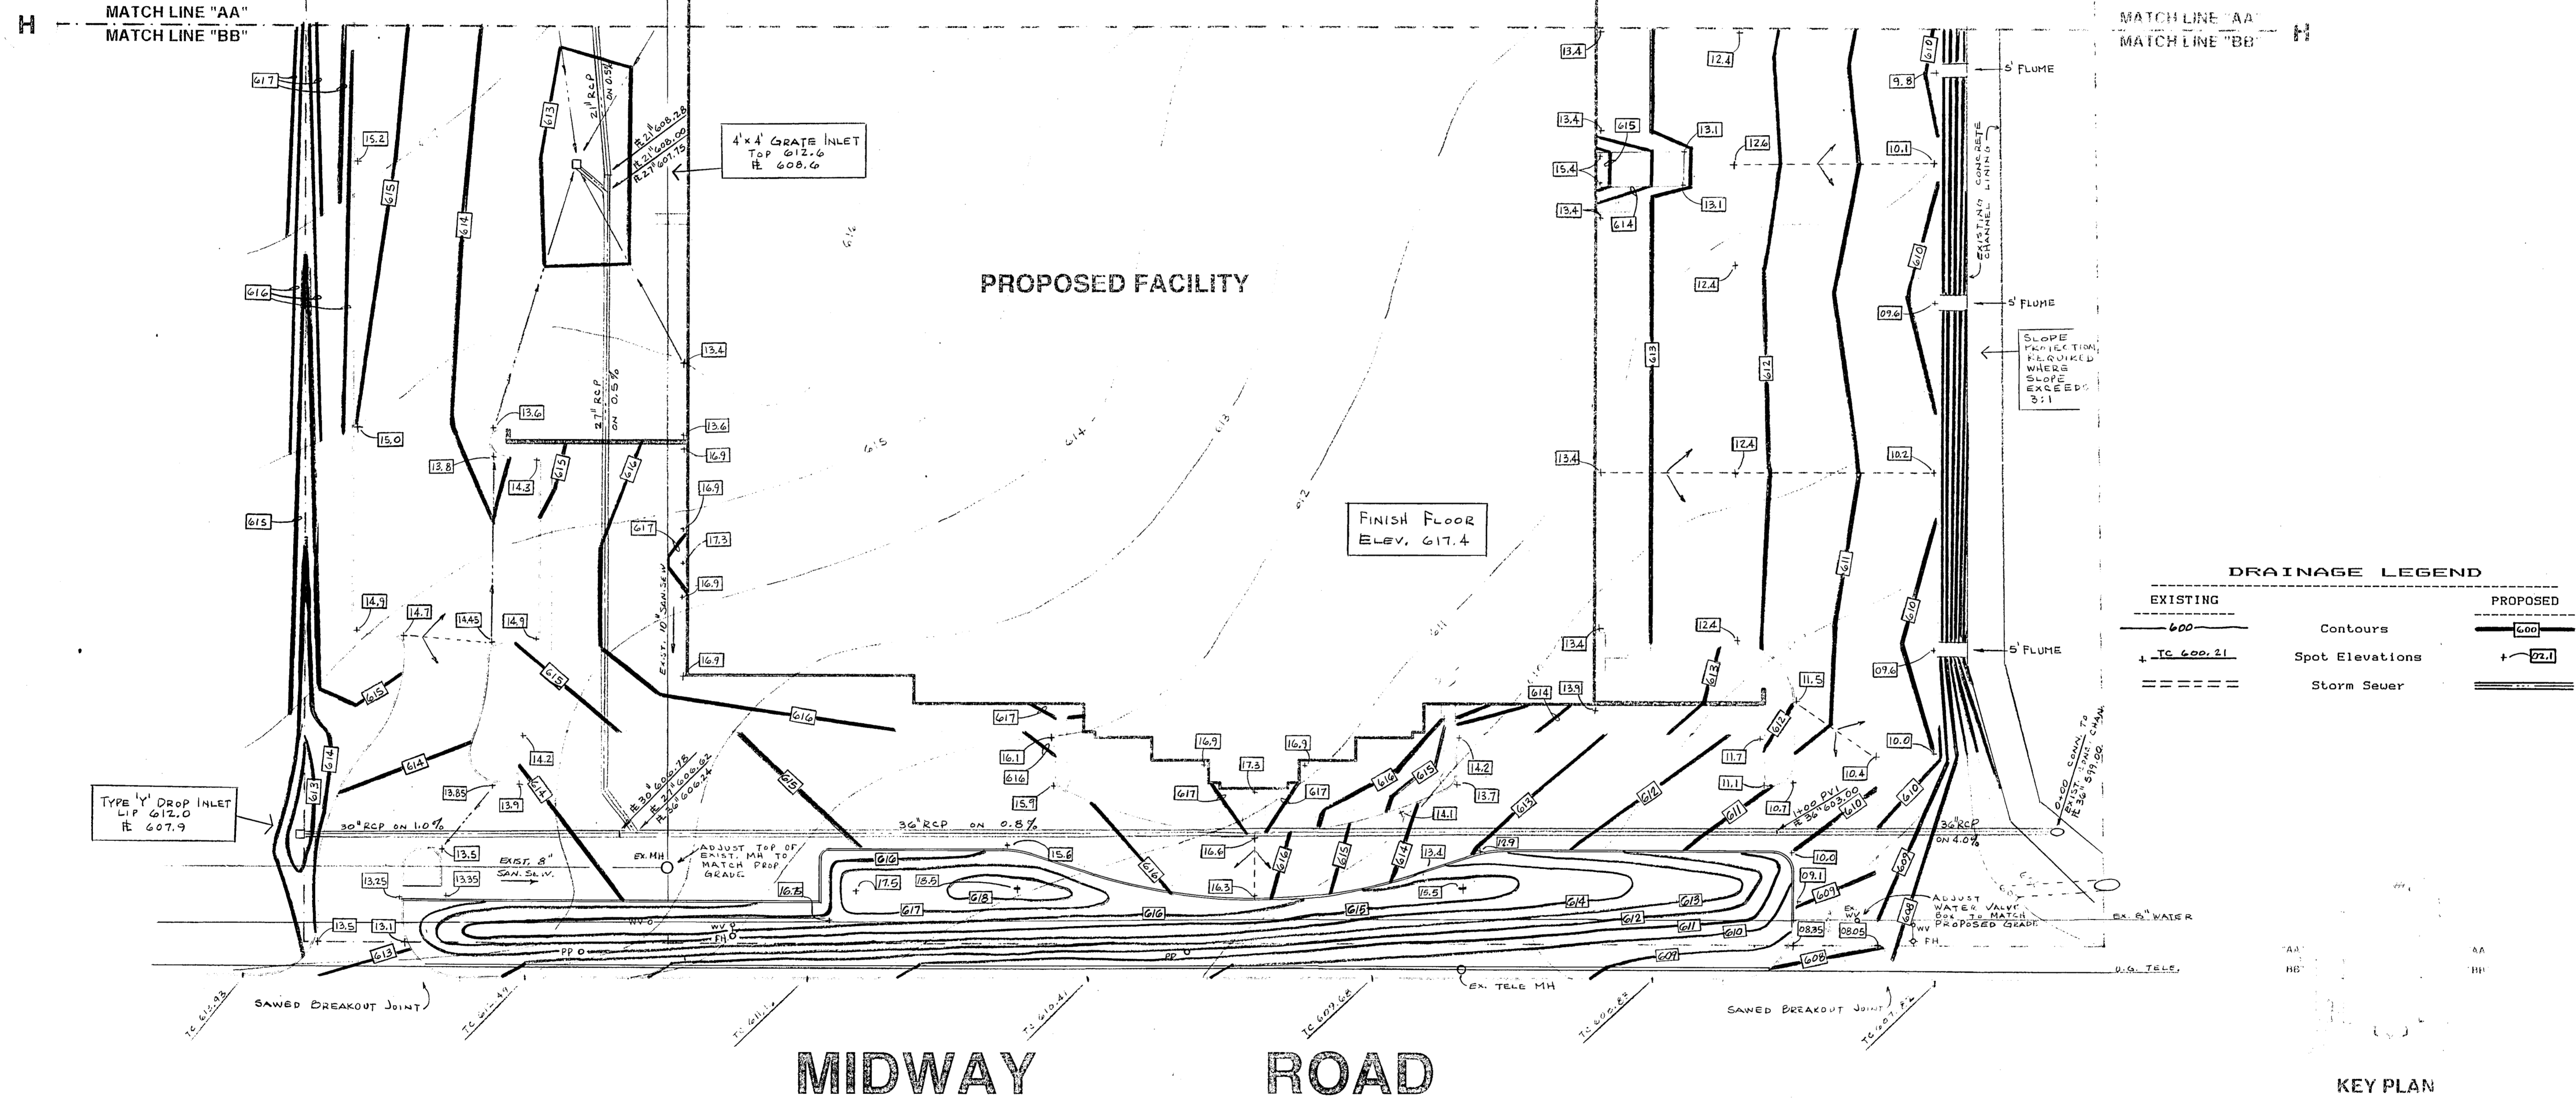
Note: The contours which are indicated on these drawings as existing were taken from a Topographic Survey performed by George Collis Land Surveyors dated Sept. 15, 1993. Since that date both fill and erosion have taken place on the site, and have altered the existing conditions.

BH: Operating Nut of Fire Hydrant at SU Corner of Site.  
 Elev. = 609.16
