BUDE & ASSOCIATES, INC.
AERIAL PHOTOGRAPHY AND MAPPING SERVICES

Sheet 29

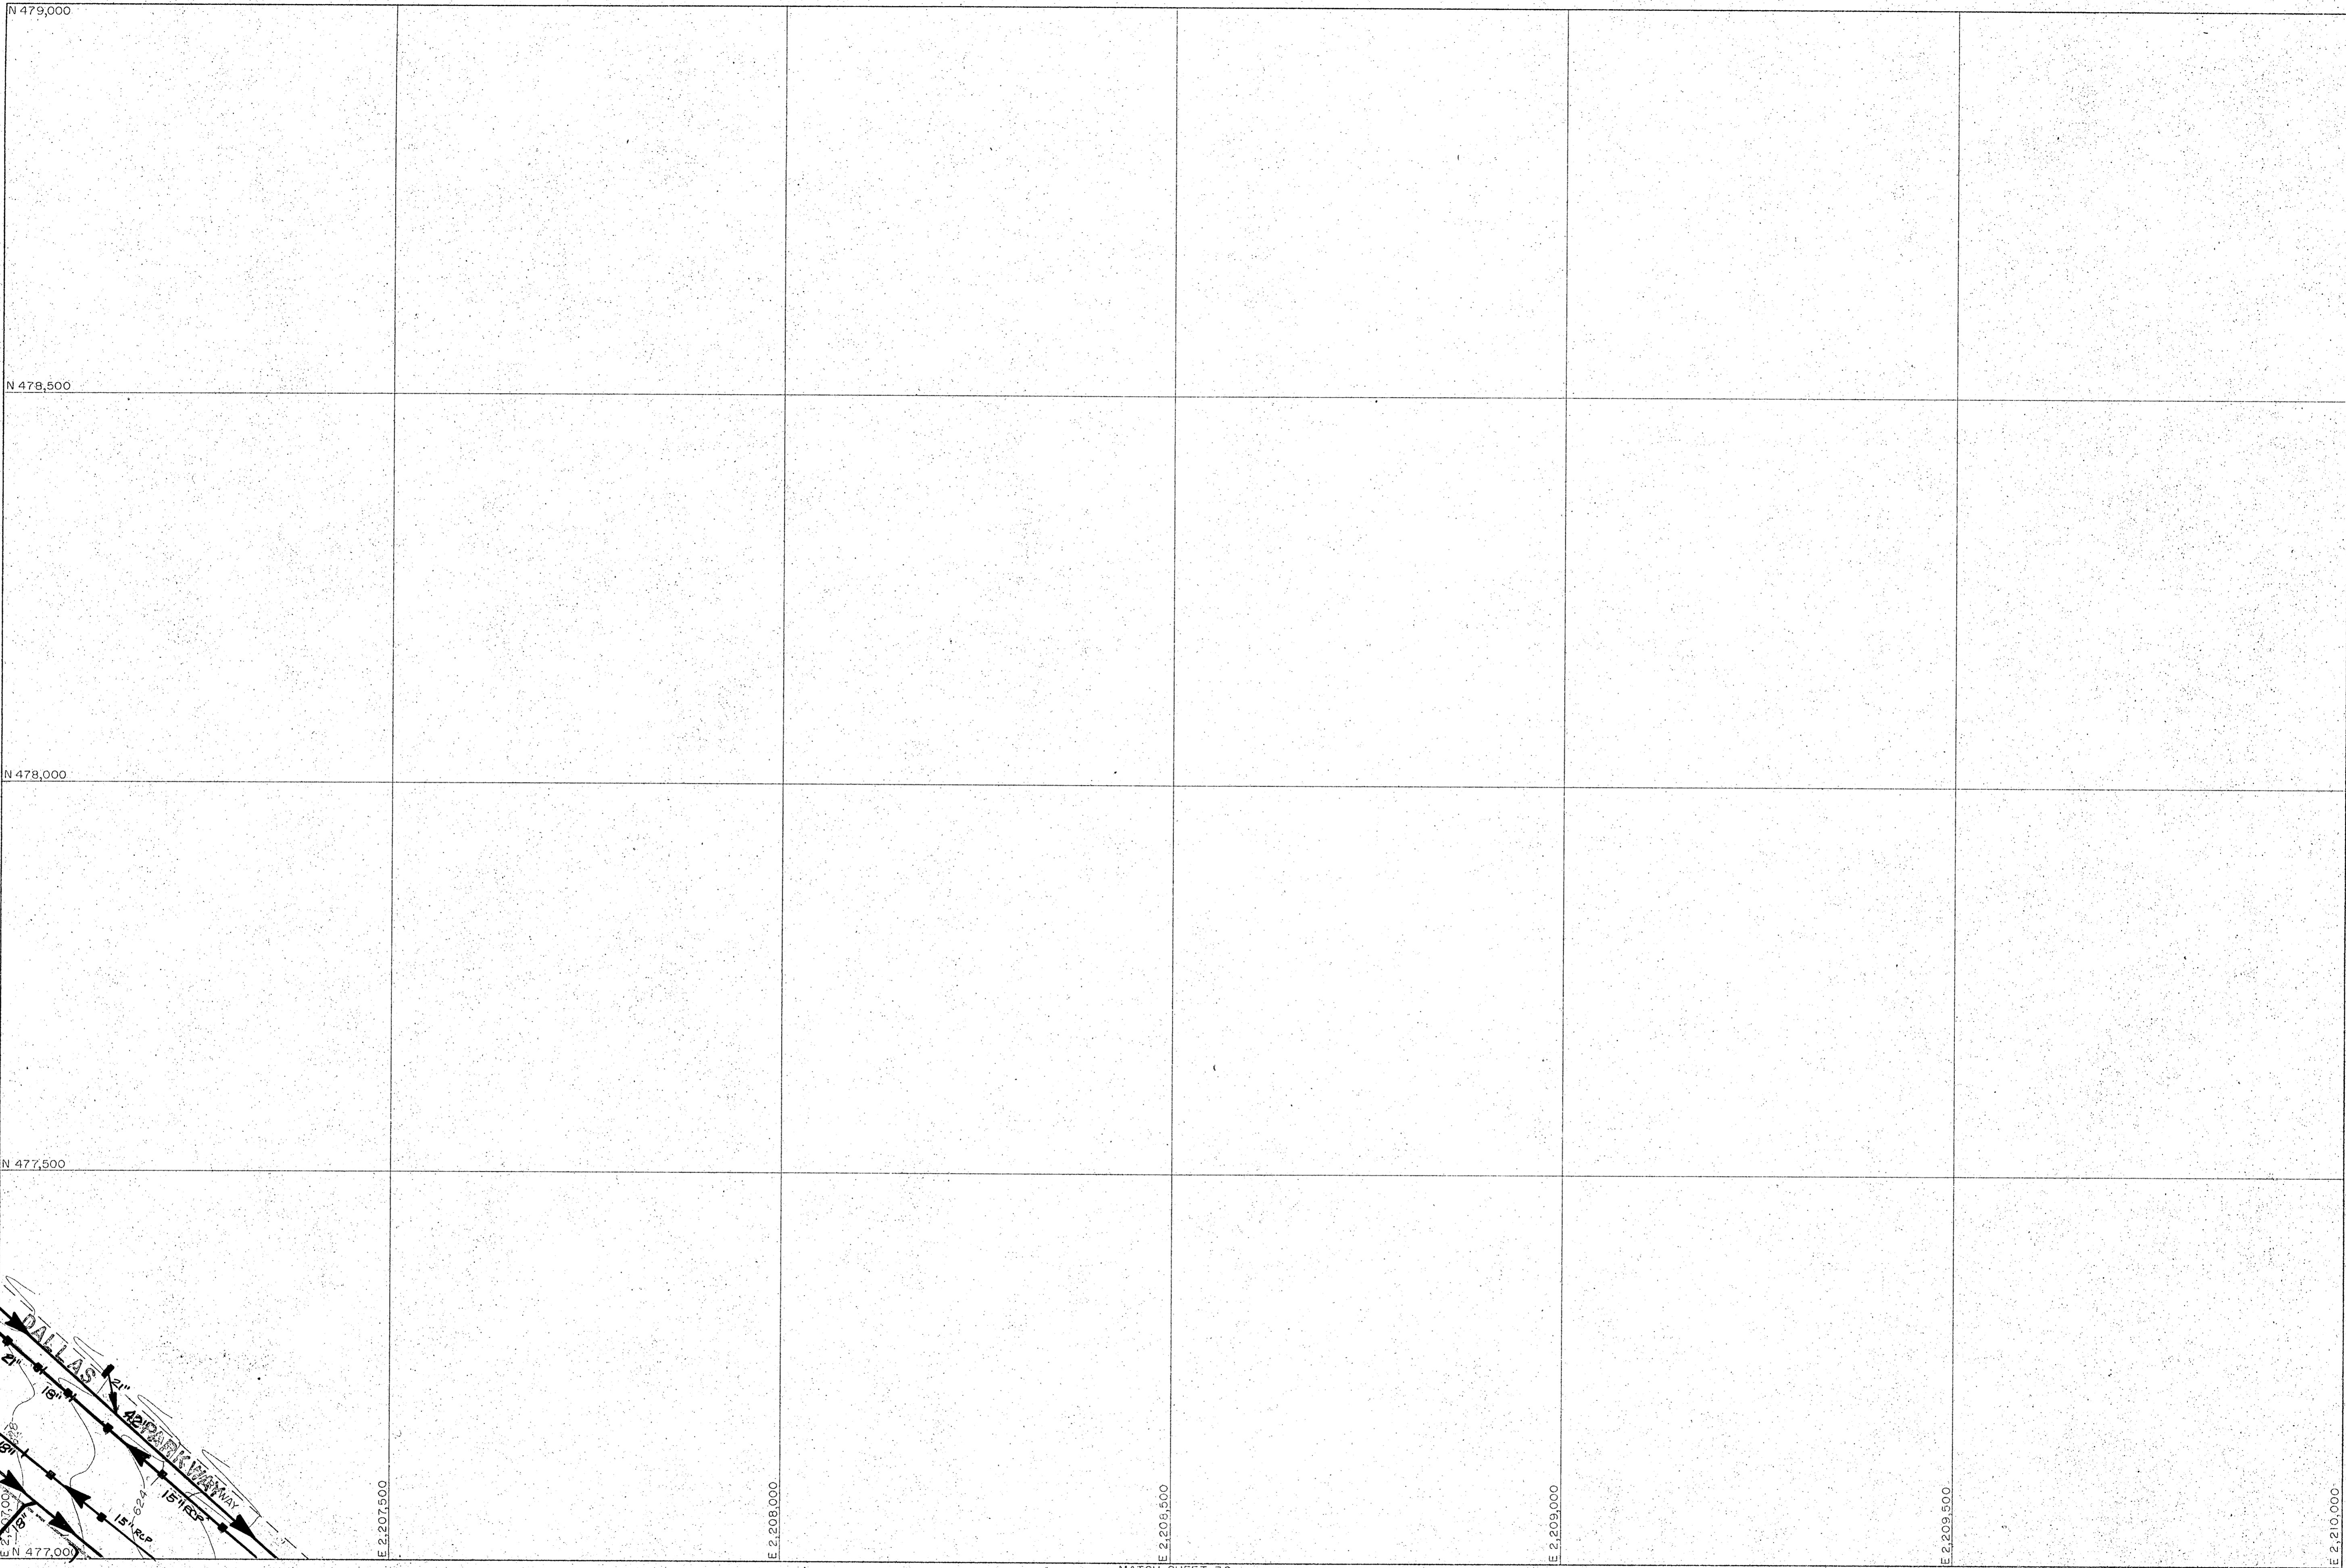
Compiled from aerial photographs taken Nov. 1, 1976 with Wild RC-9 camera. Horizontal Control was extended from existing U.S. Coast and Geodetic Survey monuments by geodimeter and theodolite measurements, with further densification by Aero-Triangular with A-5 Autograph. Vertical control extended from existing U.S.C. and G.S. Bench Marks by spirit leveling.

Grid lines and values shown are based on the Texas State Coordinate System, North Central Zone.
