"As-Built Plans"
 1-31-92

EROSION CONTROL						
WATERVIEW ESTATES						
Town Of Addison, Texas						
don a.t. DON A. TIPTON, INC. CONSULTING ENGINEERS						
6330 Belt Line Rd. ~ Suite C ~ Garland, Texas 75043						
DESIGN	DRAWN	DATE	SCALE	NOTES	FILE	NO.
d.a.t. inc.	d.a.t. inc.	7/91	1"=60'	d.b.	Waterview Estates 3626	8

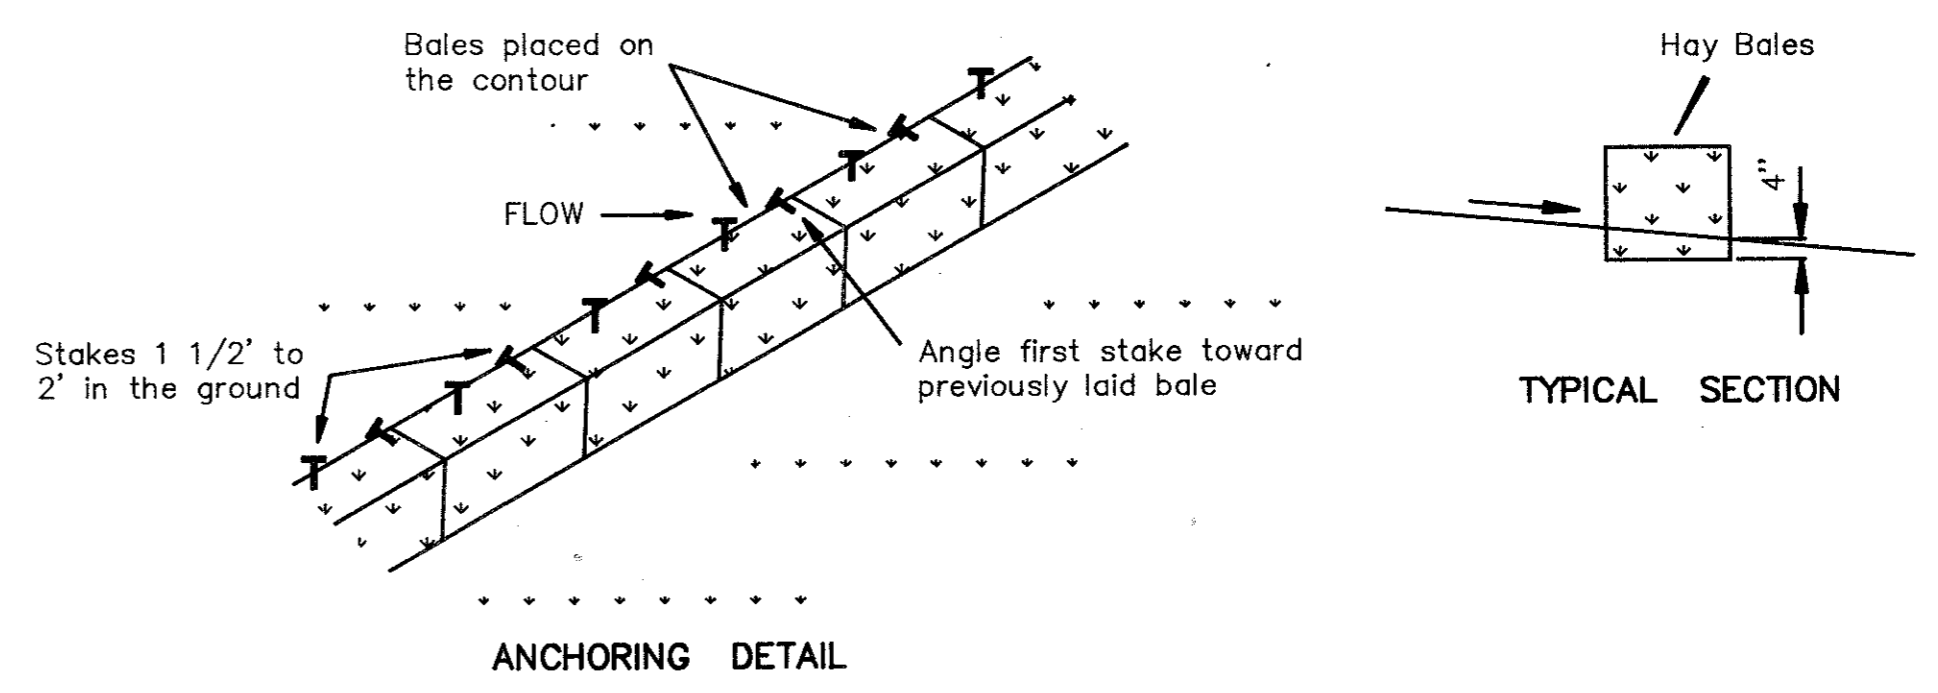
TYPICAL HAY BALE PLACEMENT

- CONSTRUCTION NOTES:
- Hay bales shall be installed a minimum of 4" into the ground.
 - Contractor will install additional erosion control where erosion protection is needed as per the owners engineers, or the Town of Addison inspector.
 - The existing vegetation along existing parkways and medians shall be replaced to its original condition or better.
 - All drainage swales shall be grassed as per Town Standards, prior to the City acceptance of project.
 - All construction erosion control shall meet Town of Addisons Ordinance.
 - Install grass in all new parkway as per Town Standards.

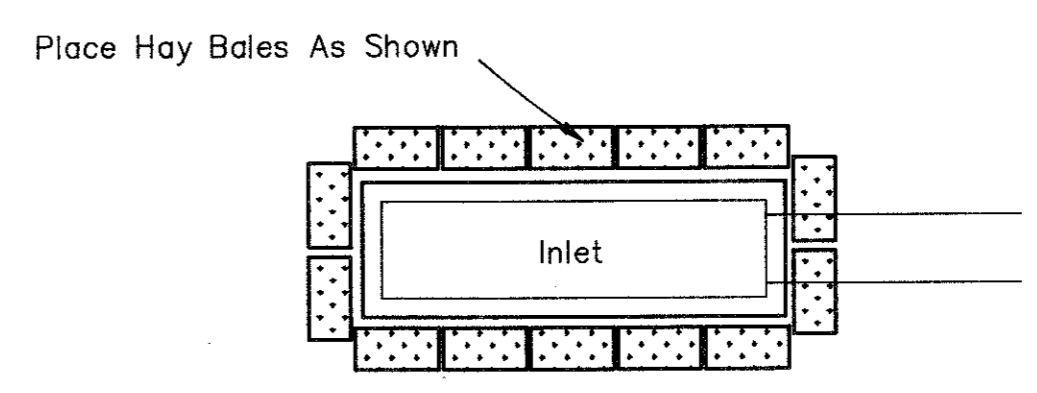
TYPICAL HAY BALE PLACEMENT AROUND INLETS
