| EROSION CONTROL | | | | | | |
| WATERVIEW ESTATES | | | | | | |
| Town Of Addison, Texas | | | | | | |
| DON A. TIPTON, INC. CONSULTING ENGINEERS | | | | | | |

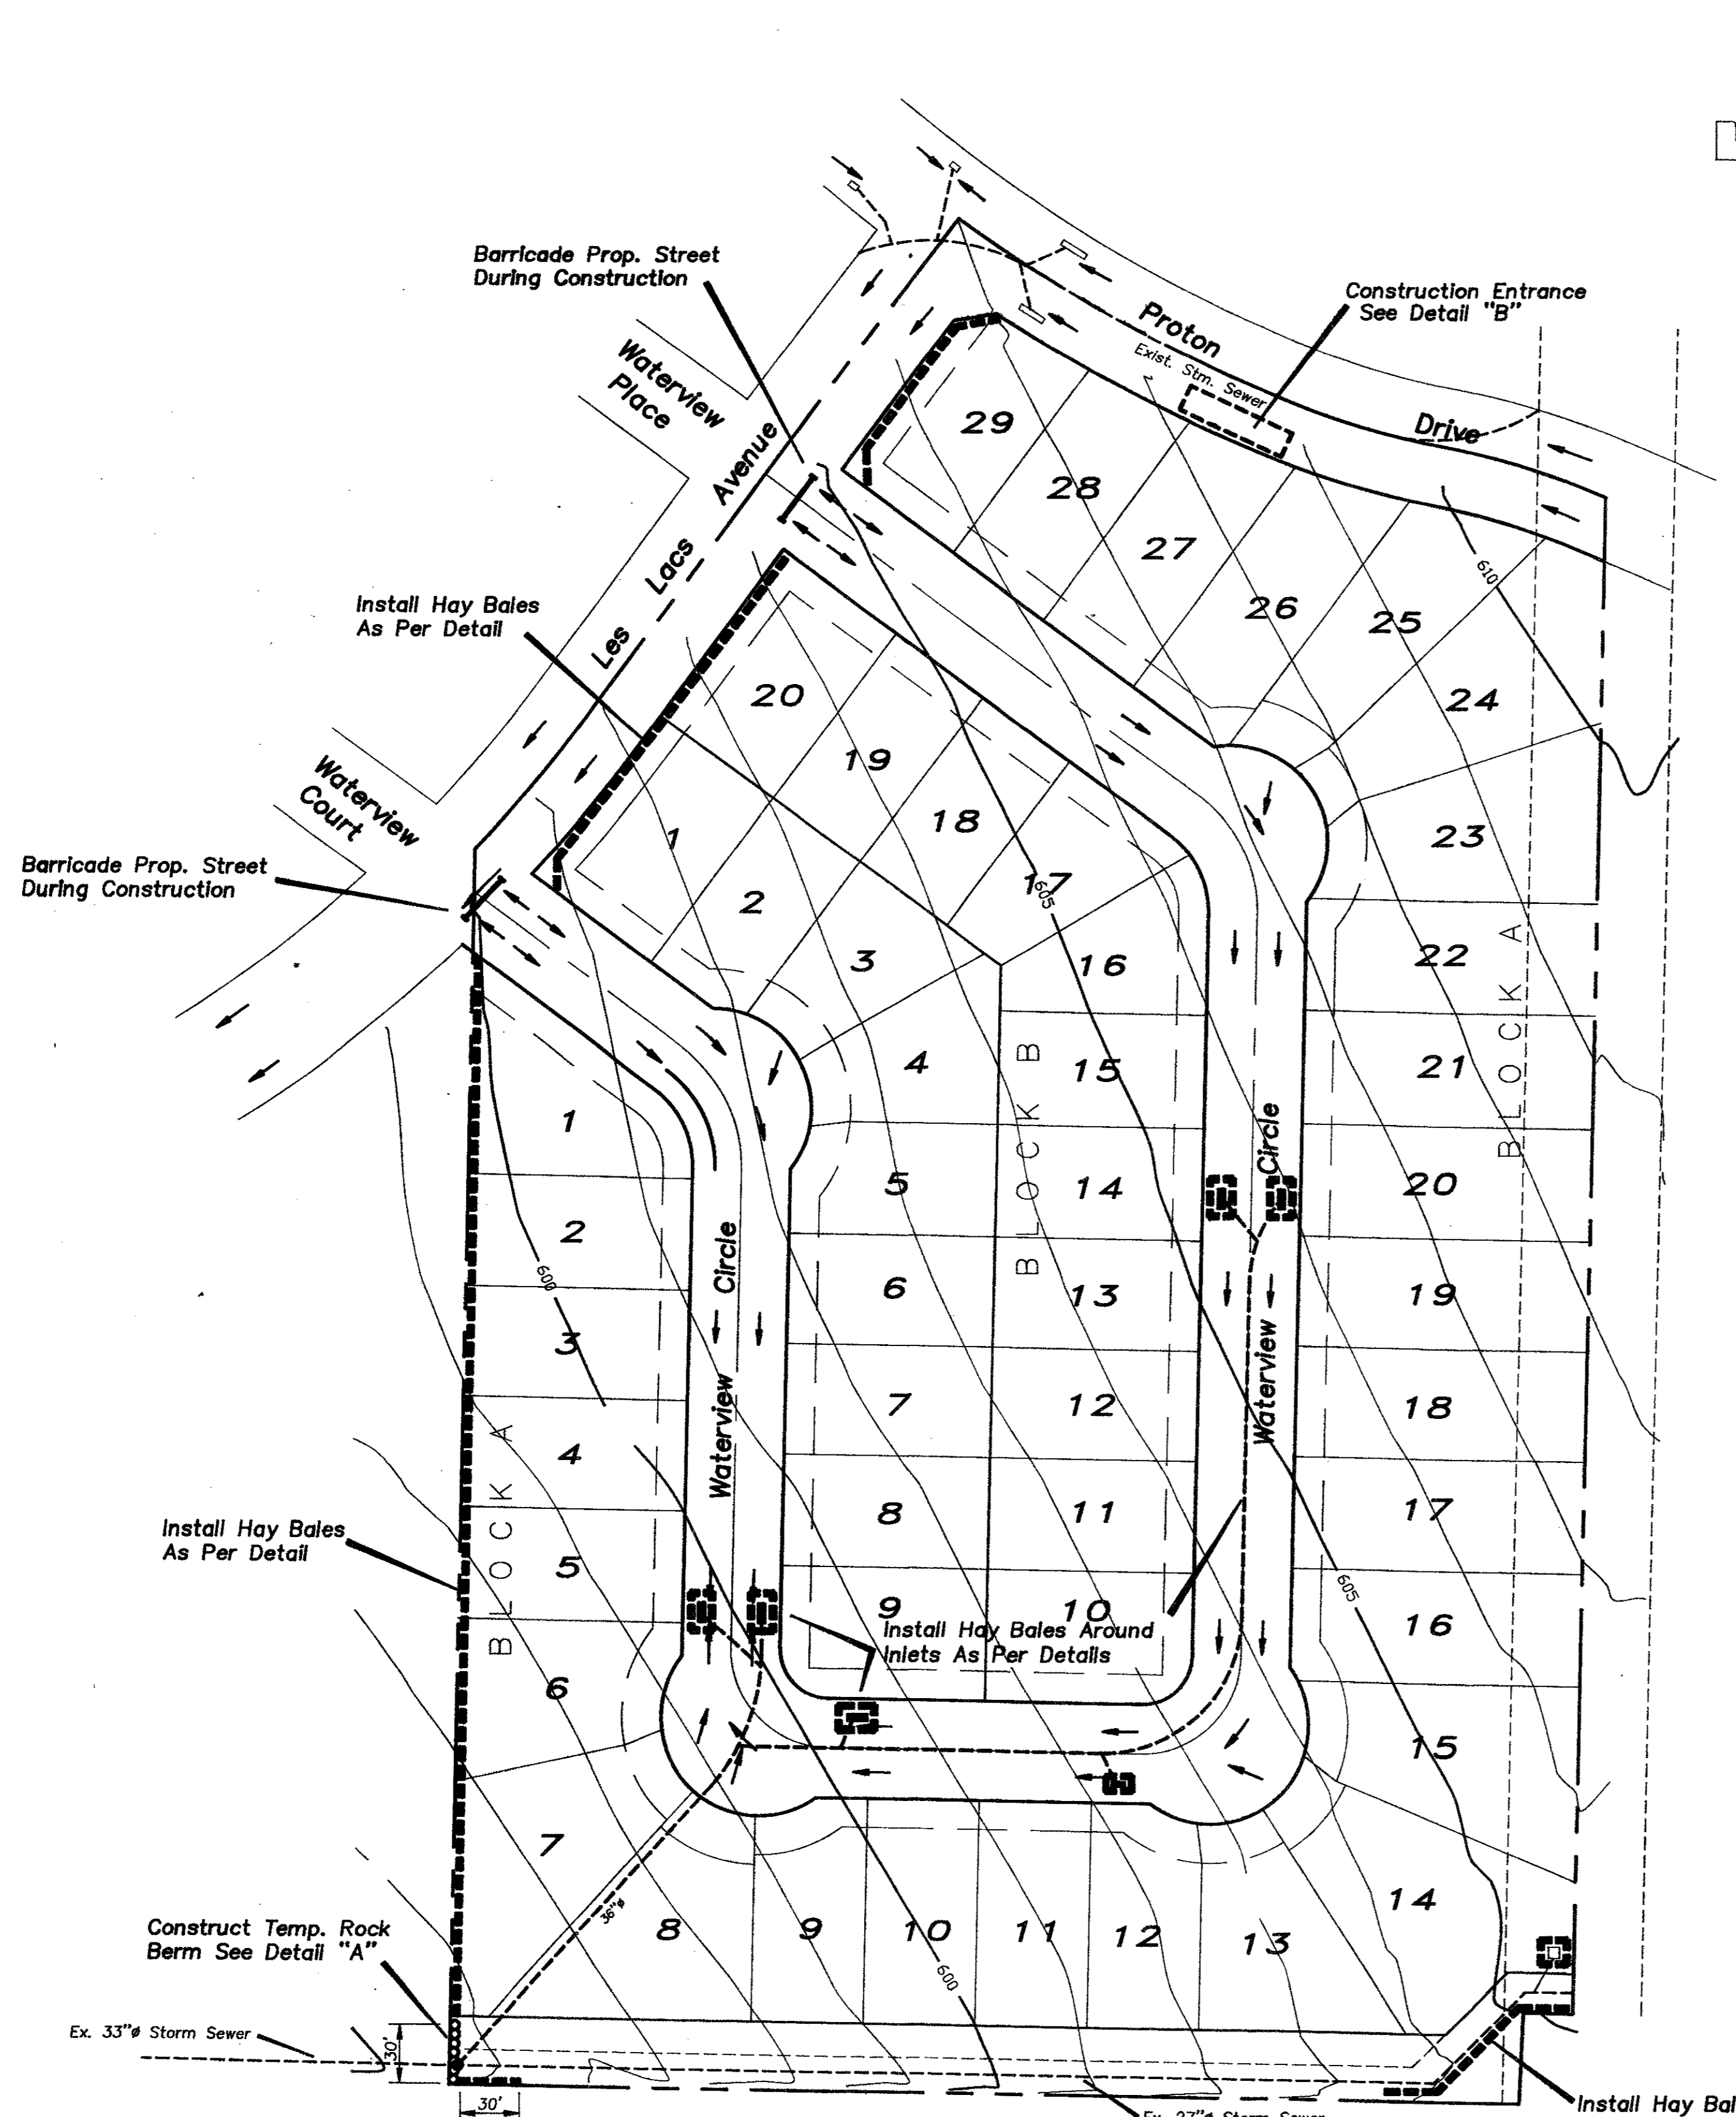
- Hay bales shall be installed a minimum of 4" into the ground.
- Contractor will install additional erosion control where erosion protection is needed as per the owners engineers, or the Town of Addison Inspector.
- The existing vegetation along existing parkways and medians shall be replaced to its original condition or better.
- All drainage swales shall be grassed as per Town Standards, prior to the City acceptance of project.
- All construction erosion control shall meet Town of Addisons Ordinance.
- Install grass in all new parkway as per Town Standards.

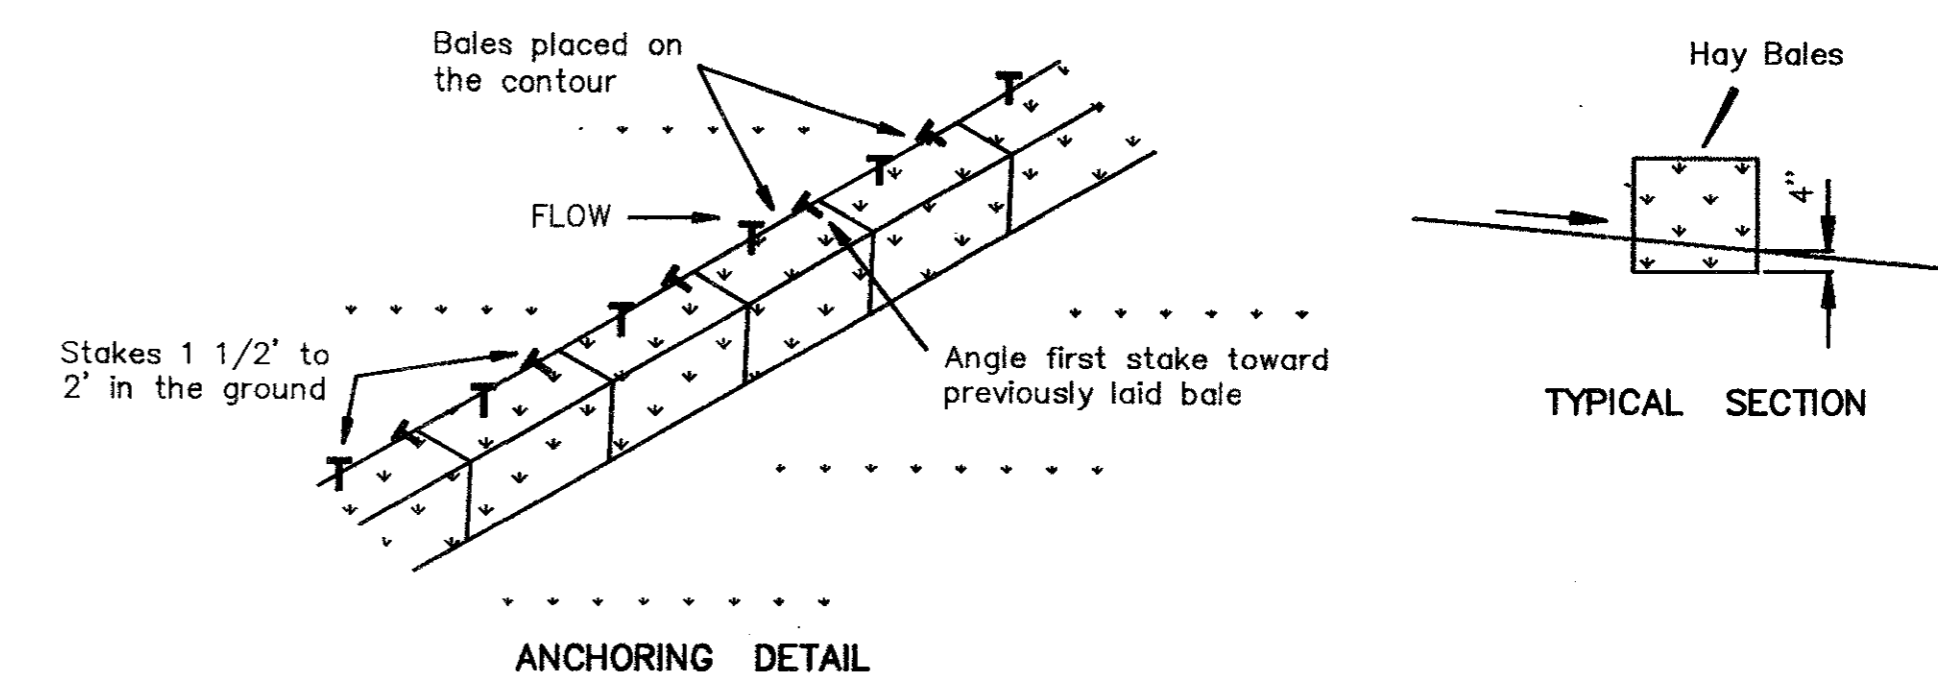
TYPICAL HAY BALE PLACEMENT

Place Hay Bales As Shown
