"As-Built Plans"
1-31-92

| EROSION CONTROL | | | | | | |
| WATERVIEW ESTATES | | | | | | |
| Town Of Addison, Texas | | | | | | |

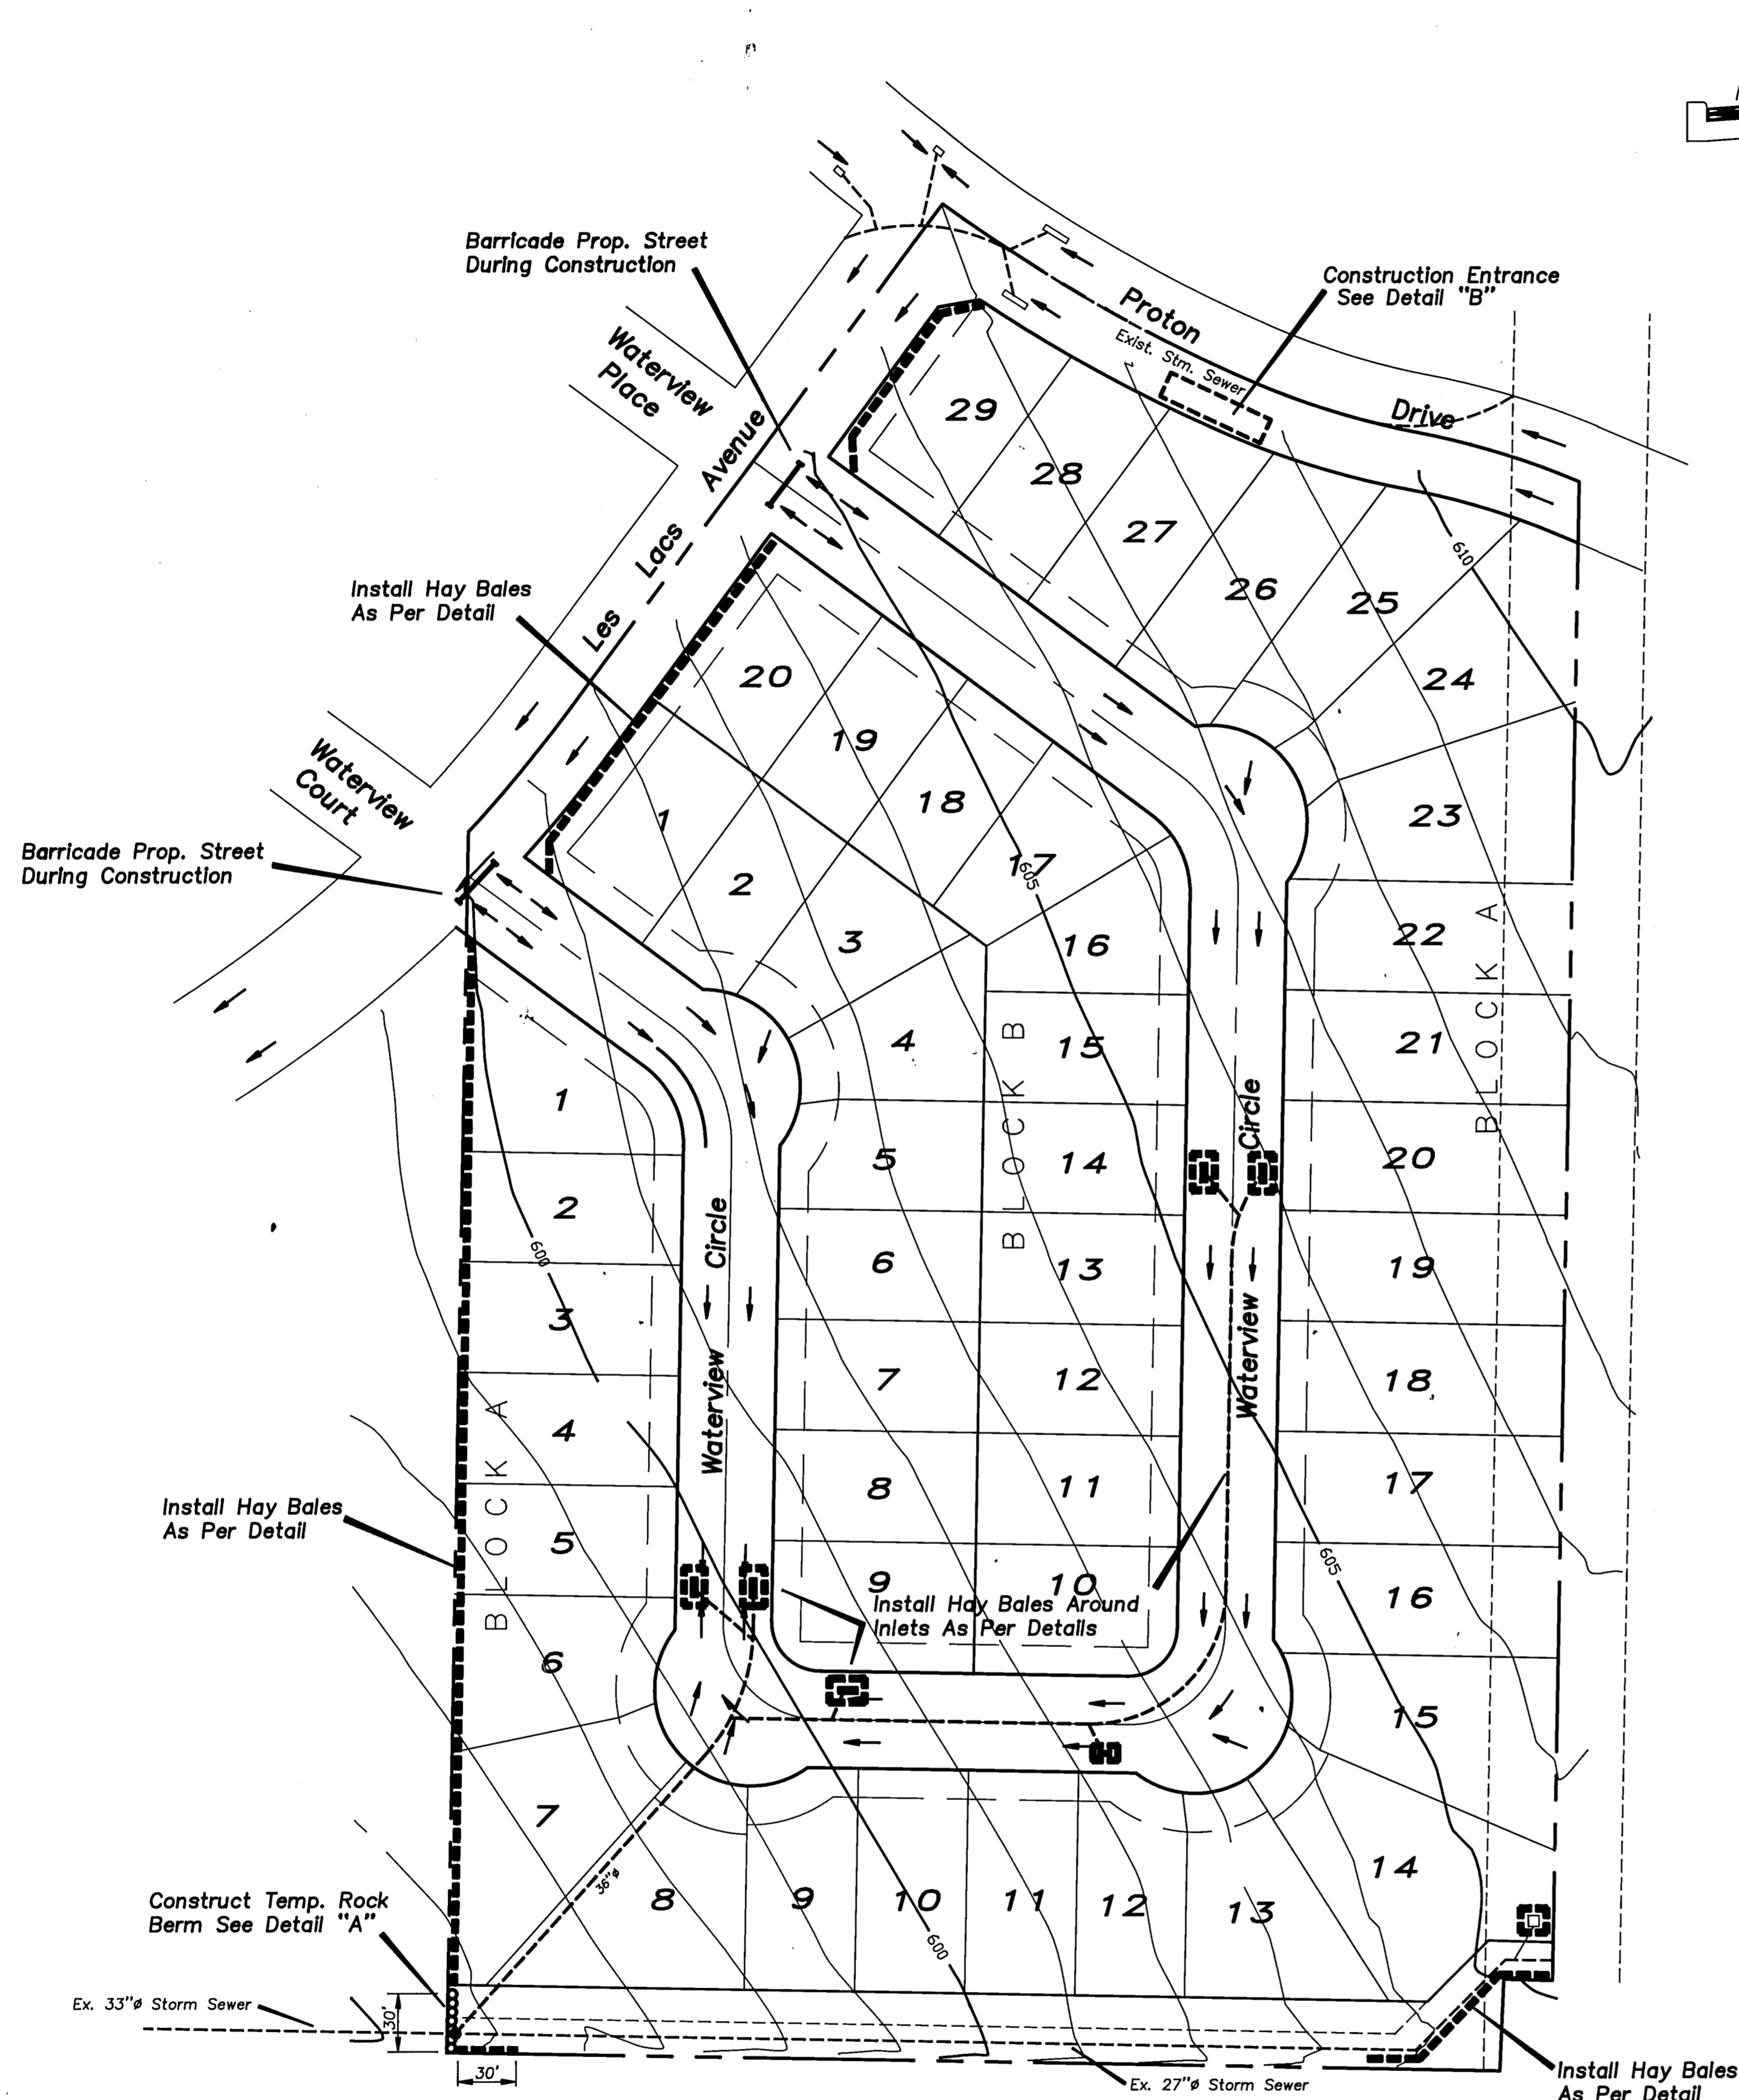
- Hay bales shall be installed a minimum of 4" into the ground.
- Contractor will install additional erosion control where erosion protection is needed as per the owners engineers, or the Town of Addison inspector.
- The existing vegetation along existing parkways and medians shall be replaced to its original condition or better.
- All drainage swales shall be graded as per Town Standards, prior to the City acceptance of project.
- All construction erosion control shall meet Town of Addisons Ordinance.
- Install grass in all new parkway as per Town Standards.

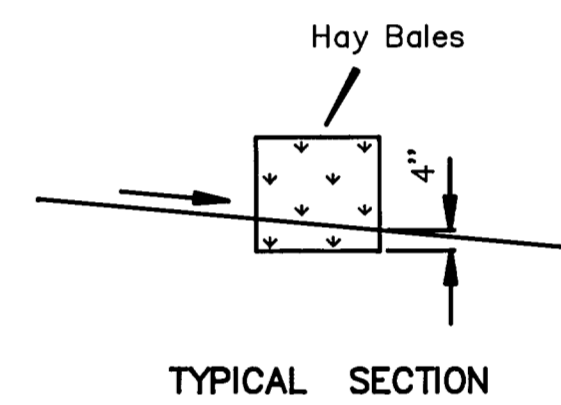
TYPICAL HAY BALE PLACEMENT

Place Hay Bales As Shown
