AIRPORT ESA EXTRA CODE FIGURES

ADDISON AIRPORT
ADDISON, TEXAS

STAINED SURFACE AREAS

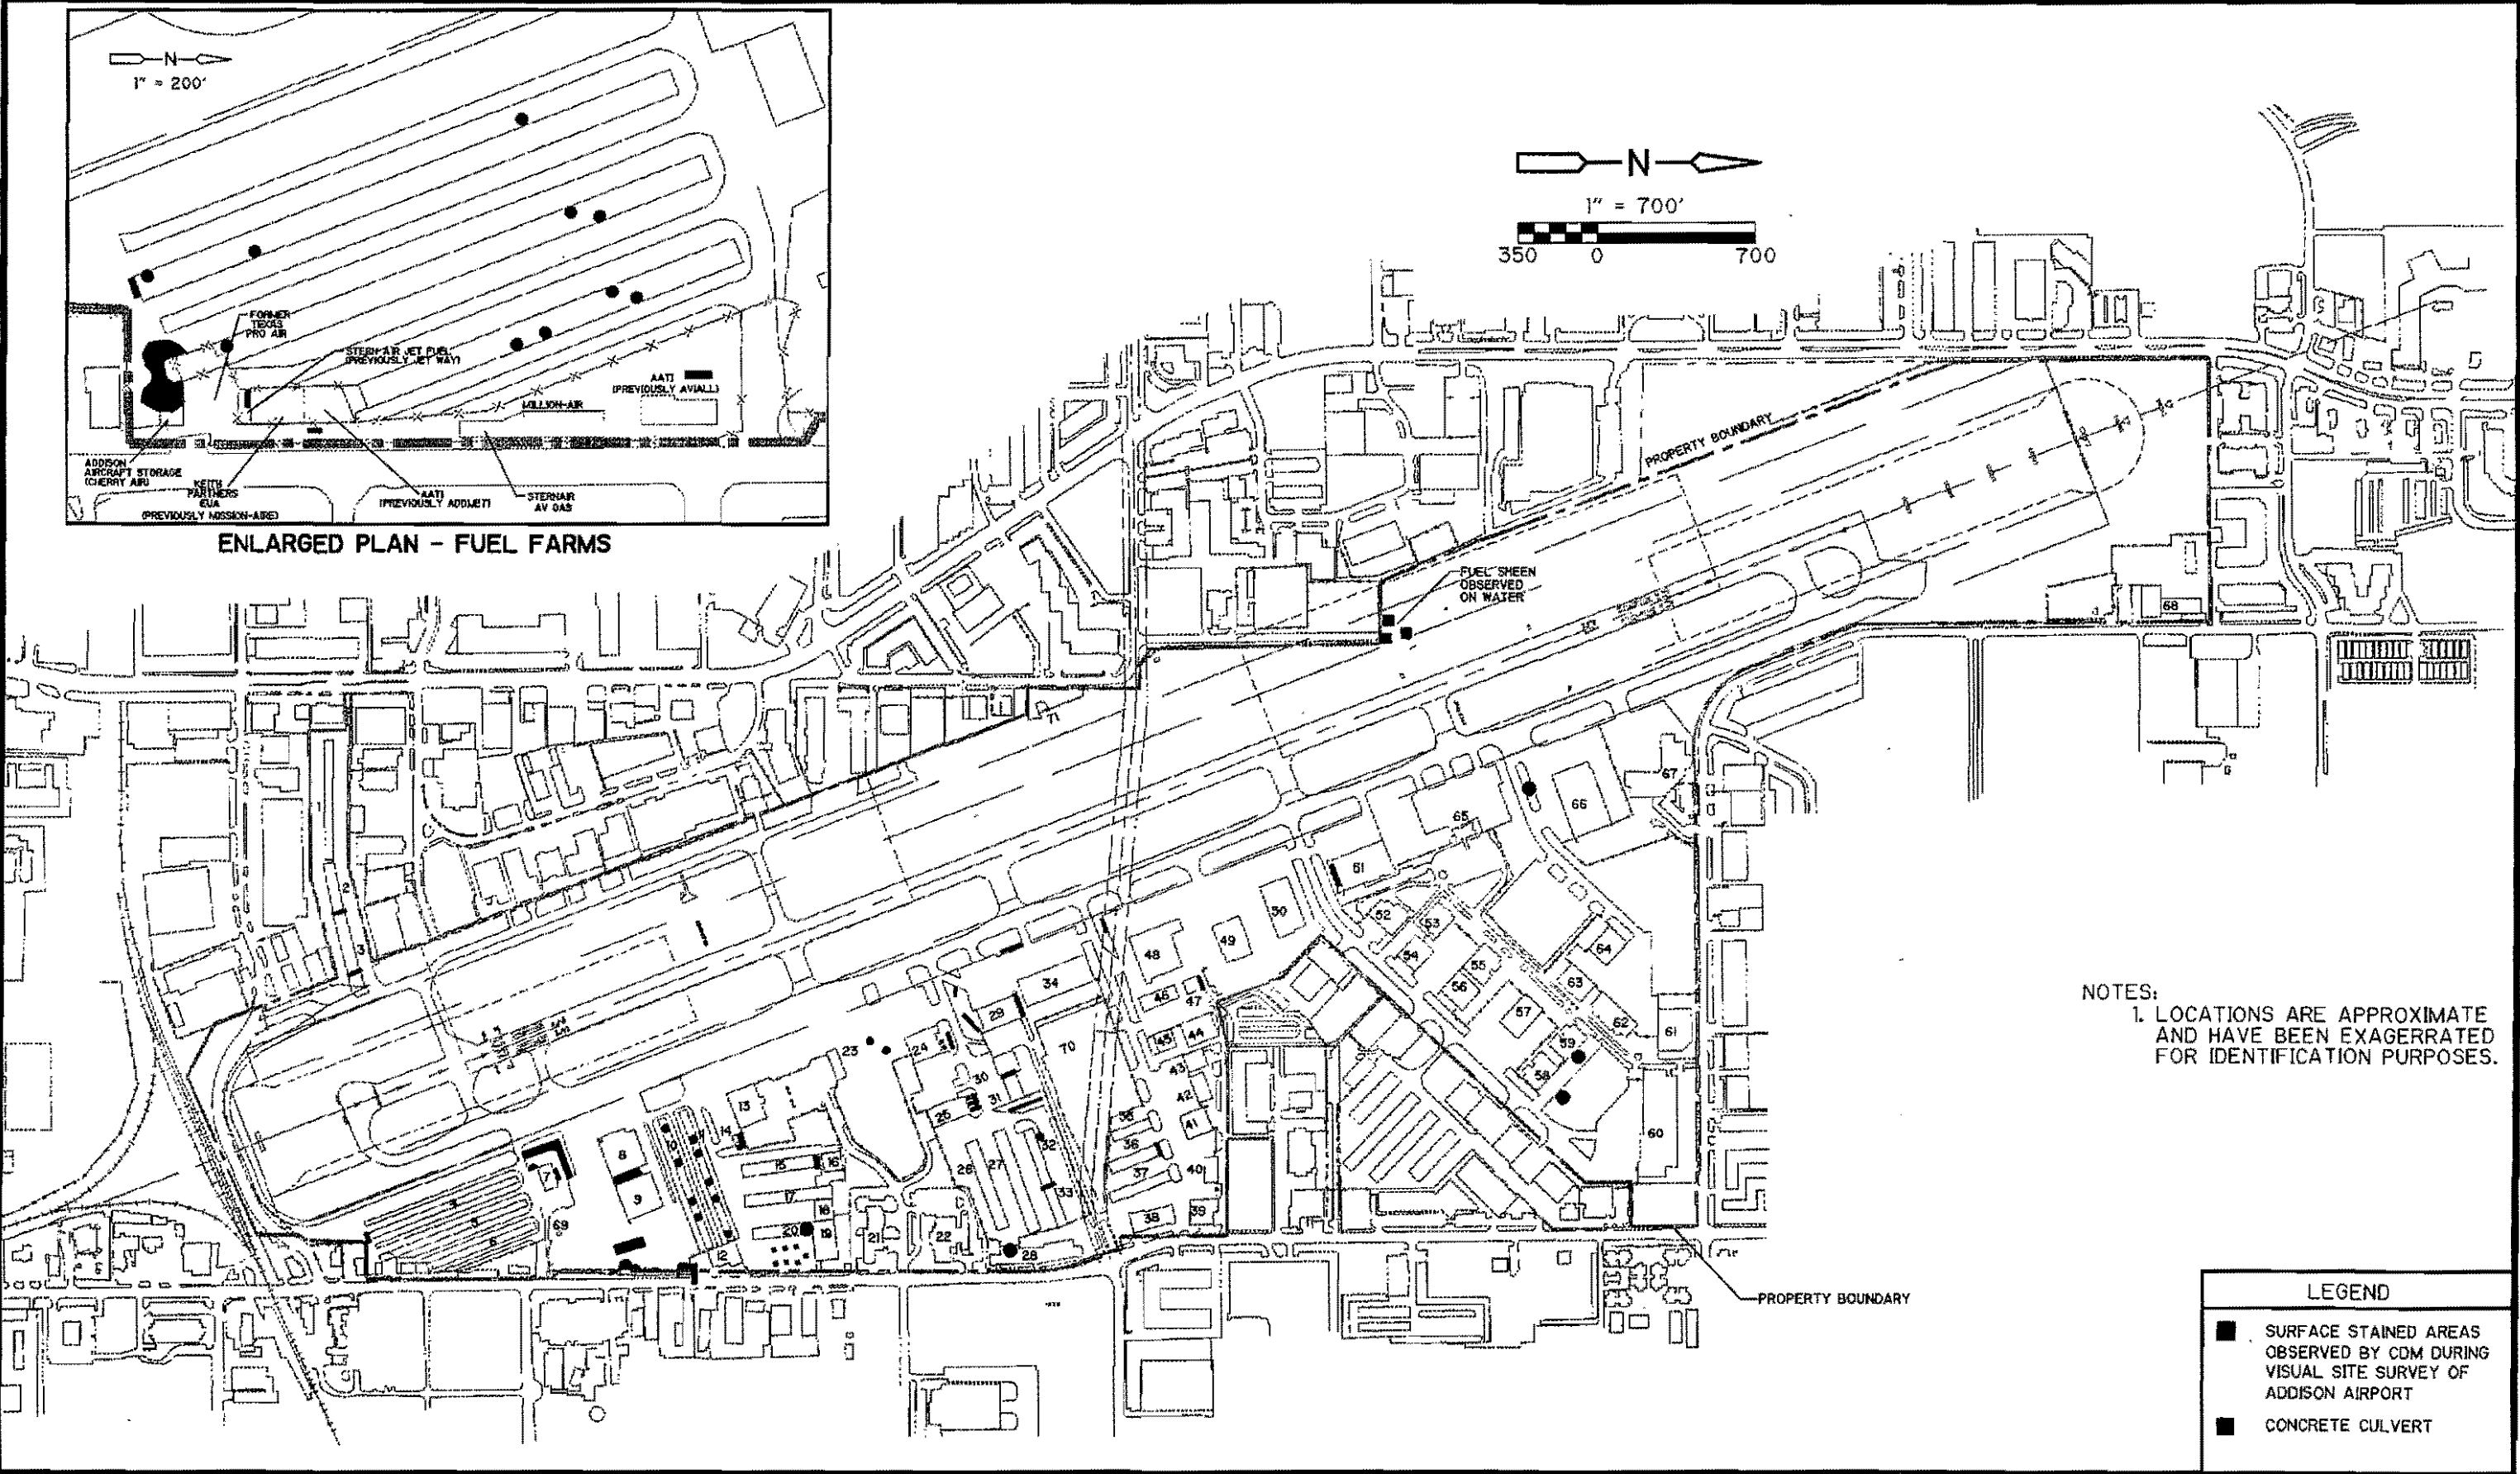
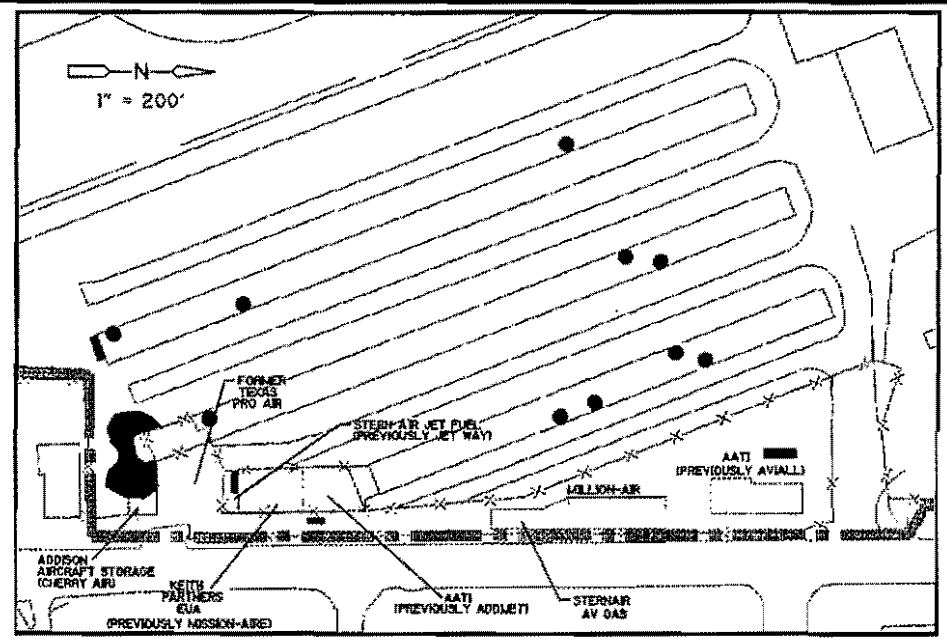
LEGEND	
	SURFACE STAINED AREAS OBSERVED BY CDM DURING VISUAL SITE SURVEY OF ADDISON AIRPORT
	CONCRETE CULVERT

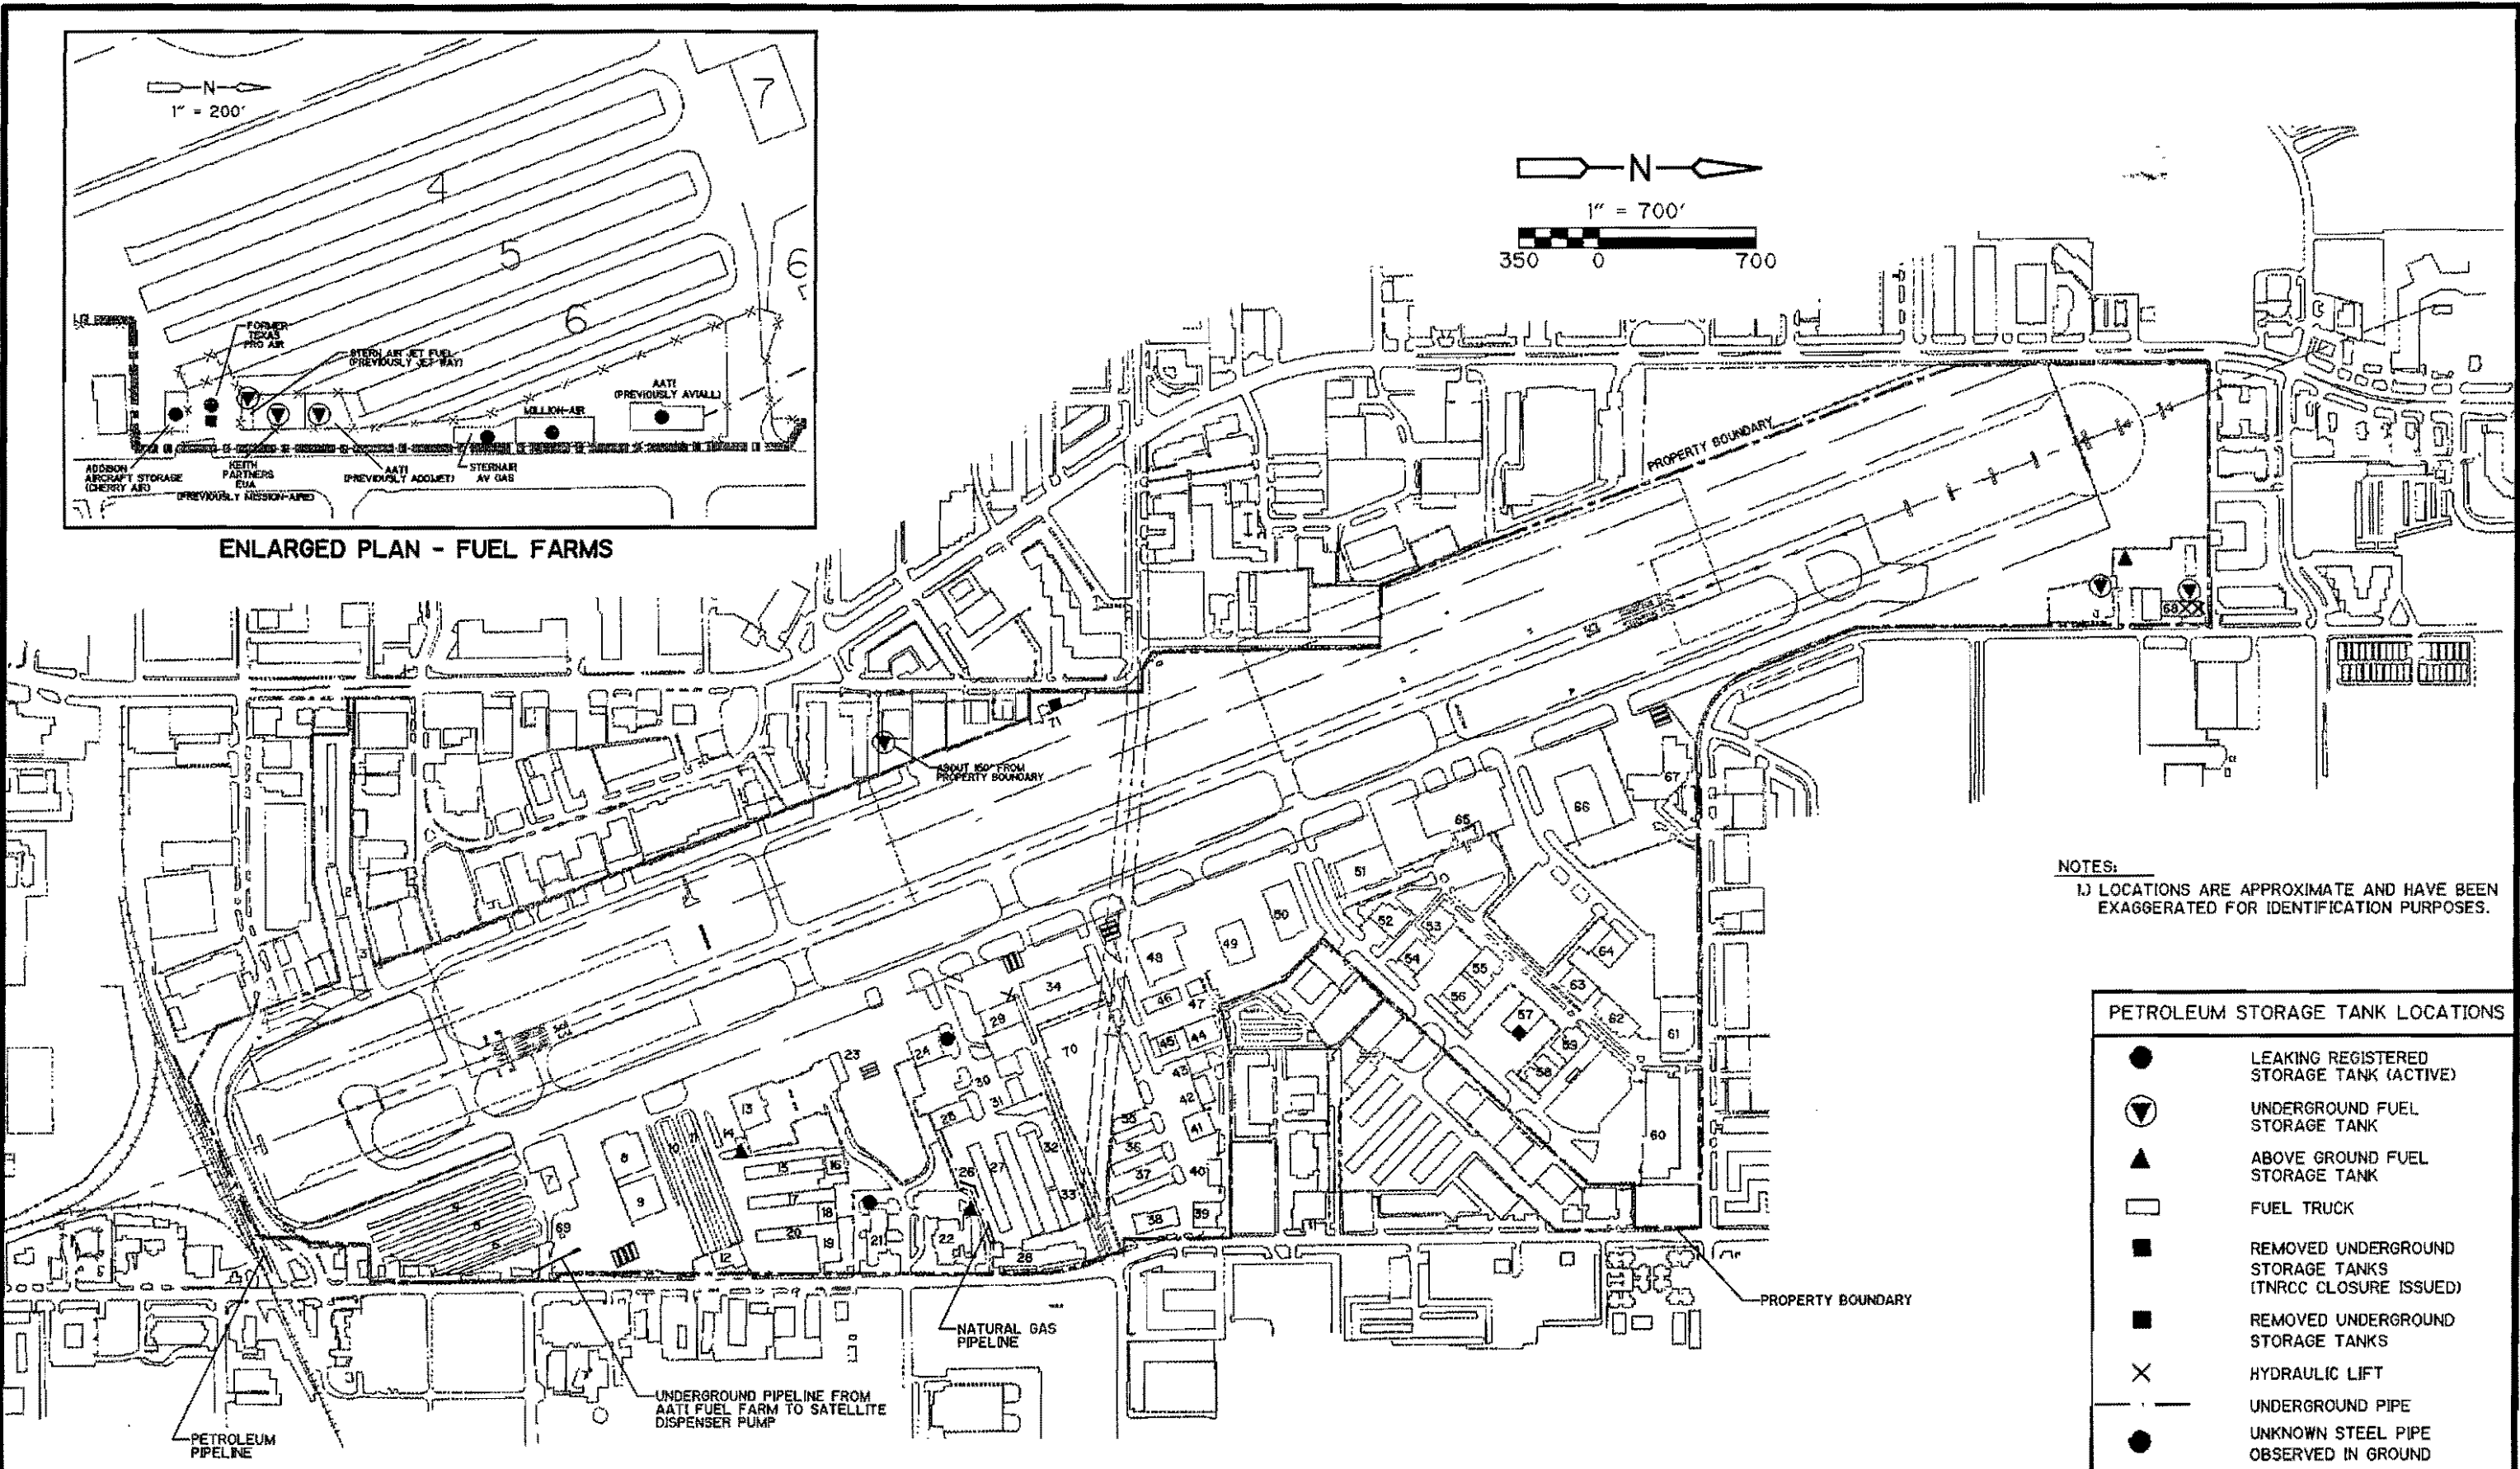
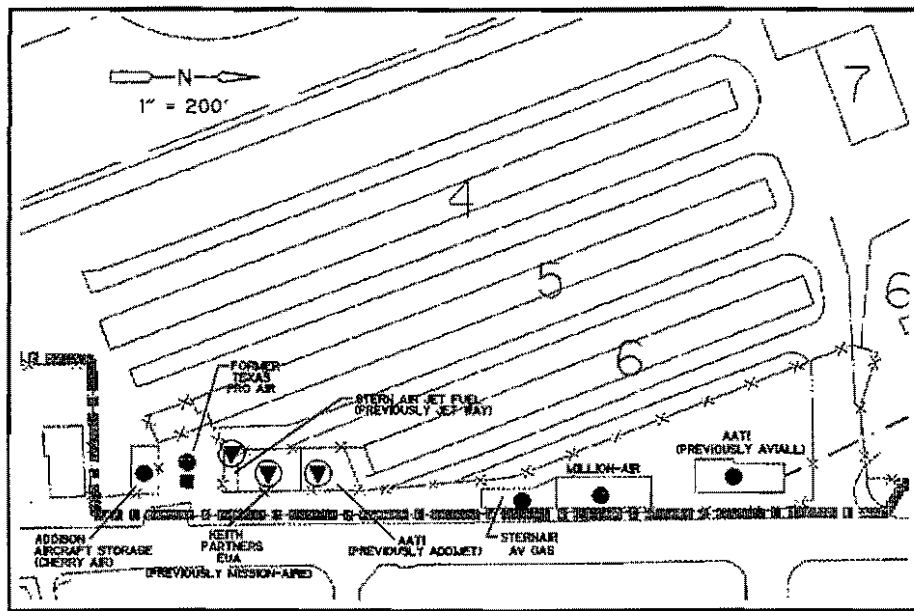
FIGURE ES-2

PETROLEUM STORAGE TANK LOCATIONS	
●	LEAKING REGISTERED STORAGE TANK (ACTIVE)
▼	UNDERGROUND FUEL STORAGE TANK
▲	ABOVE GROUND FUEL STORAGE TANK
□	FUEL TRUCK
■	REMOVED UNDERGROUND STORAGE TANKS (TNRCC CLOSURE ISSUED)
■	REMOVED UNDERGROUND STORAGE TANKS
×	HYDRAULIC LIFT
—	UNDERGROUND PIPE
●	UNKNOWN STEEL PIPE OBSERVED IN GROUND

HISTORICAL AND EXISTING PETROLEUM STORAGE TANK LOCATIONS

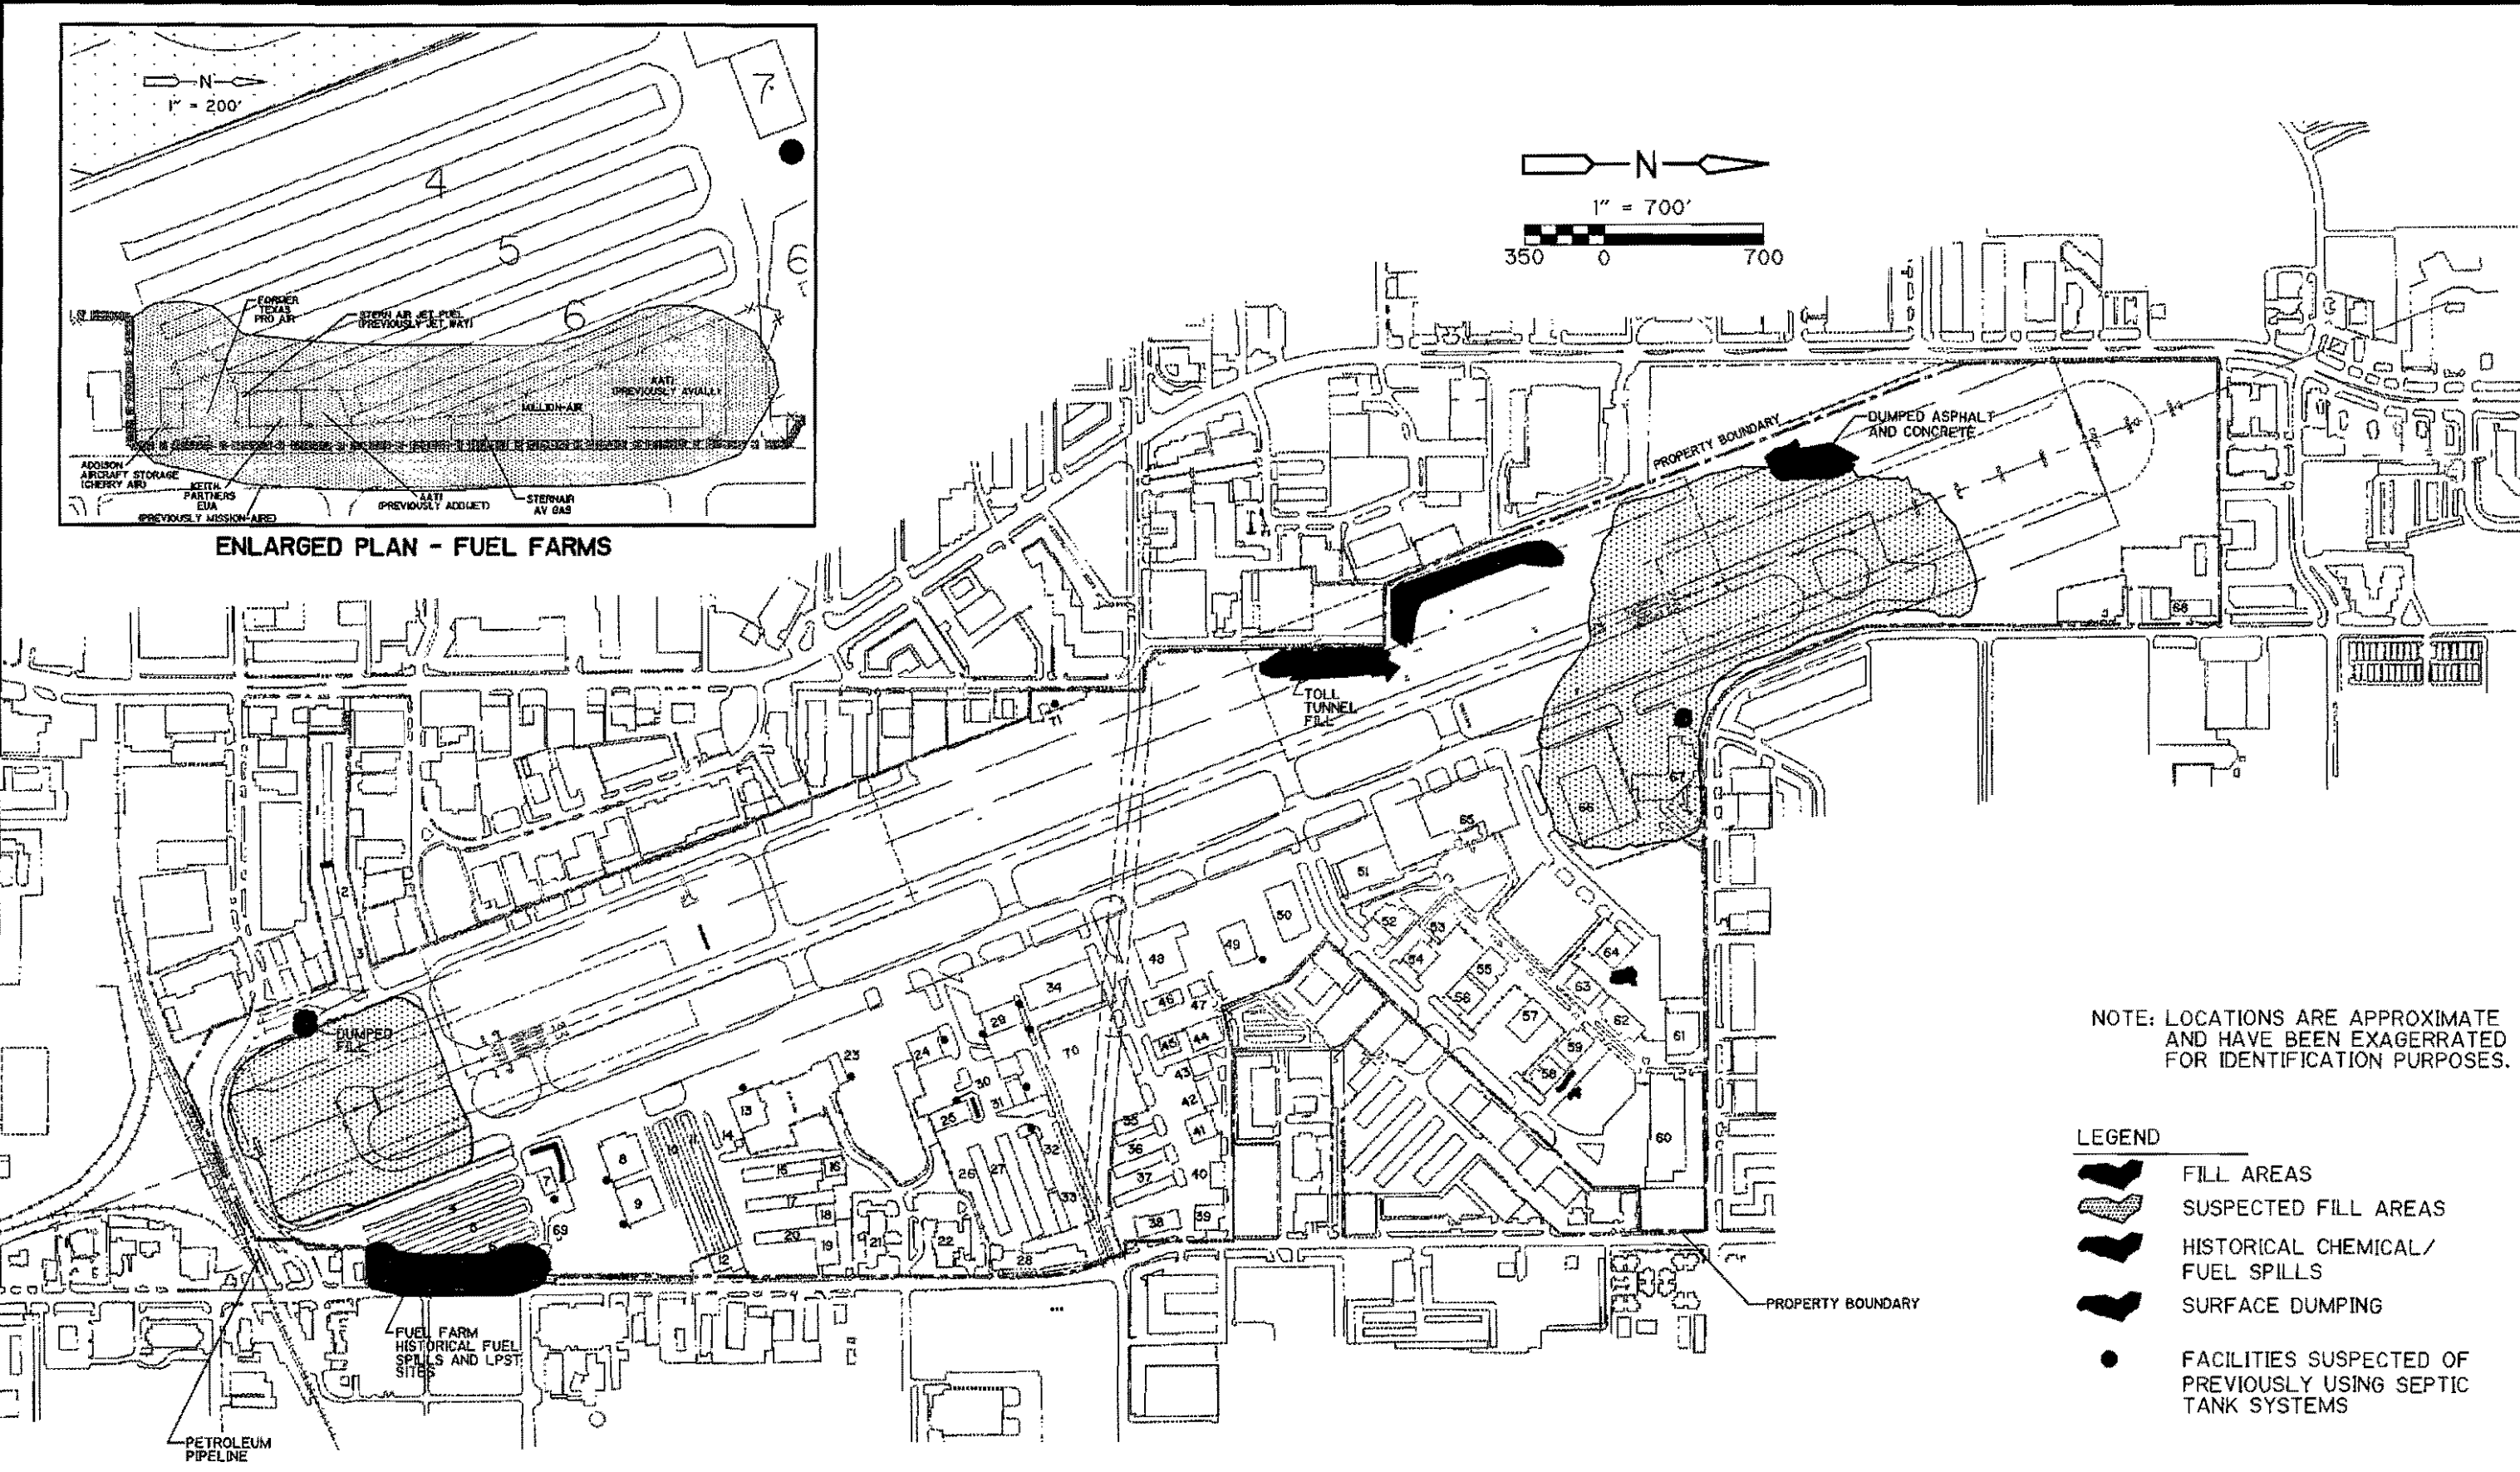
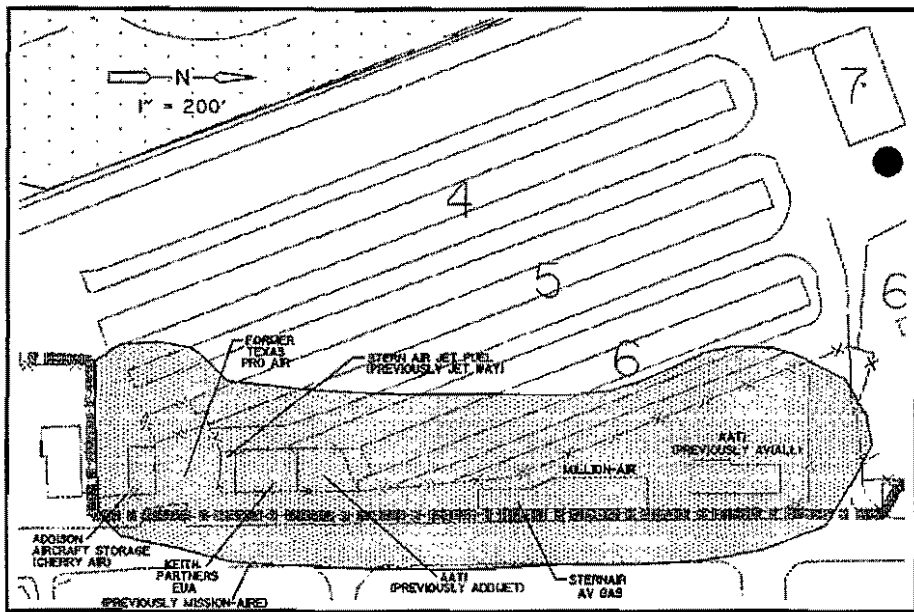
HISTORICAL AREAS OF ENVIRONMENTAL CONCERN

- LEGEND**
- FILL AREAS
 - SUSPECTED FILL AREAS
 - HISTORICAL CHEMICAL/ FUEL SPILLS
 - SURFACE DUMPING
 - FACILITIES SUSPECTED OF PREVIOUSLY USING SEPTIC TANK SYSTEMS

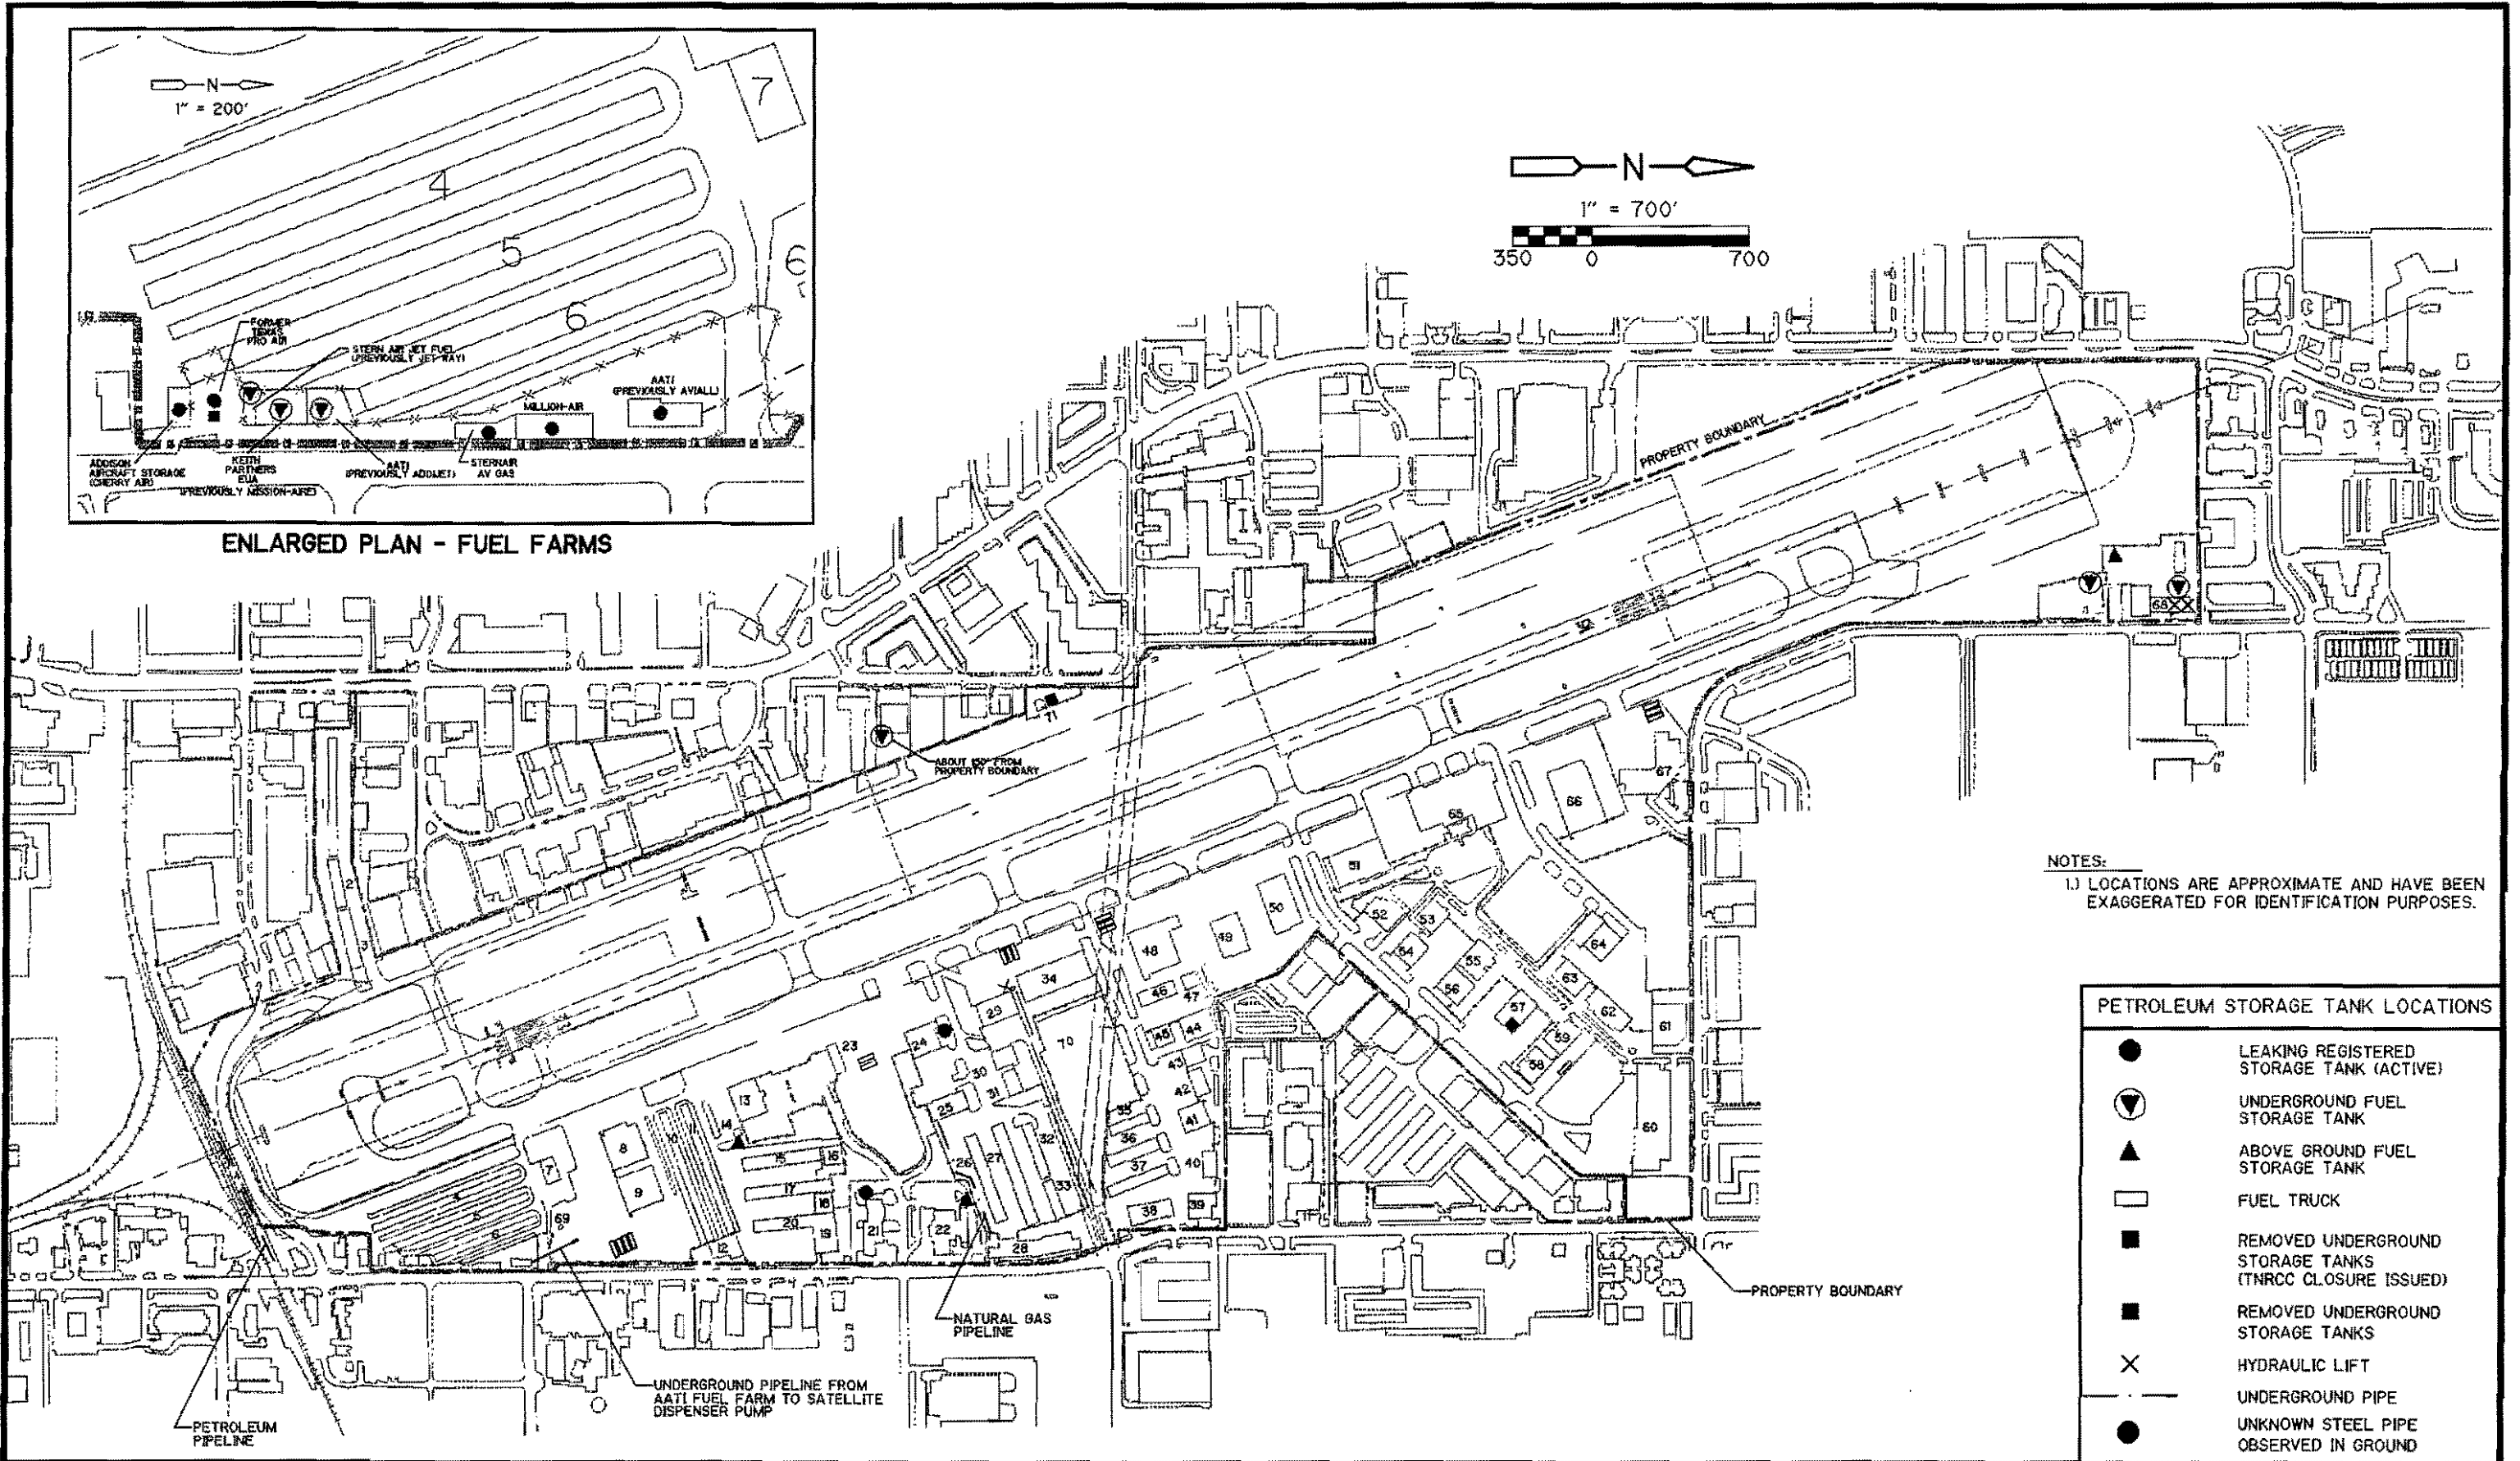
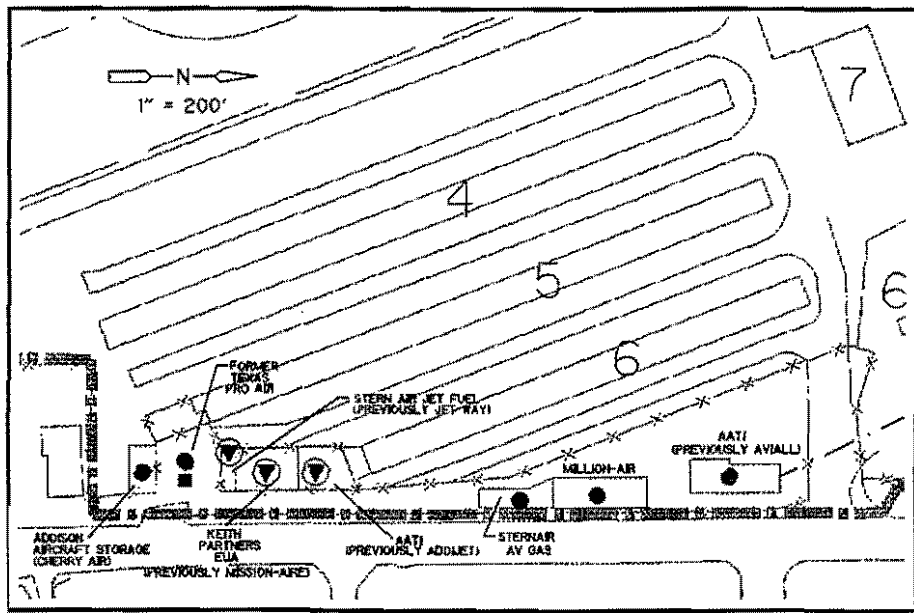
FIG4-2

PETROLEUM STORAGE TANK LOCATIONS	
●	LEAKING REGISTERED STORAGE TANK (ACTIVE)
▼	UNDERGROUND FUEL STORAGE TANK
▲	ABOVE GROUND FUEL STORAGE TANK
□	FUEL TRUCK
■	REMOVED UNDERGROUND STORAGE TANKS (TNRCC CLOSURE ISSUED)
■	REMOVED UNDERGROUND STORAGE TANKS
×	HYDRAULIC LIFT
—	UNDERGROUND PIPE
●	UNKNOWN STEEL PIPE OBSERVED IN GROUND

HISTORICAL AND EXISTING PETROLEUM STORAGE TANK LOCATIONS

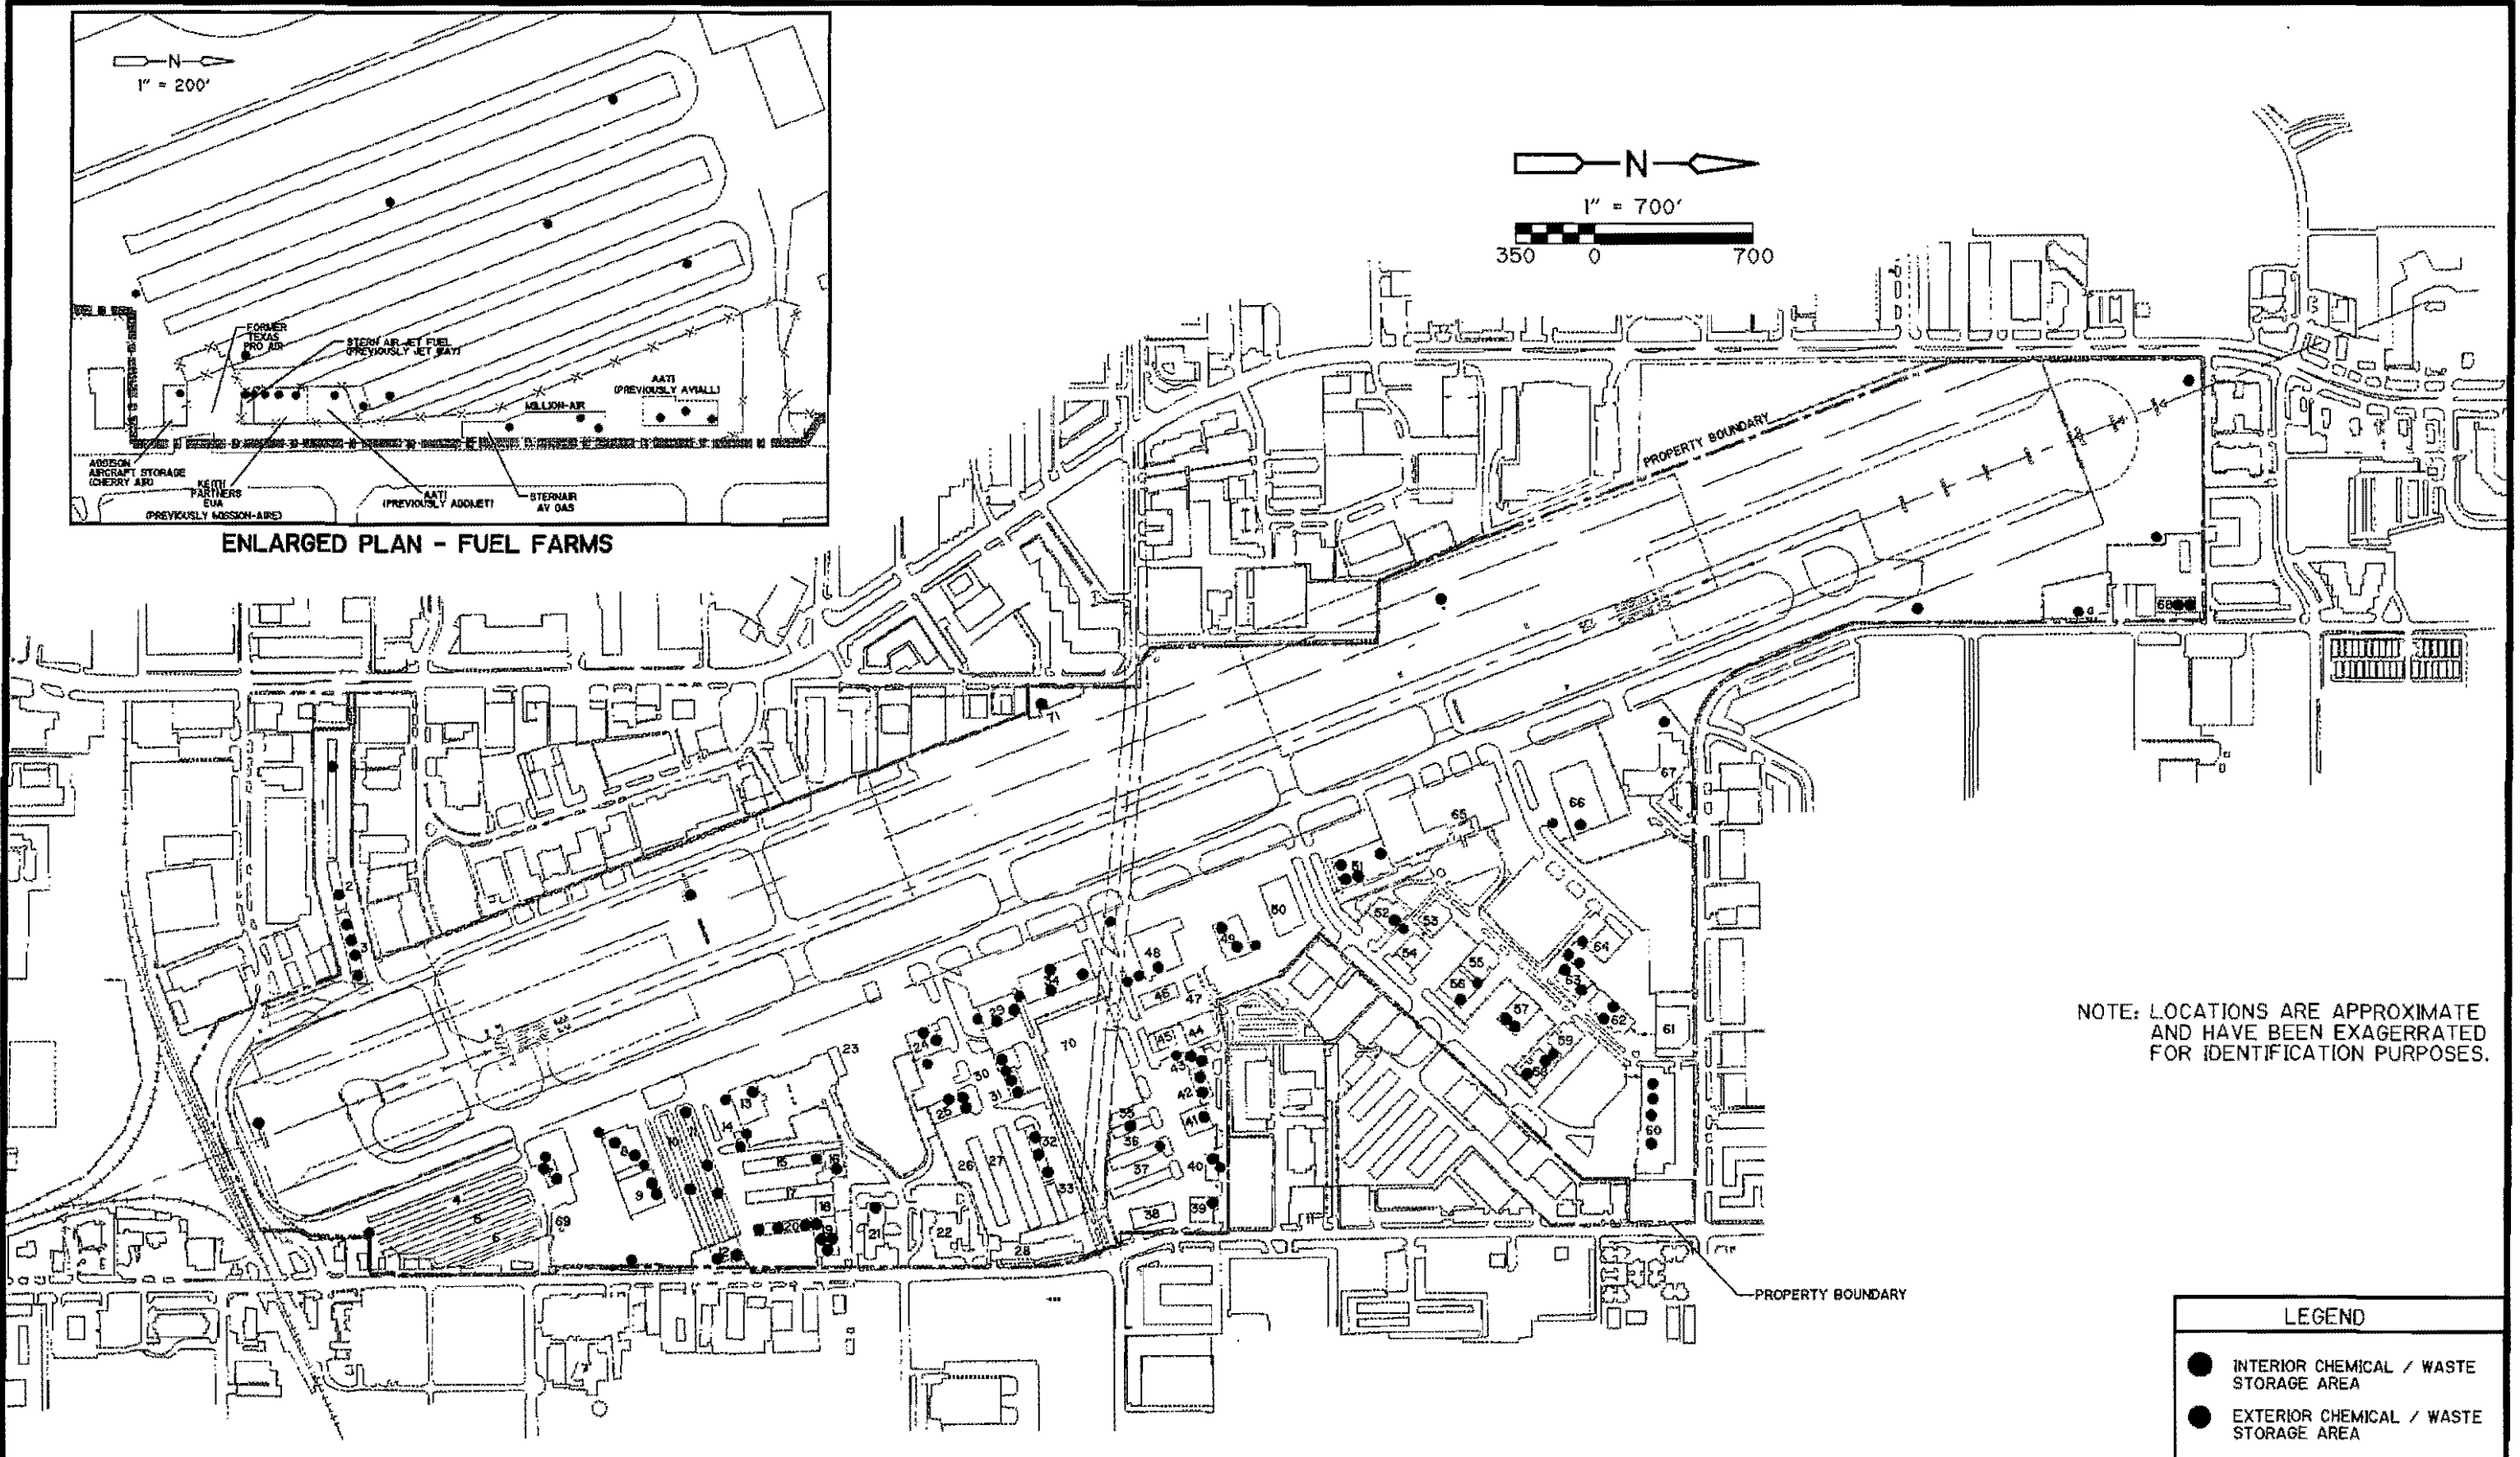
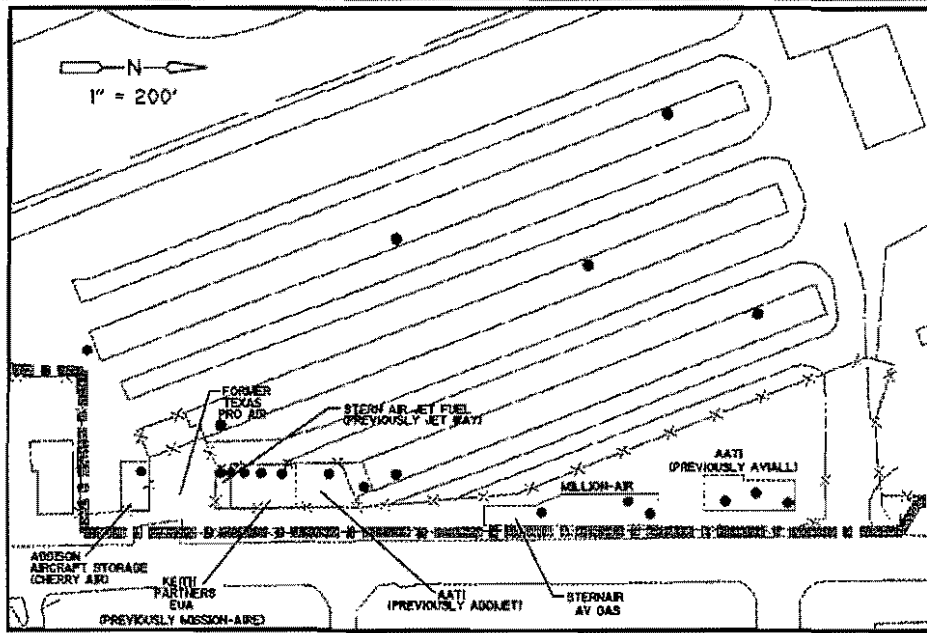
FIGURE 4-2

LEGEND	
●	INTERIOR CHEMICAL / WASTE STORAGE AREA
●	EXTERIOR CHEMICAL / WASTE STORAGE AREA

CHEMICAL AND WASTE STORAGE AREAS
