AIRPORT ESA EXTRA CODE FIGURES

ADDISON AIRPORT
ADDISON, TEXAS

STAINED SURFACE AREAS

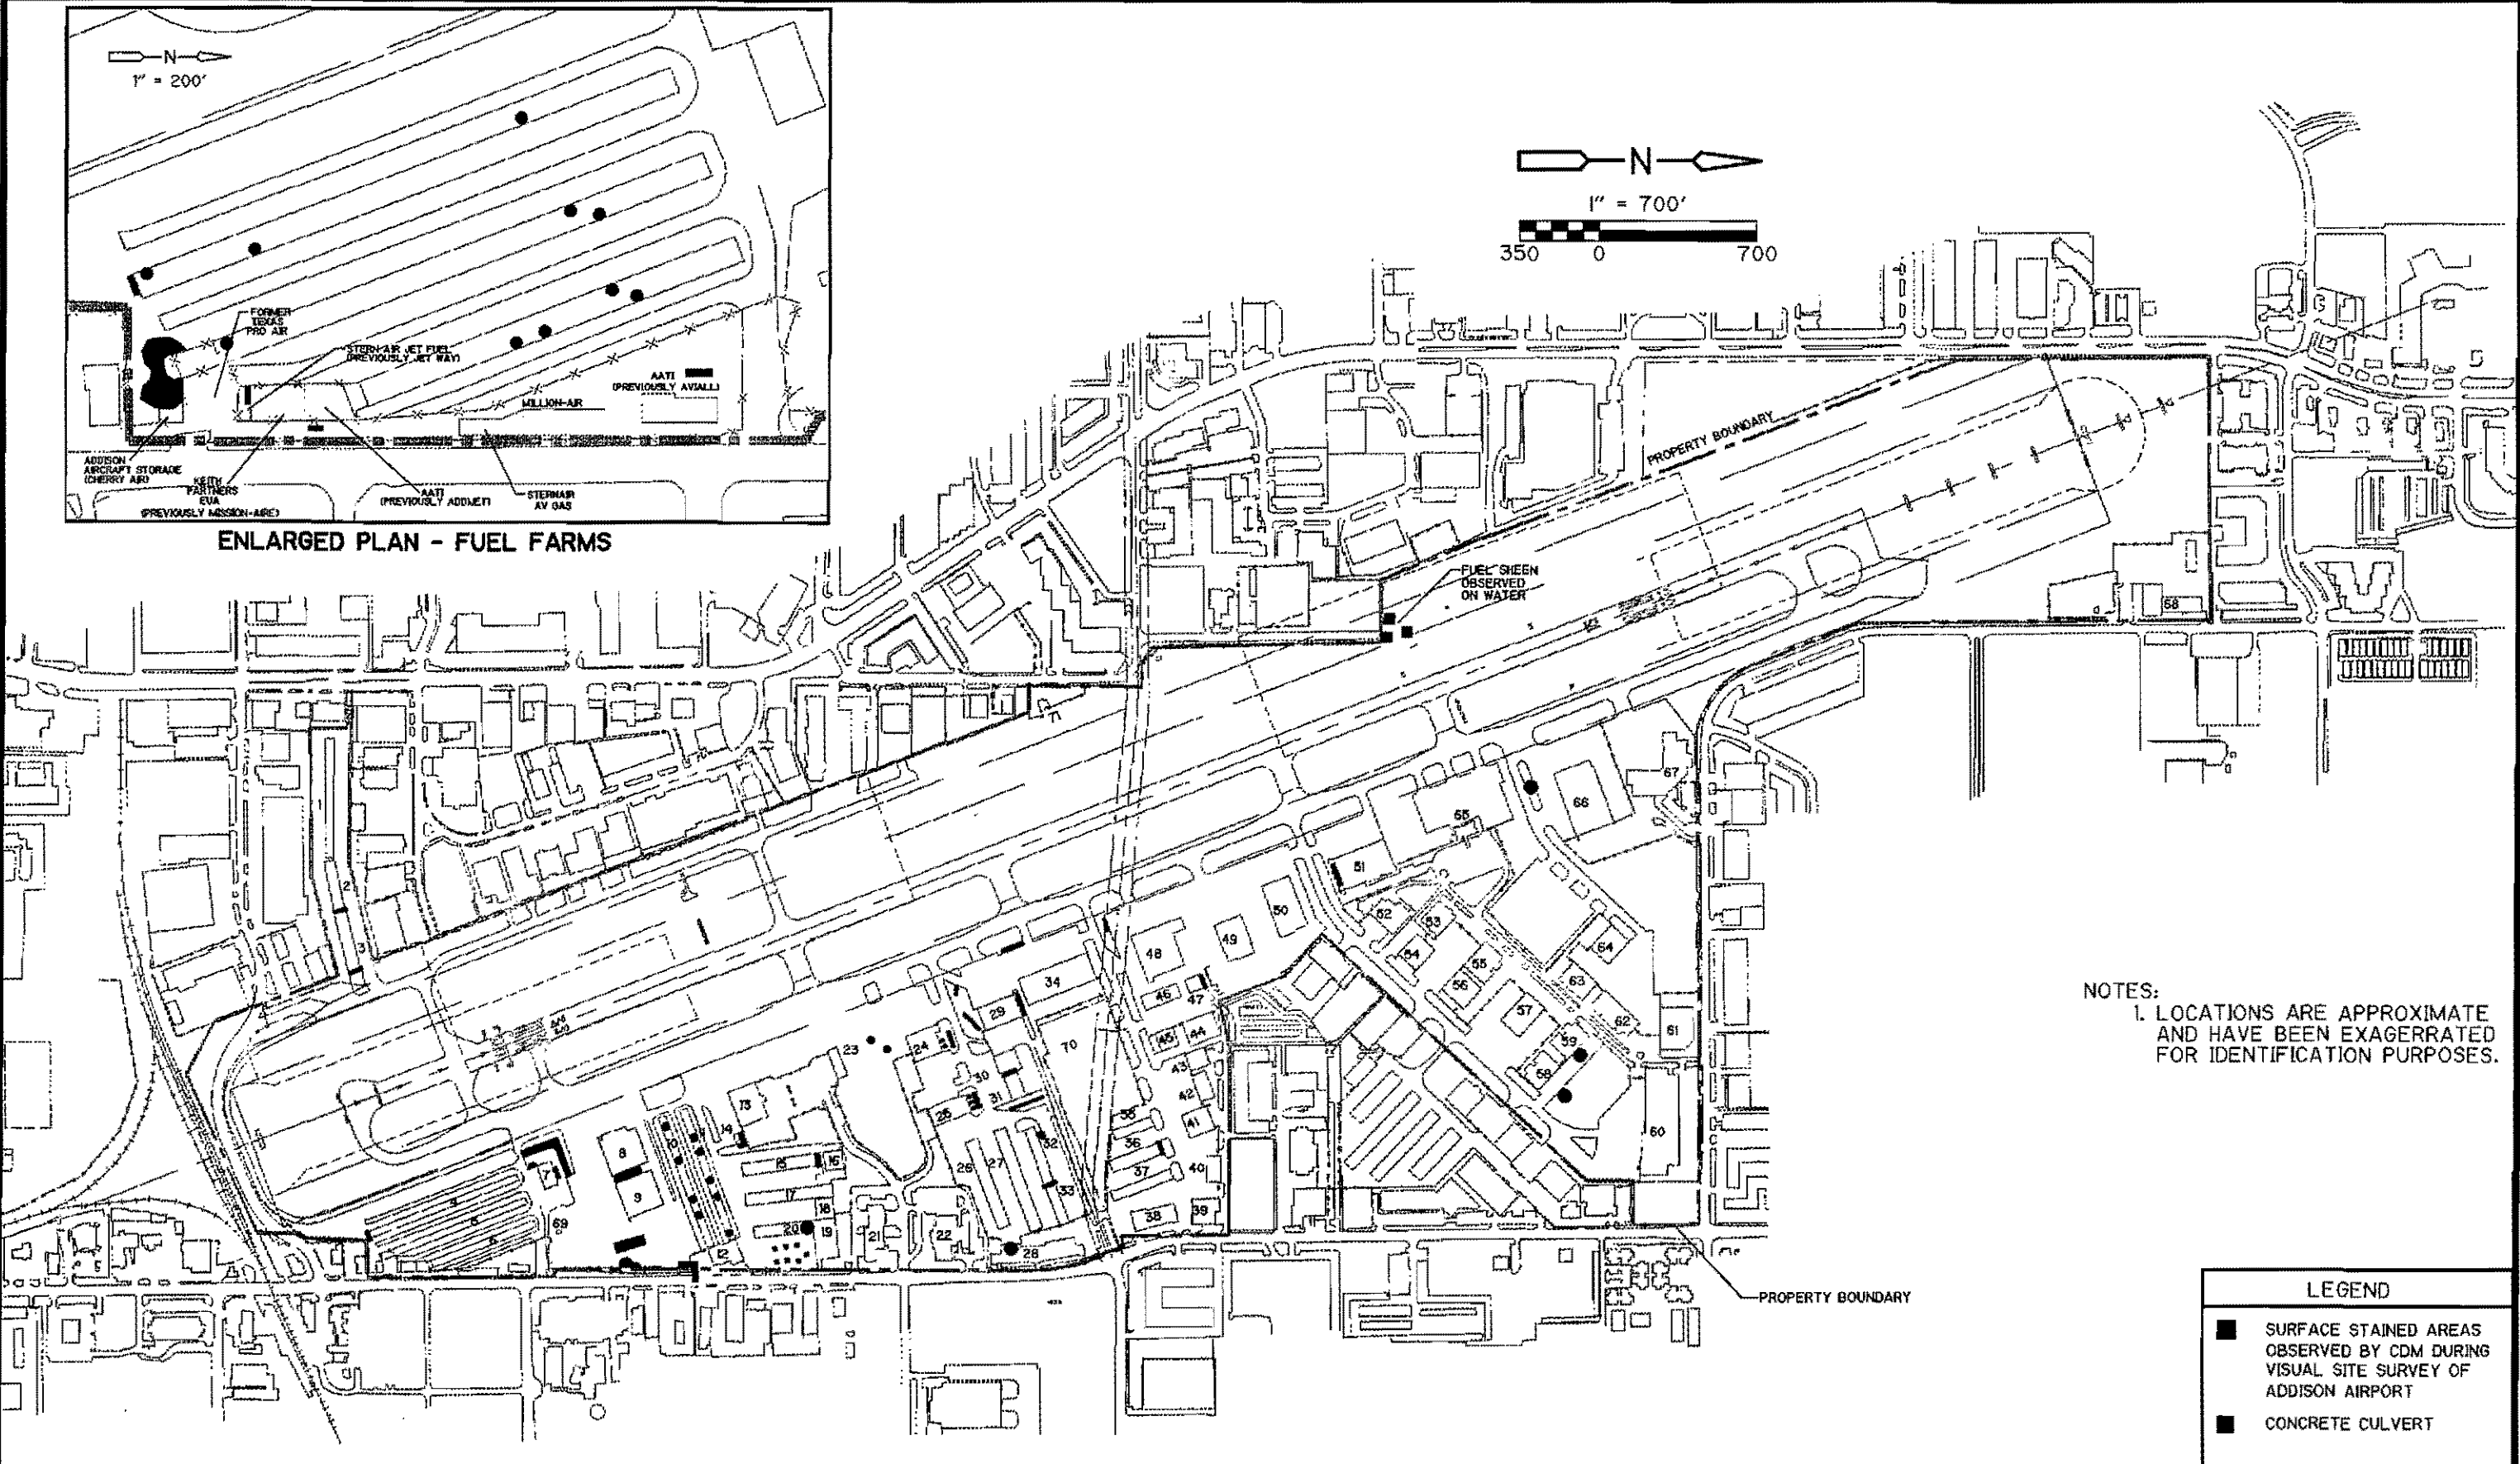
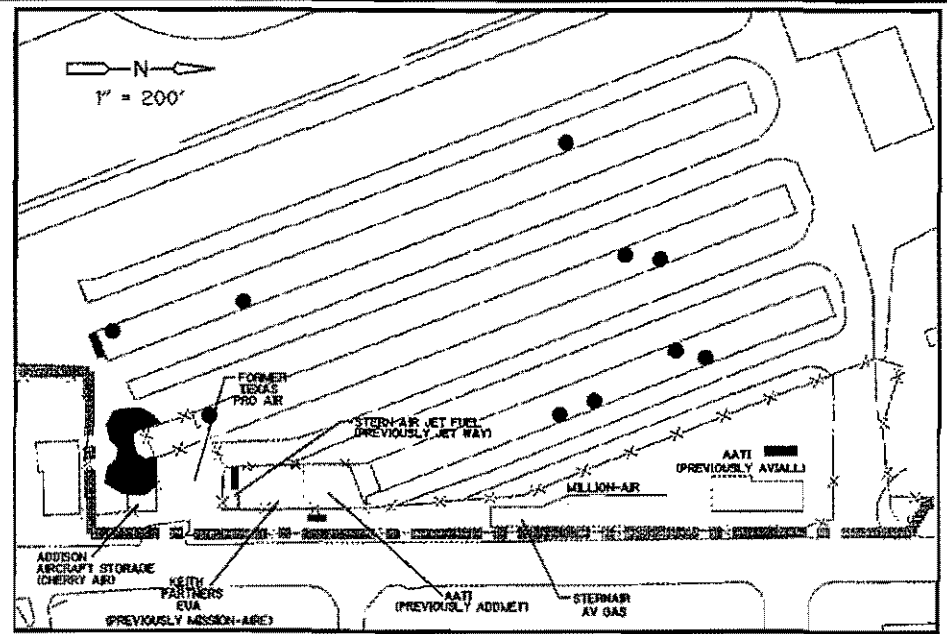
STAINED SURFACE AREAS

LEGEND	
	SURFACE STAINED AREAS OBSERVED BY CDM DURING VISUAL SITE SURVEY OF ADDISON AIRPORT
	CONCRETE CULVERT

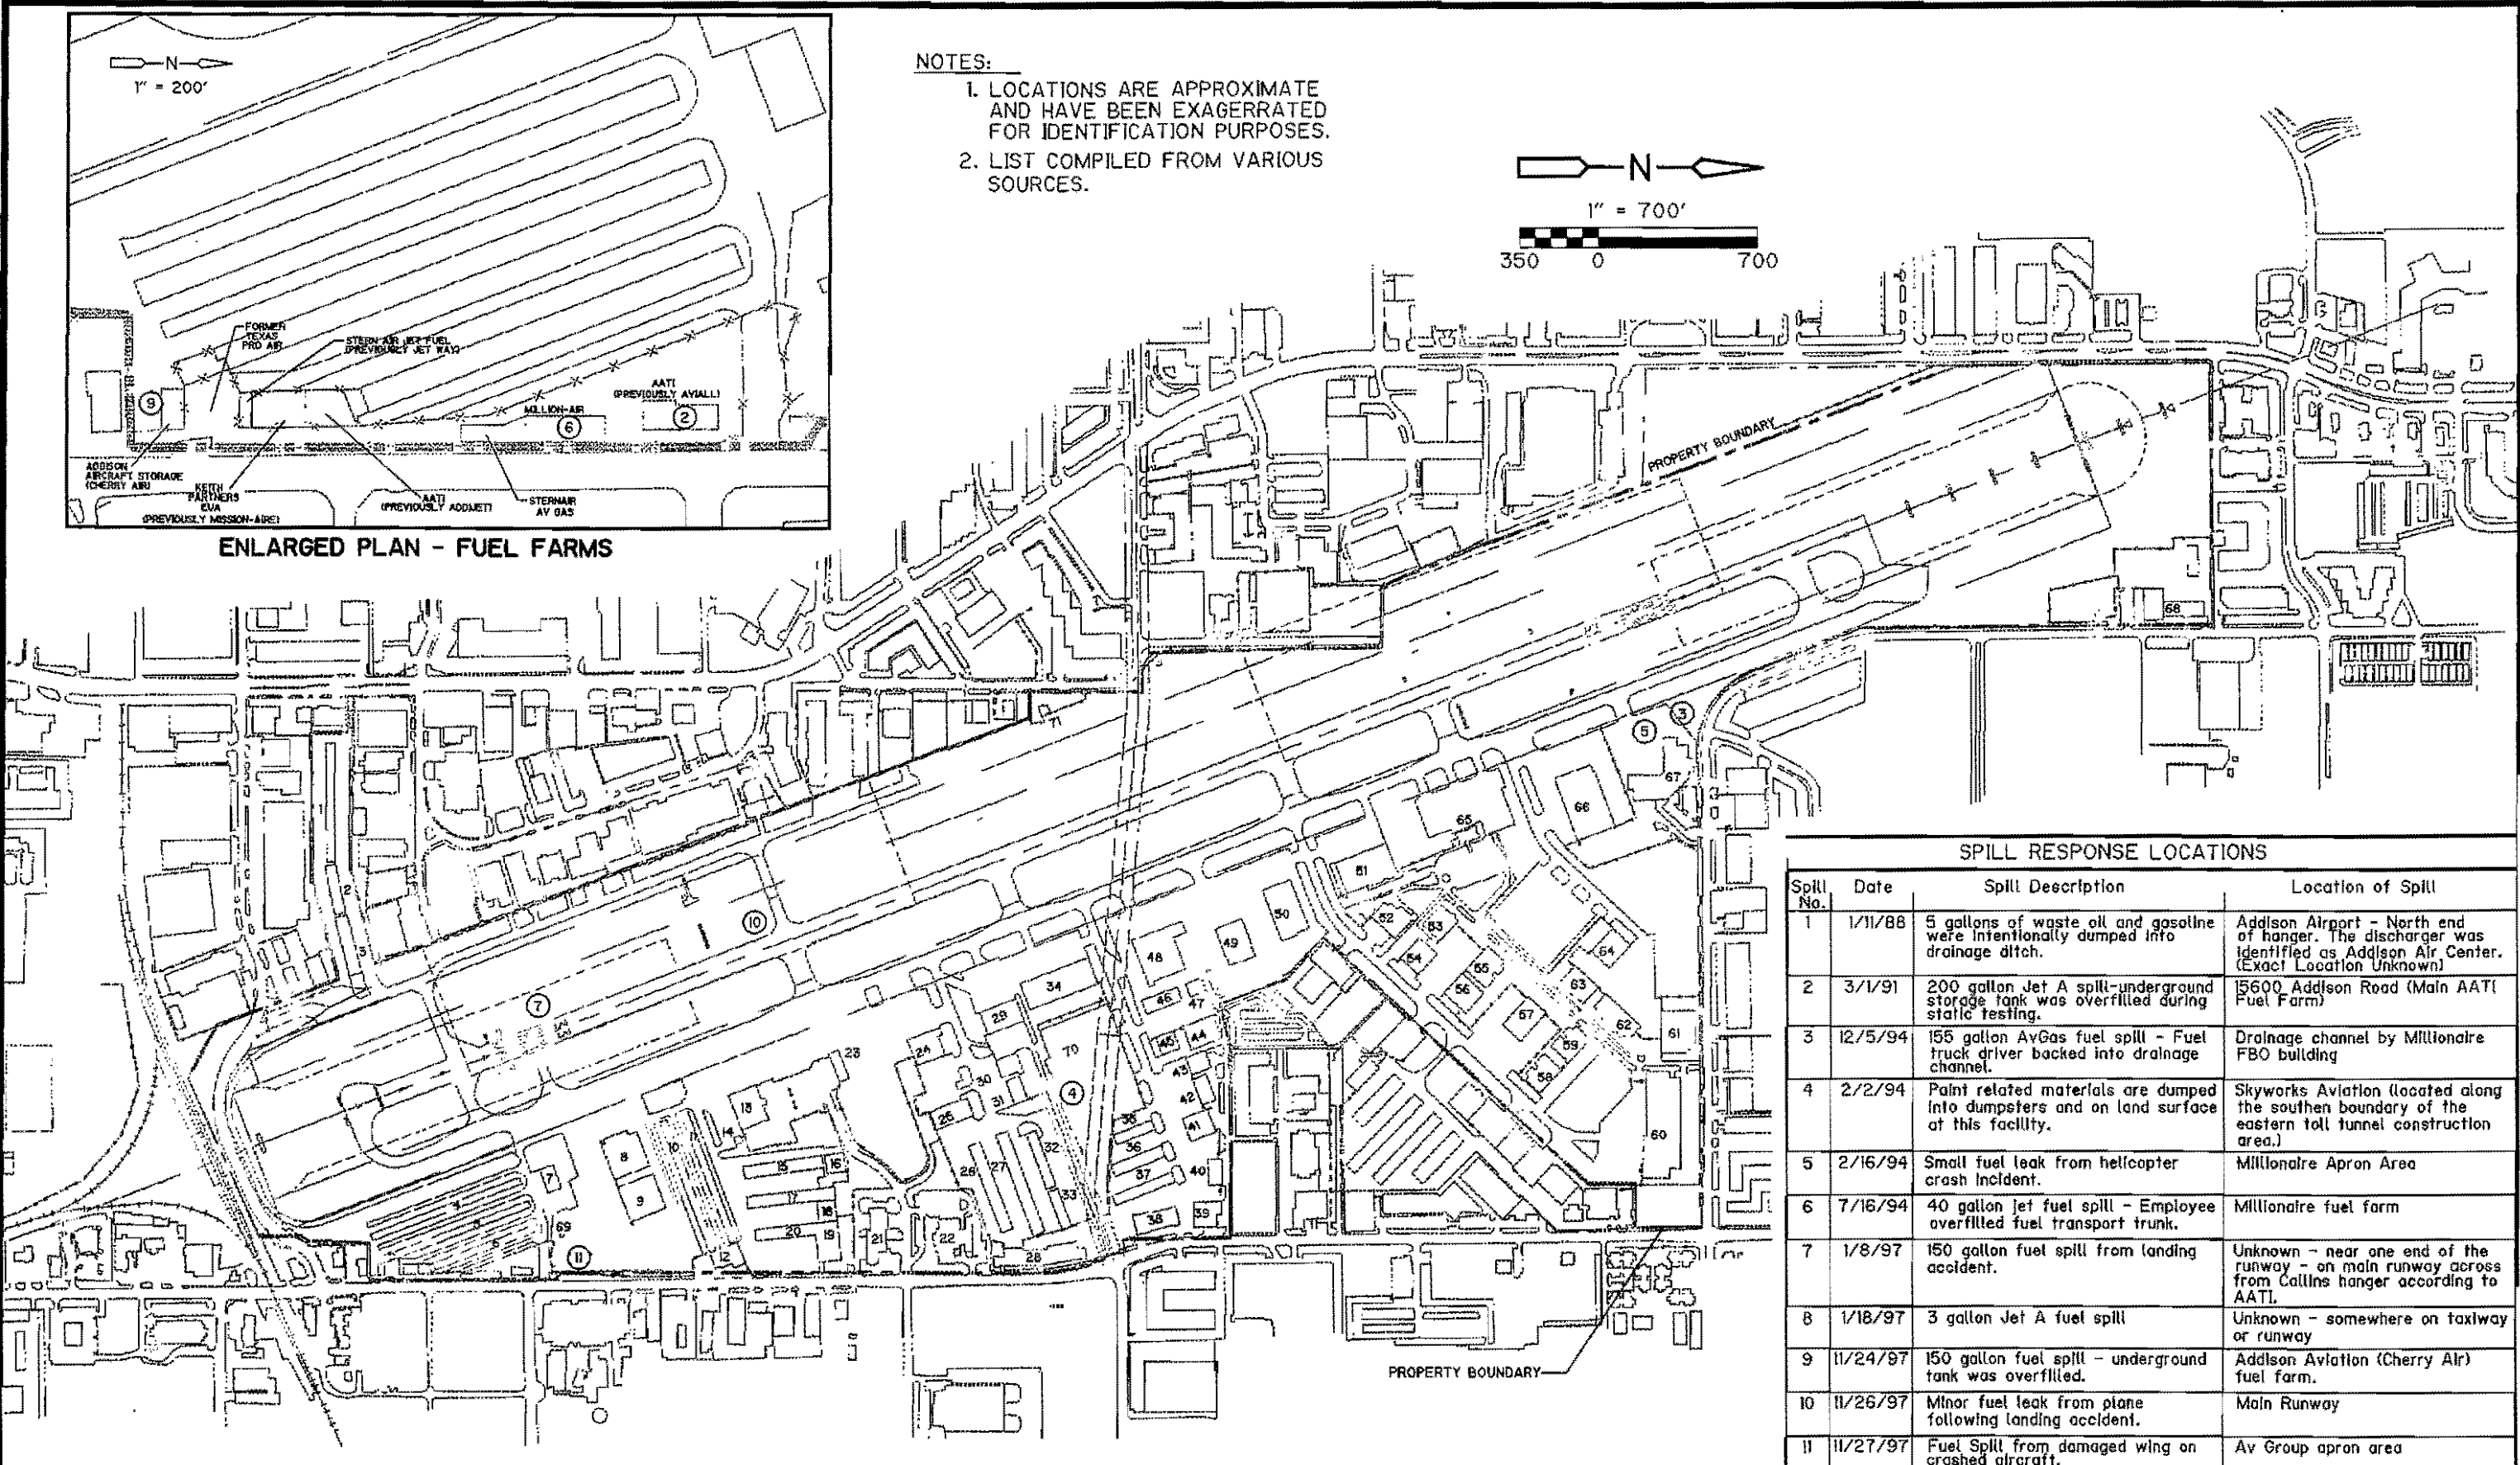
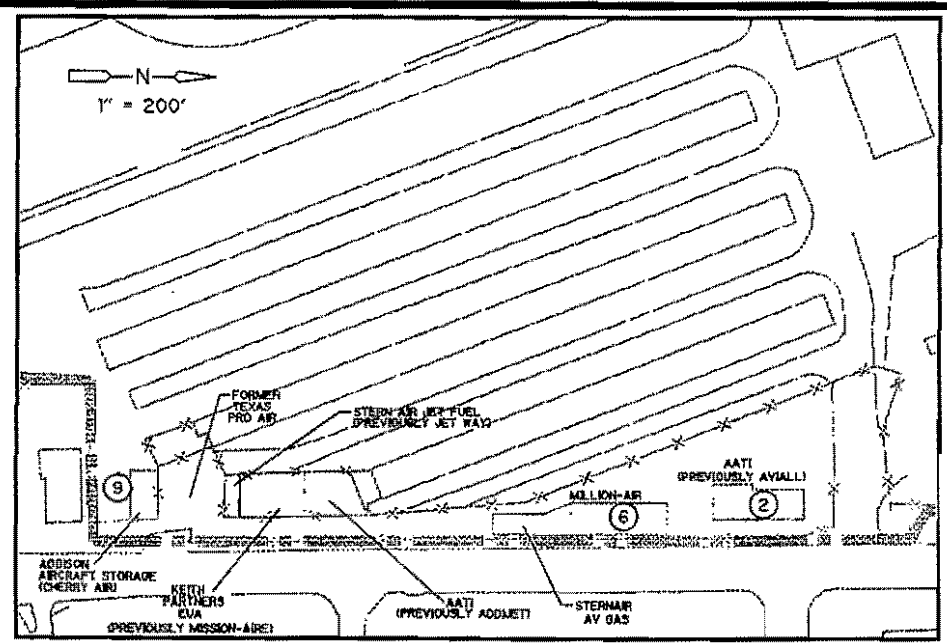
SPILL RESPONSE LOCATIONS

Spill No.	Date	Spill Description	Location of Spill
1	1/11/88	5 gallons of waste oil and gasoline were intentionally dumped into drainage ditch.	Addison Airport - North end of hanger. The discharger was identified as Addison Air Center. (Exact Location Unknown)
2	3/1/91	200 gallon Jet A spill-underground storage tank was overfilled during static testing.	15600 Addison Road (Main AATI Fuel Farm)
3	12/5/94	155 gallon AvGas fuel spill - Fuel truck driver backed into drainage channel.	Drainage channel by Millonaire FBO building
4	2/2/94	Paint related materials are dumped into dumpsters and on land surface at this facility.	Skyworks Aviation (located along the southern boundary of the eastern toll tunnel construction area.)
5	2/16/94	Small fuel leak from helicopter crash incident.	Millonaire Apron Area
6	7/16/94	40 gallon Jet fuel spill - Employee overfilled fuel transport trunk.	Millonaire fuel farm

7	1/8/97	150 gallon fuel spill from landing accident.	Unknown - near one end of the runway - on main runway across from Collins hanger according to AATI.
8	1/18/97	3 gallon Jet A fuel spill	Unknown - somewhere on taxiway or runway
9	11/24/97	150 gallon fuel spill - underground tank was overfilled.	Addison Aviation (Cherry Air) fuel farm.
10	11/26/97	Minor fuel leak from plane following landing accident.	Main Runway
11	11/27/97	Fuel Spill from damaged wing on crashed aircraft.	Av Group apron area

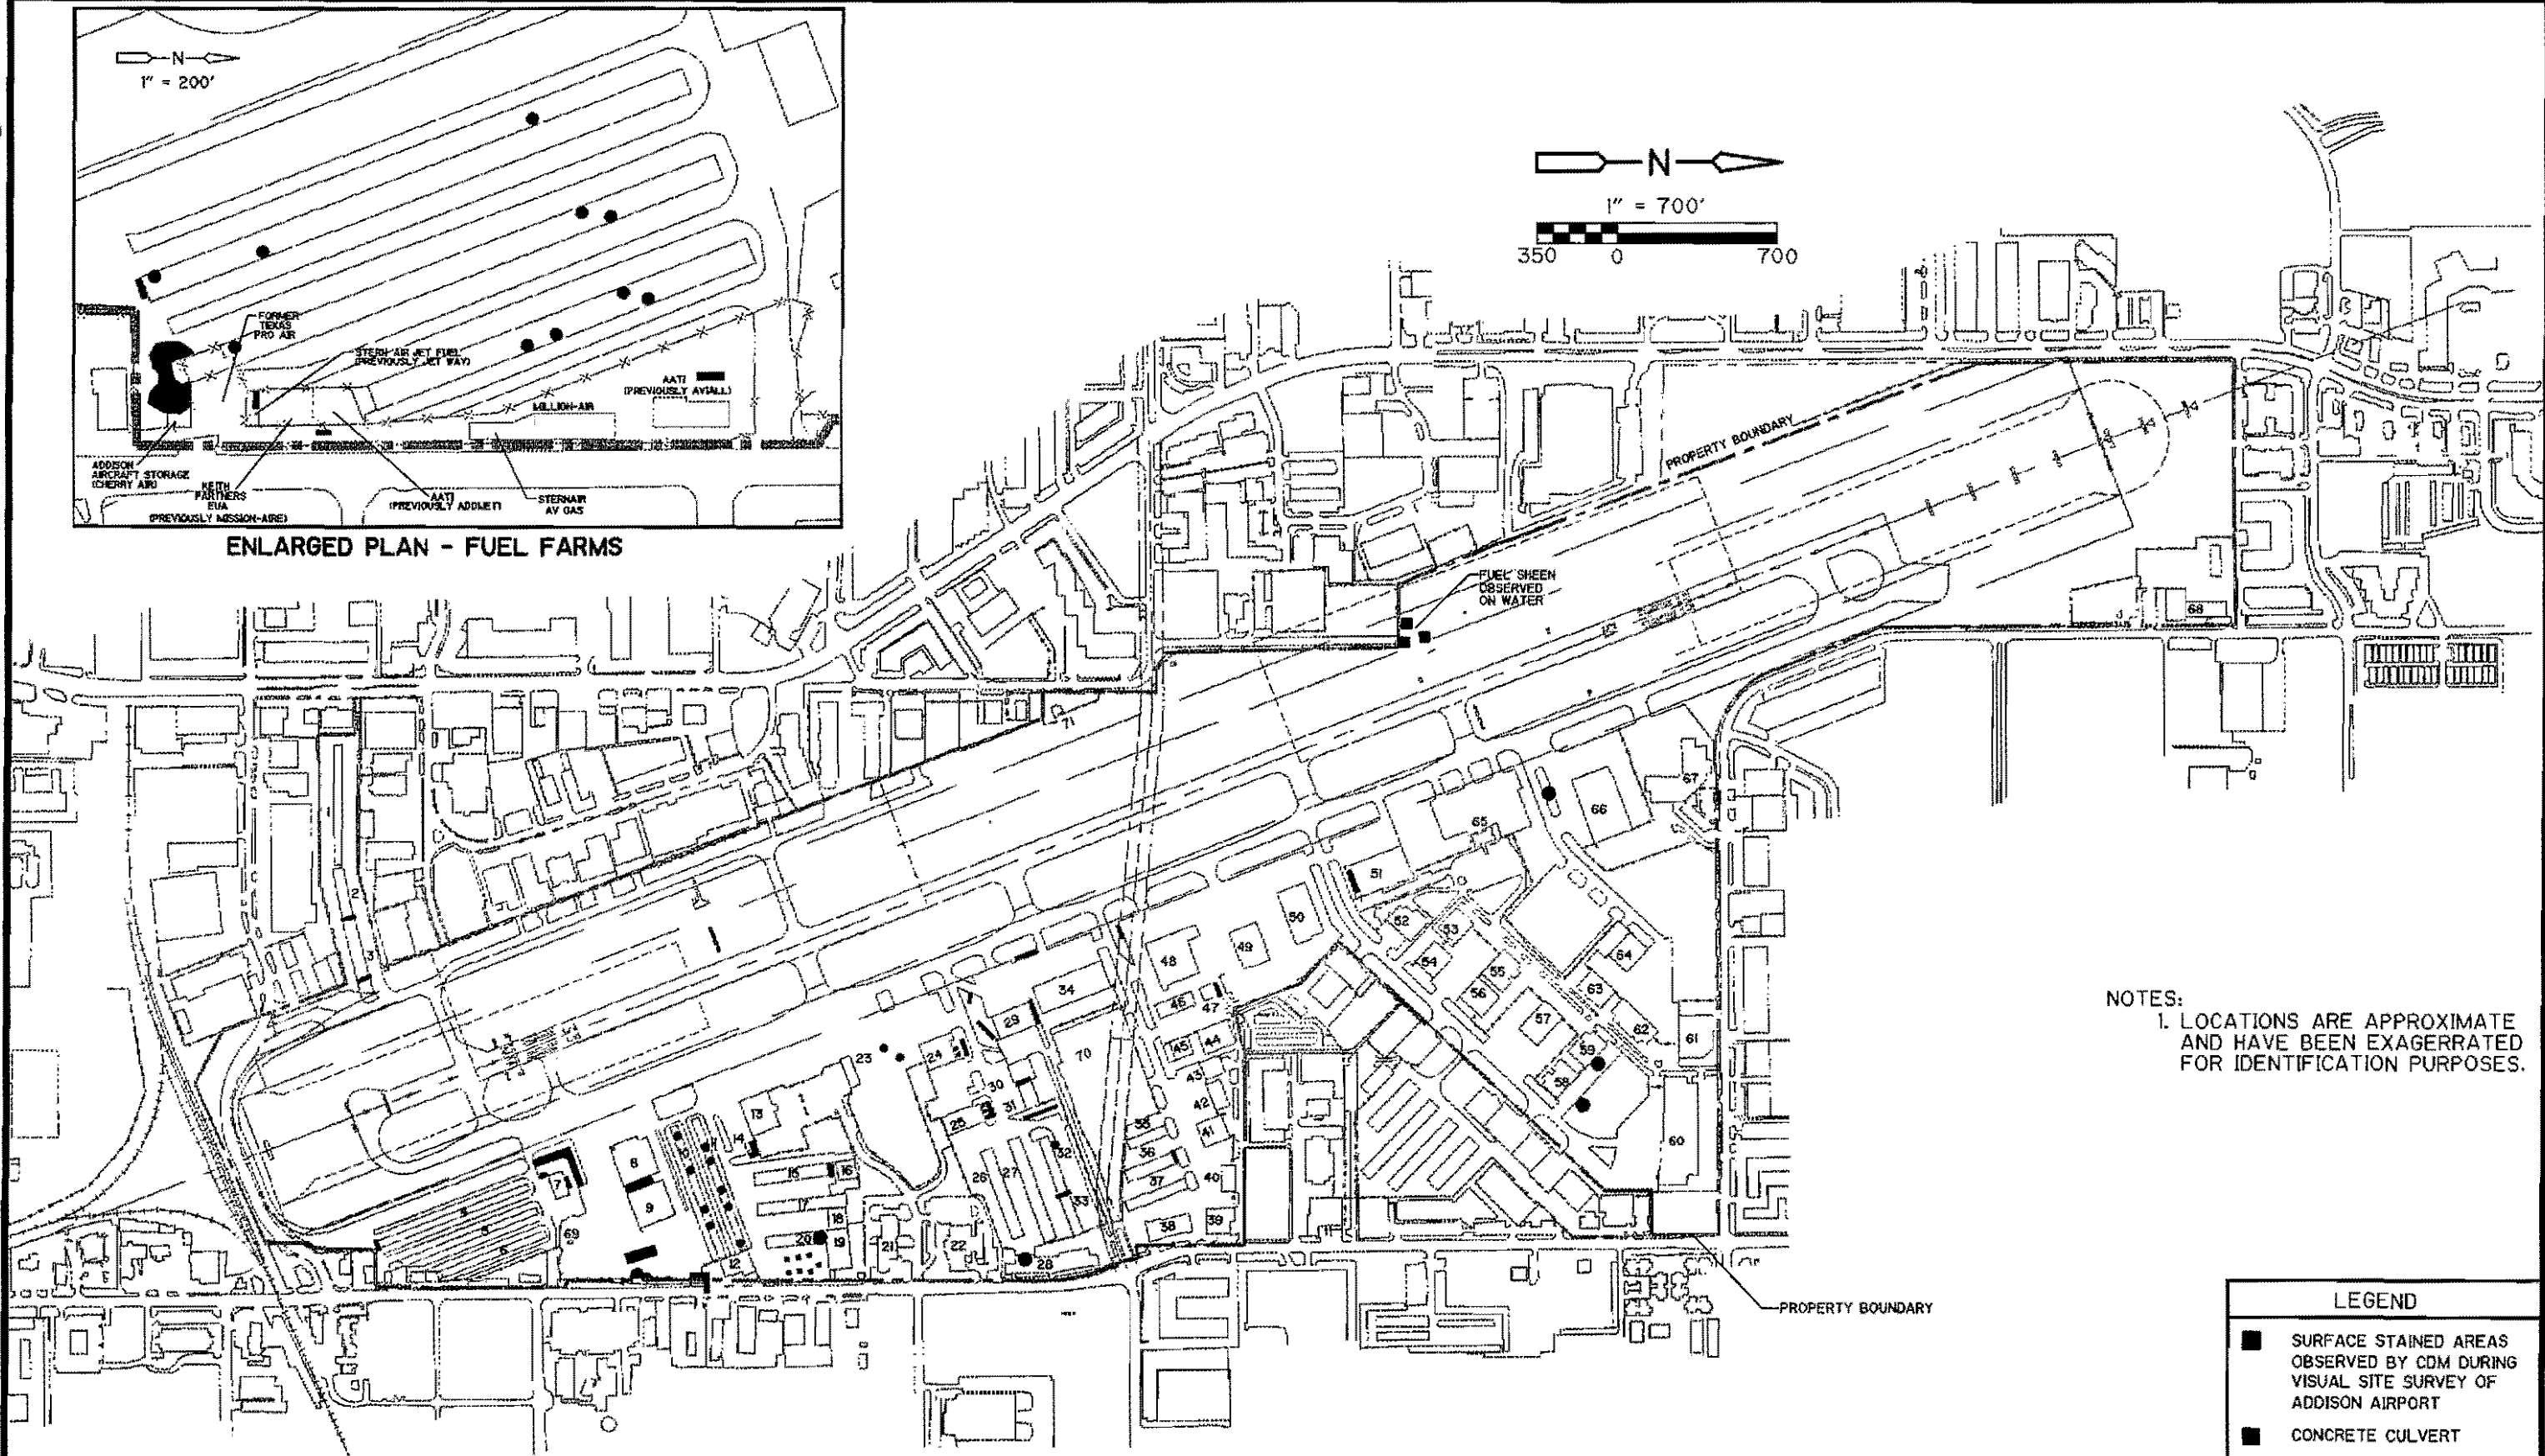
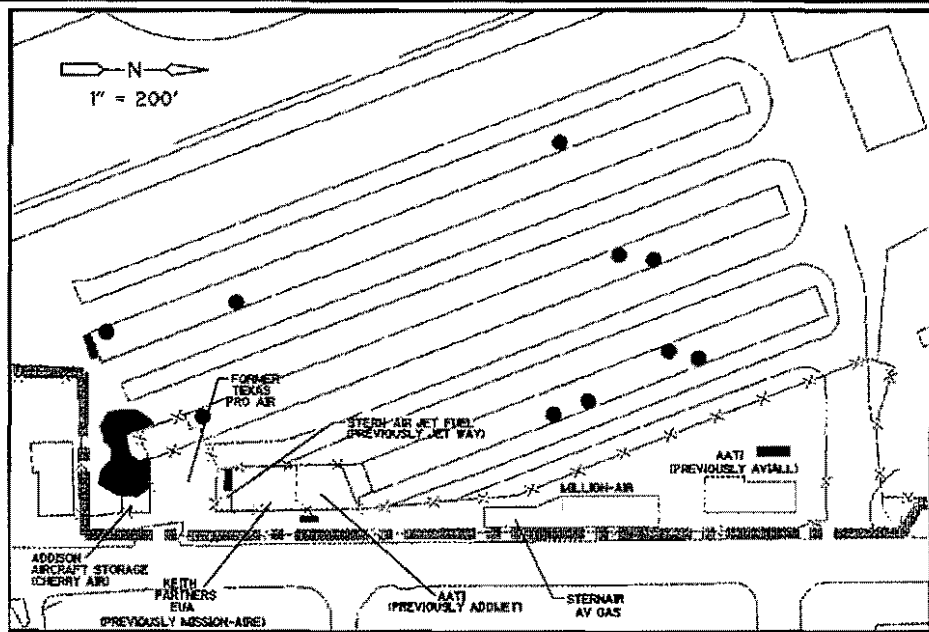
STAINED SURFACE AREAS

SURFACE STAINED AREAS OBSERVED BY CDM DURING VISUAL SITE SURVEY OF ADDISON AIRPORT

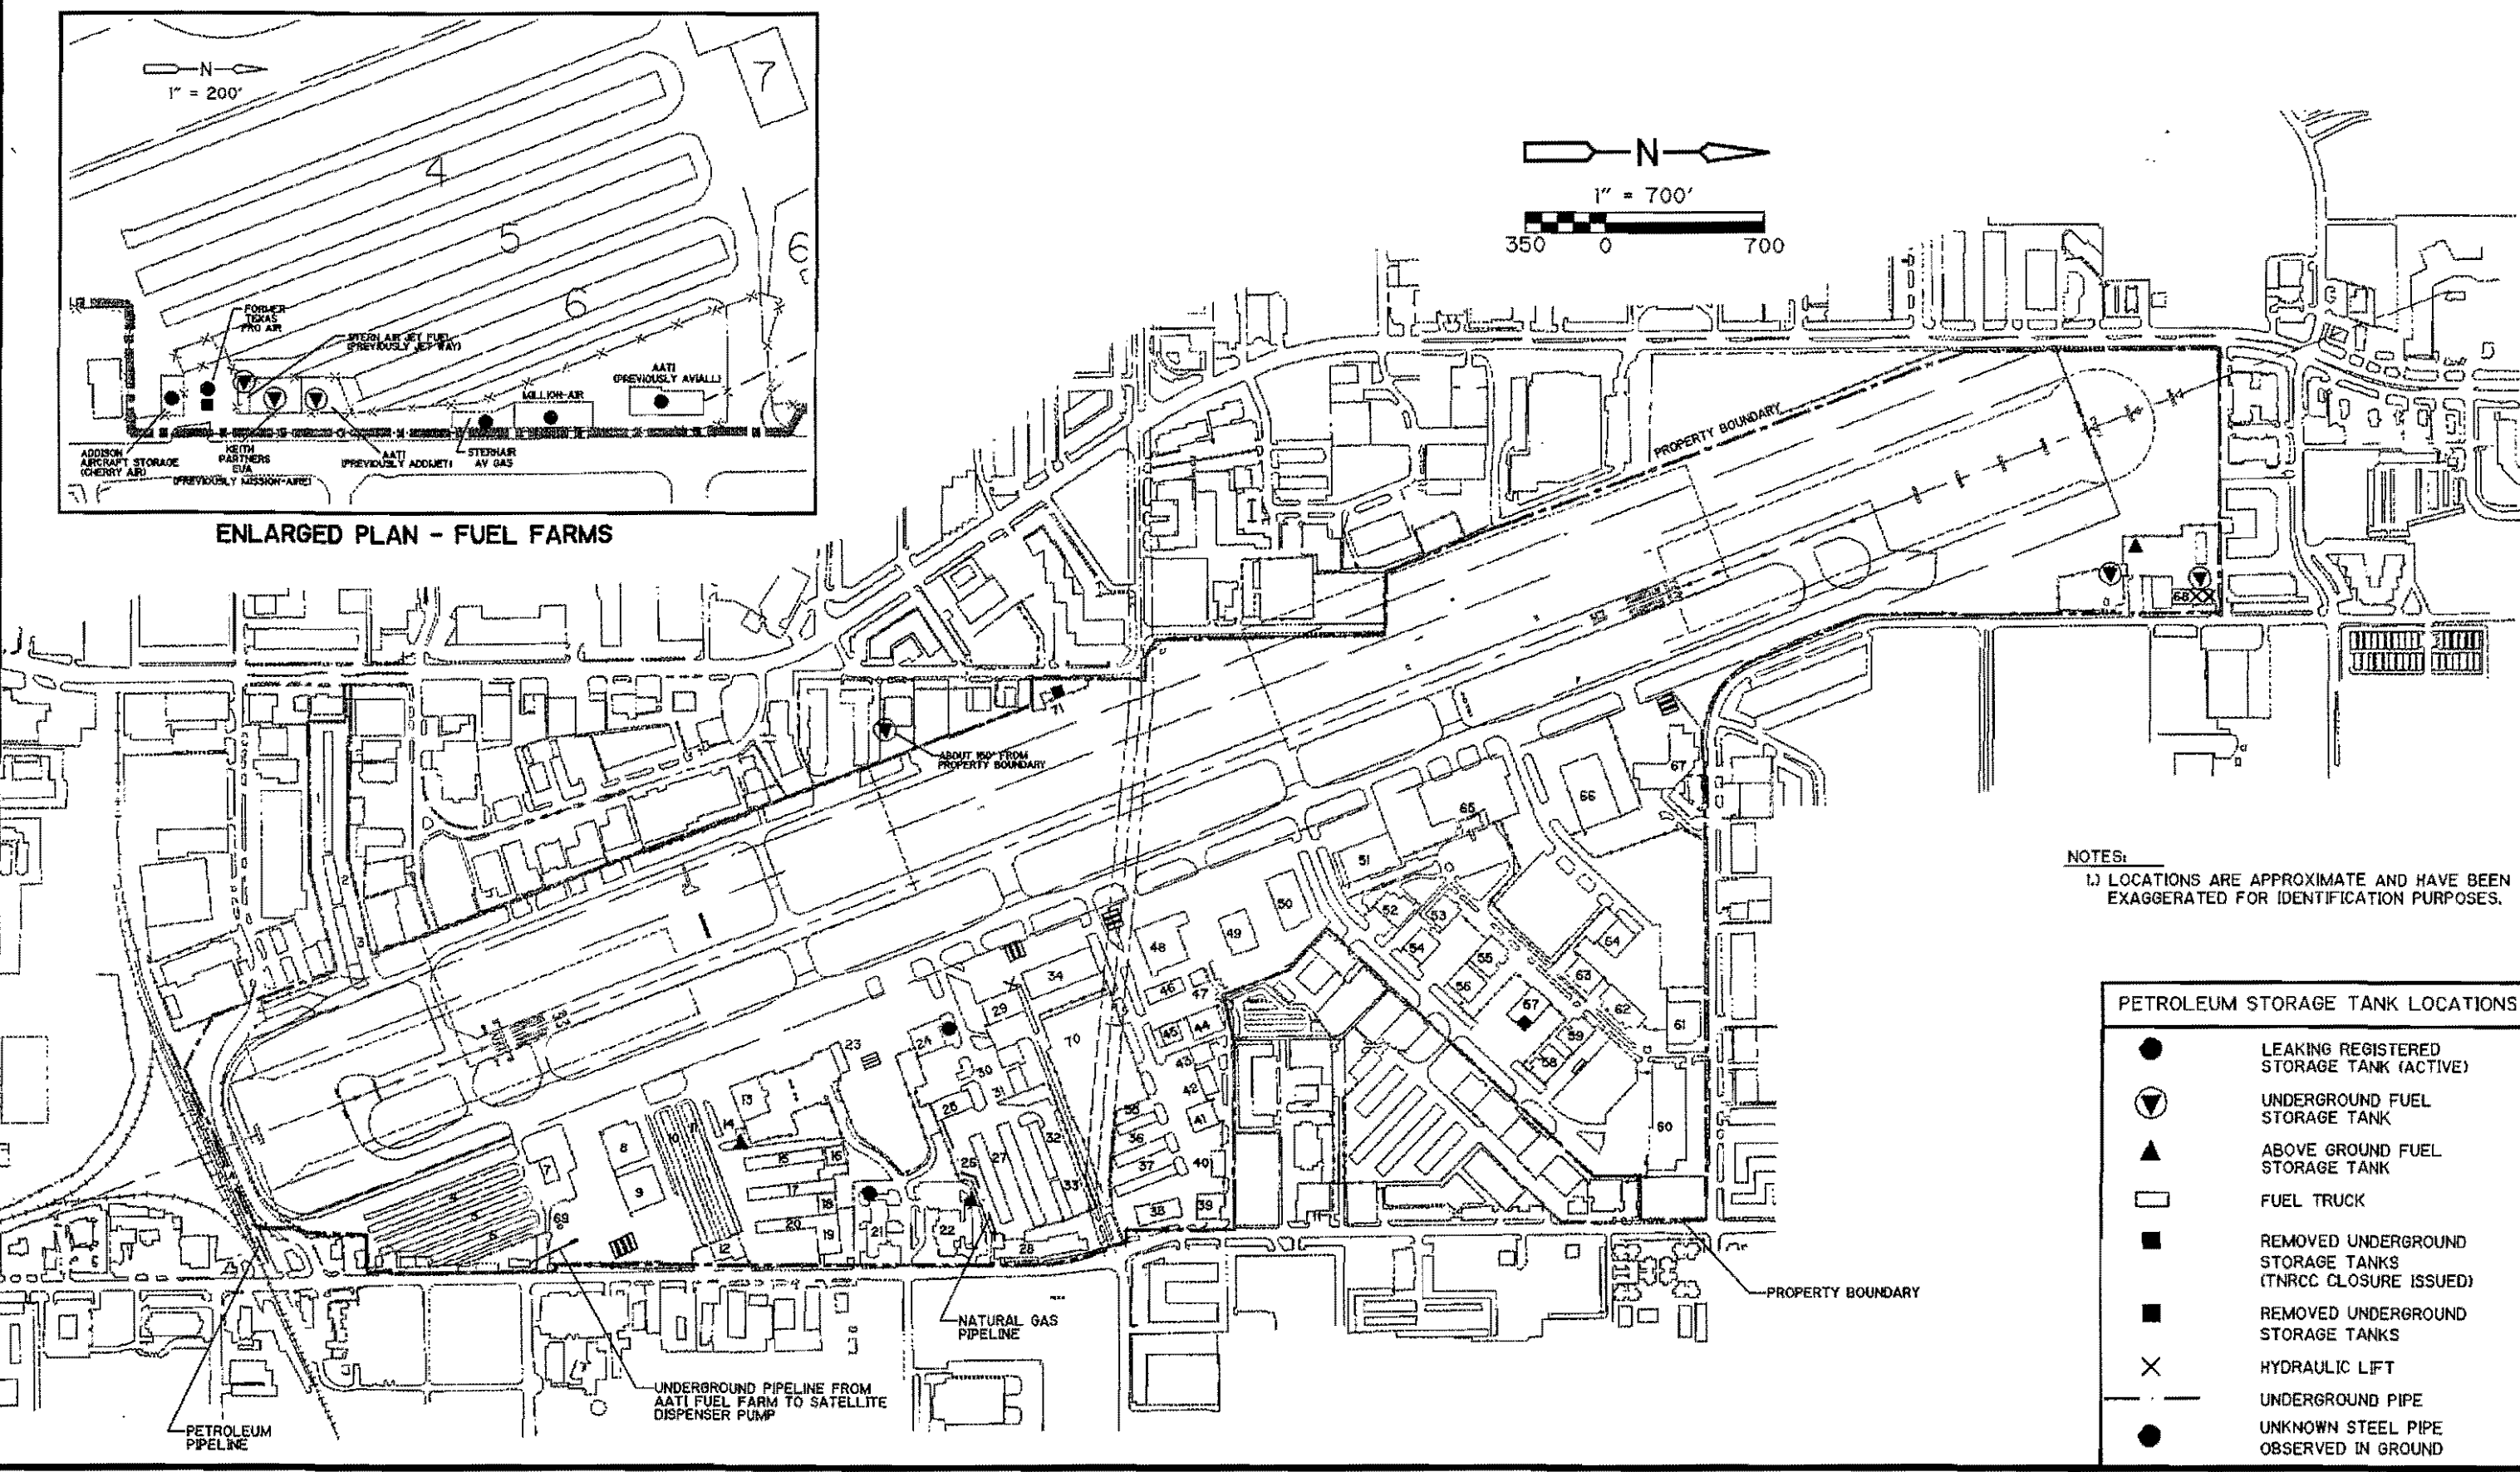
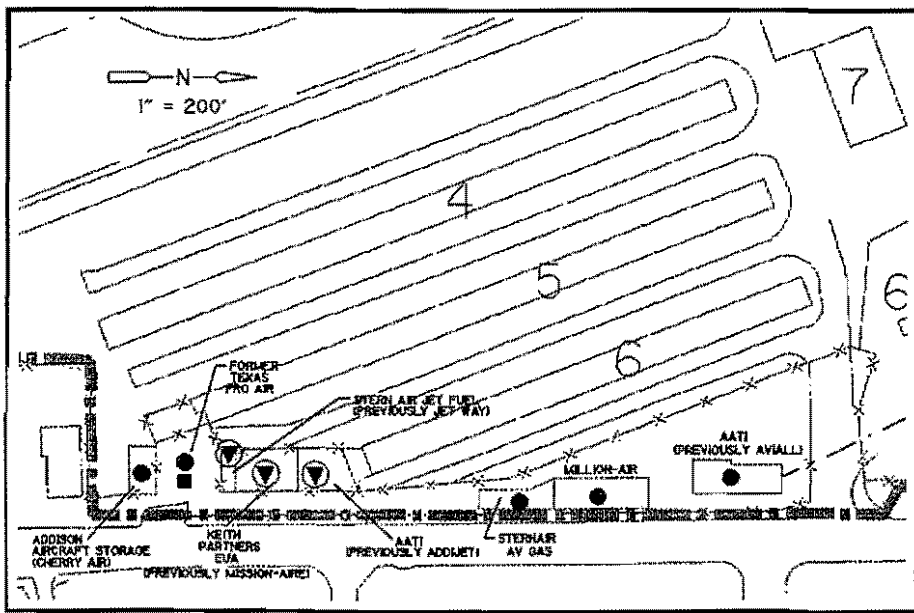
FIGURE ES-2

PETROLEUM STORAGE TANK LOCATIONS	
●	LEAKING REGISTERED STORAGE TANK (ACTIVE)
▼	UNDERGROUND FUEL STORAGE TANK
▲	ABOVE GROUND FUEL STORAGE TANK
□	FUEL TRUCK
■	REMOVED UNDERGROUND STORAGE TANKS (TNRCC CLOSURE ISSUED)
■	REMOVED UNDERGROUND STORAGE TANKS
×	HYDRAULIC LIFT
—	UNDERGROUND PIPE
●	UNKNOWN STEEL PIPE OBSERVED IN GROUND

HISTORICAL AND EXISTING PETROLEUM STORAGE TANK LOCATIONS

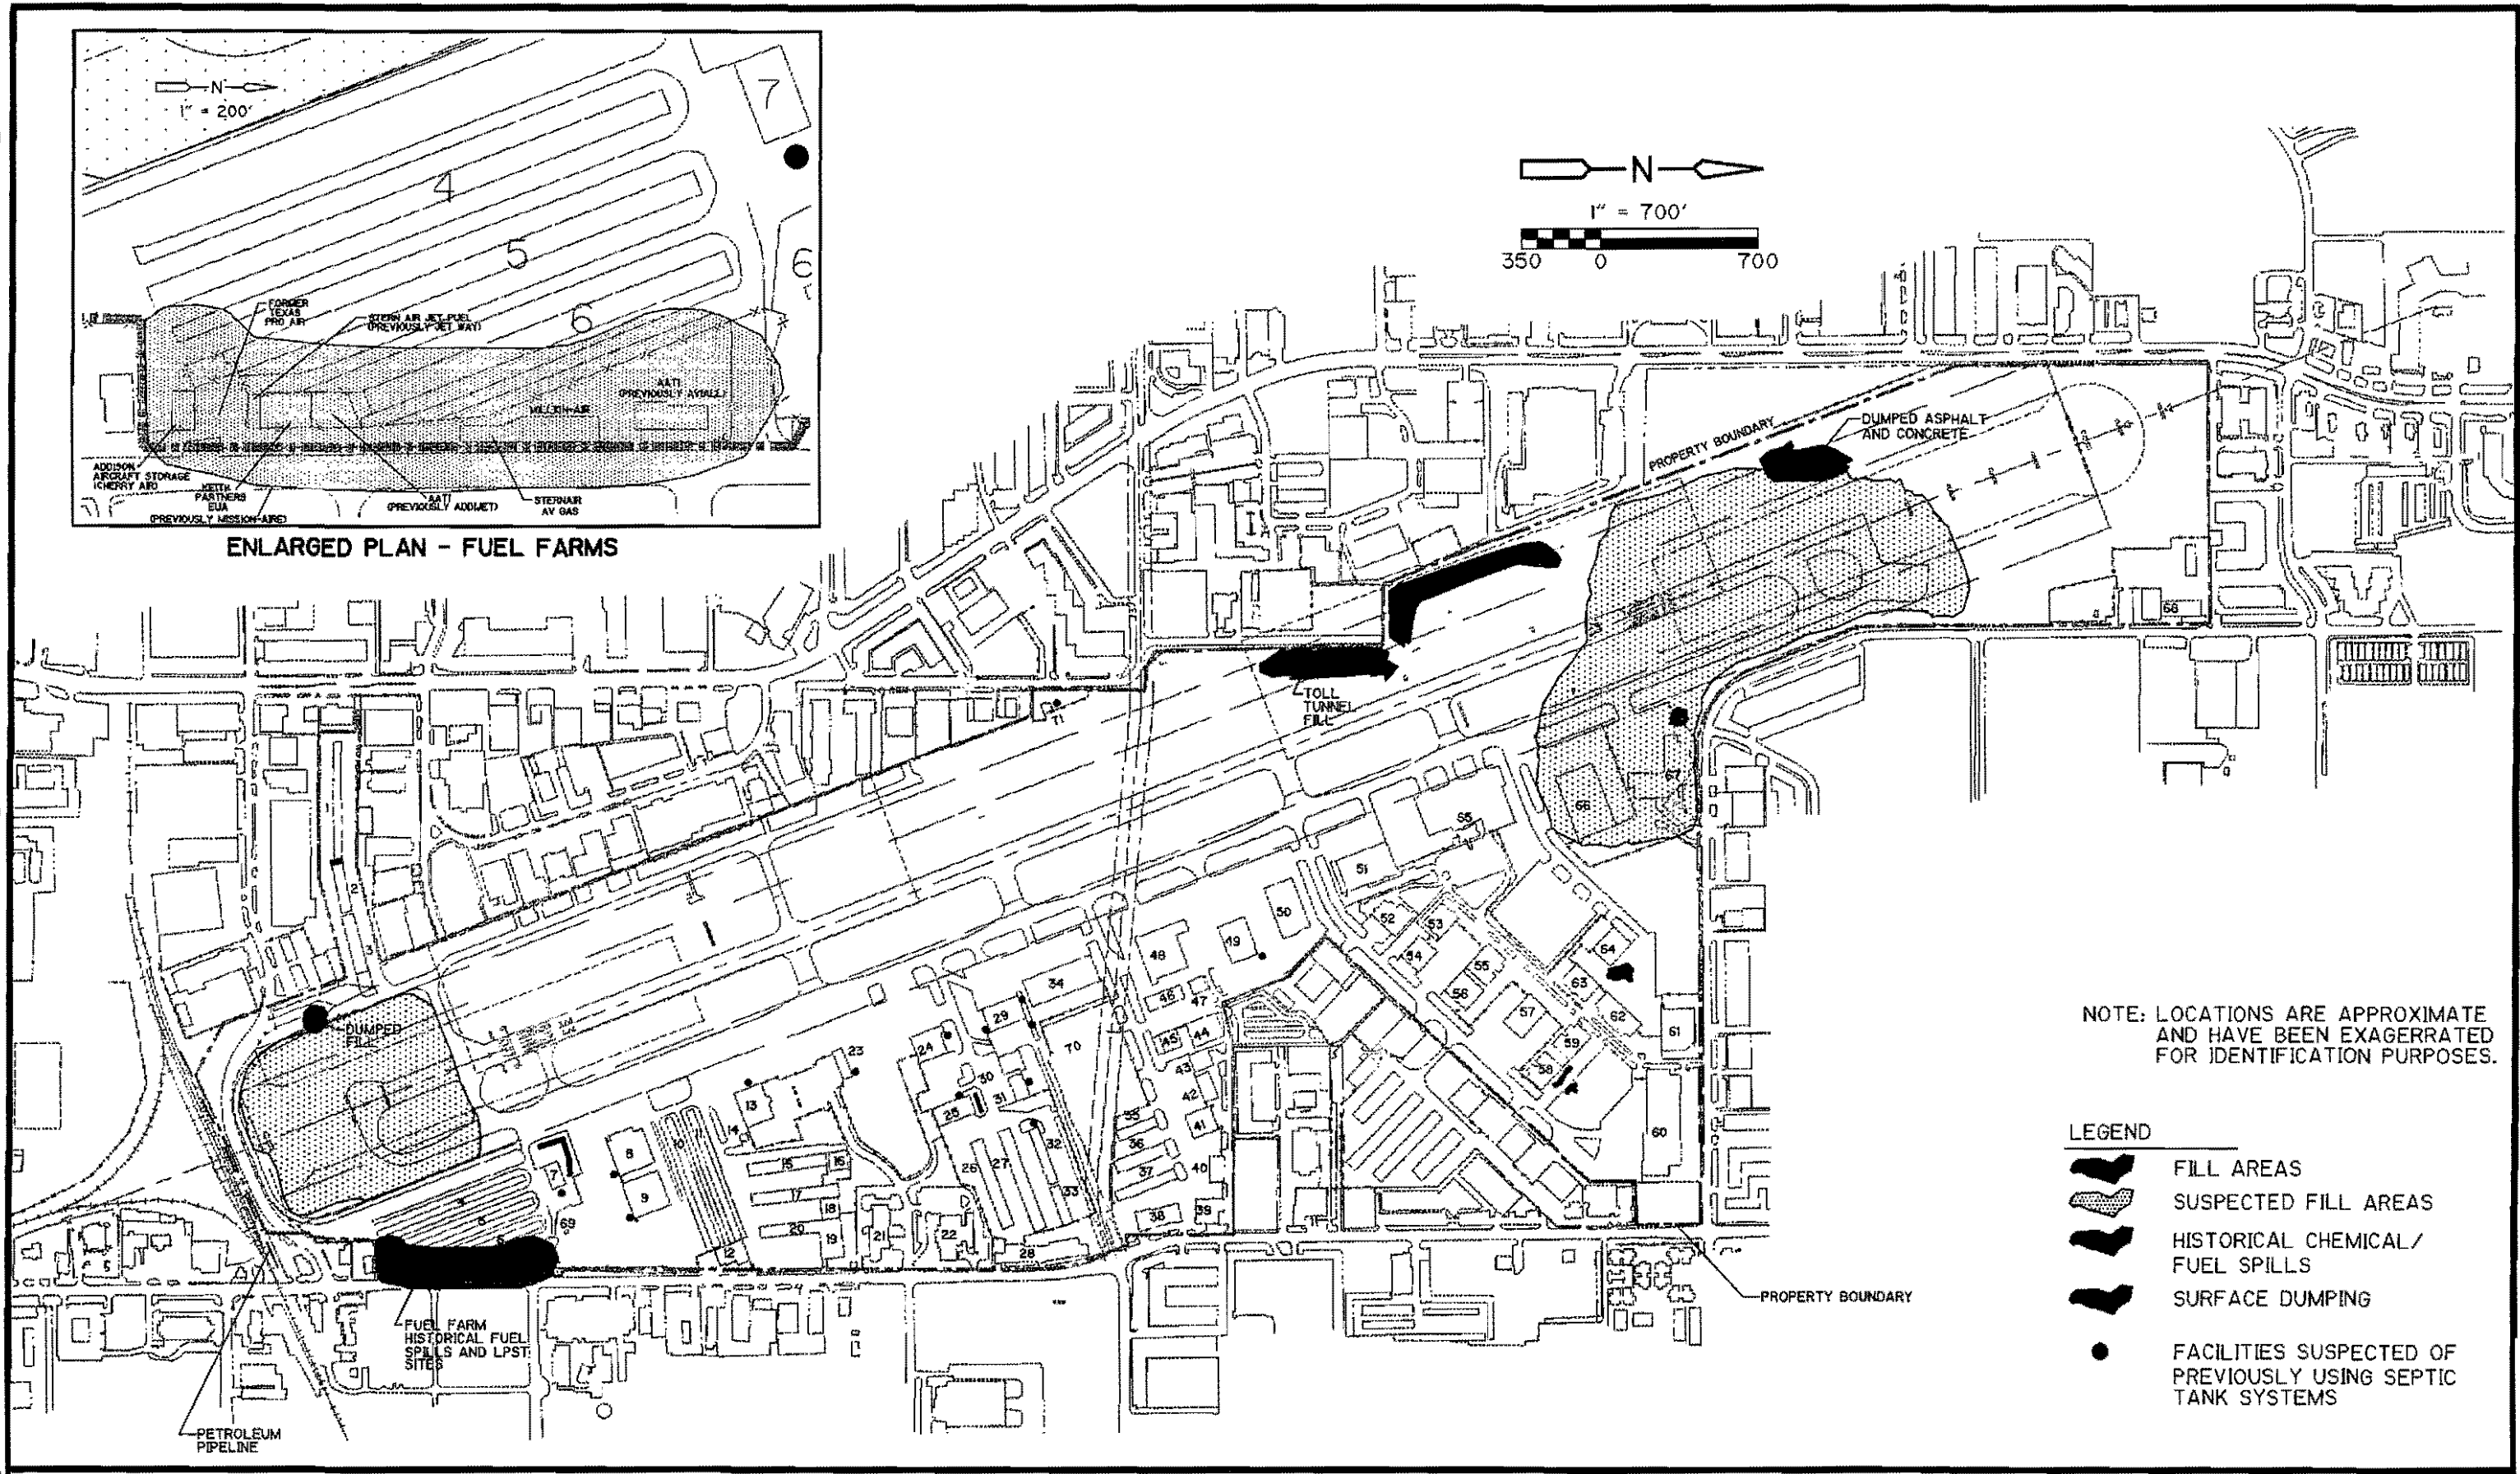
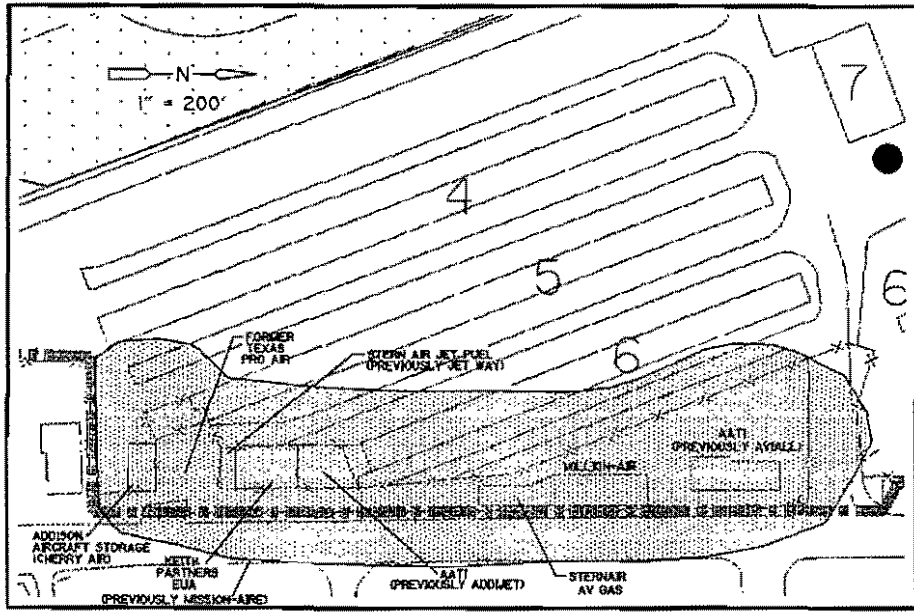
HISTORICAL AREAS OF ENVIRONMENTAL CONCERN

HISTORICAL CHEMICAL / FUEL SPILLS
-

SURFACE DUMPING
-
