AIRPORT ESA EXTRA CODE FIGURES

ADDISON AIRPORT
ADDISON, TEXAS

STAINED SURFACE AREAS

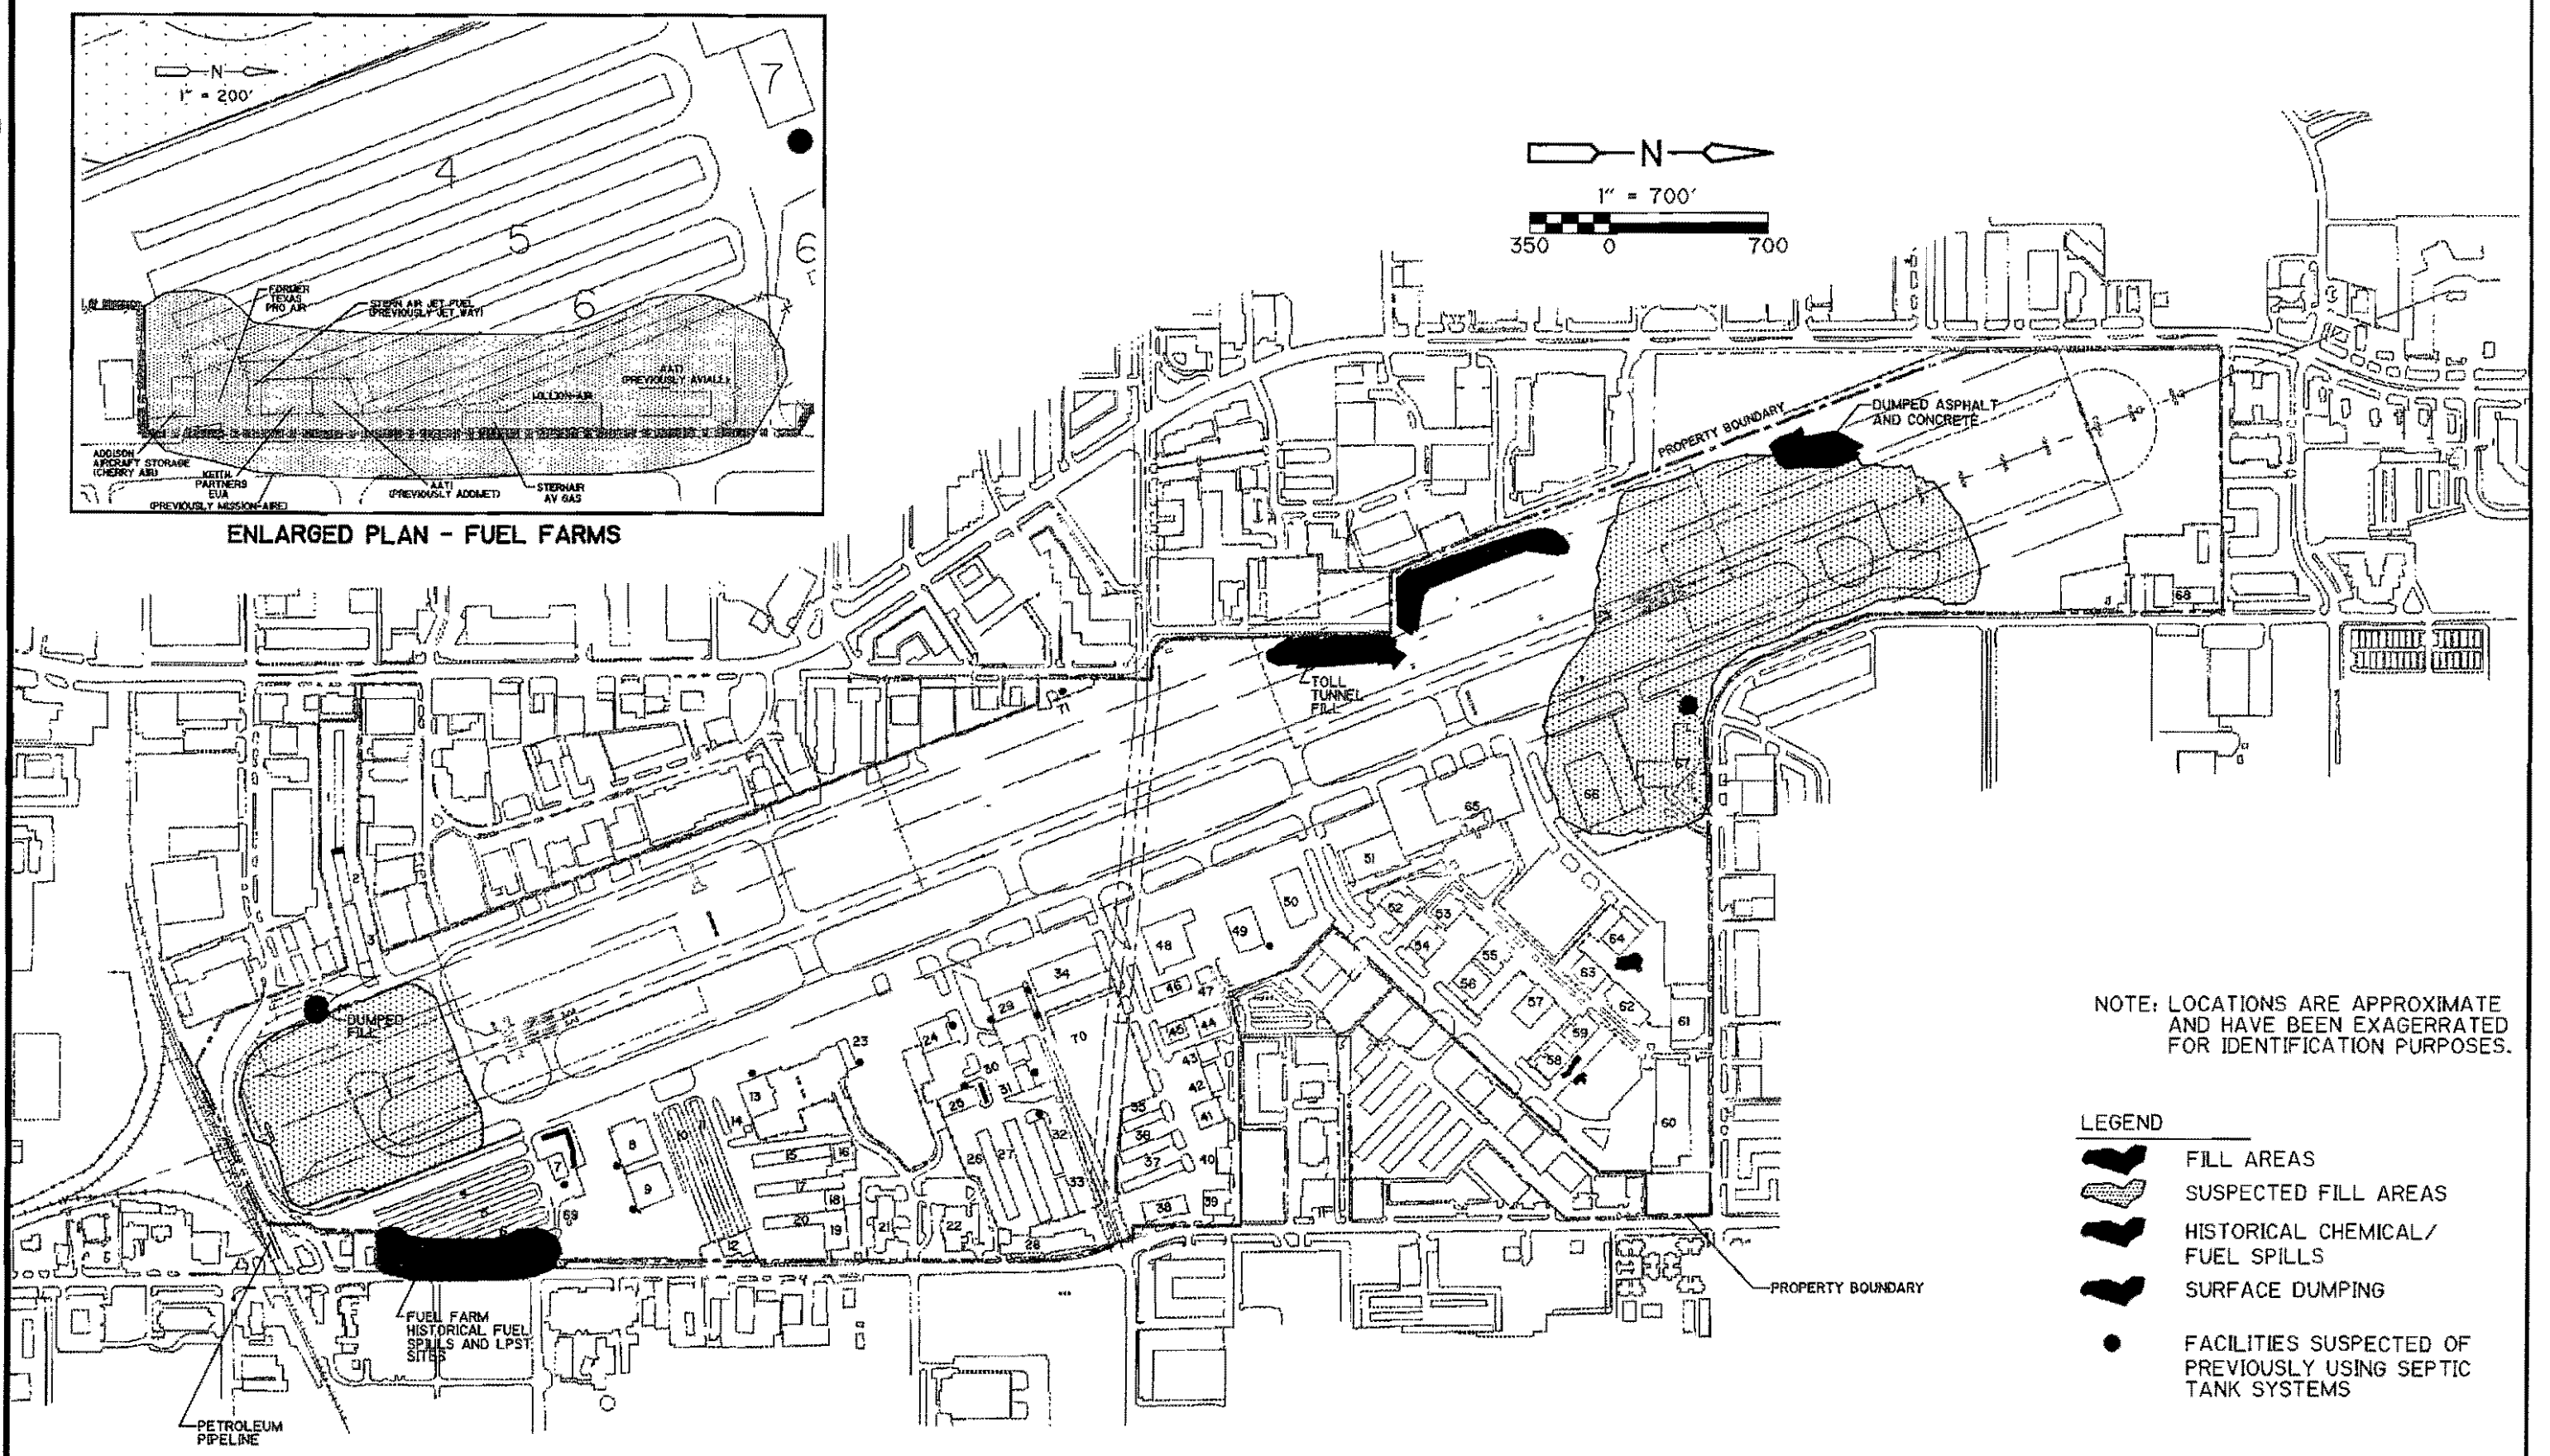
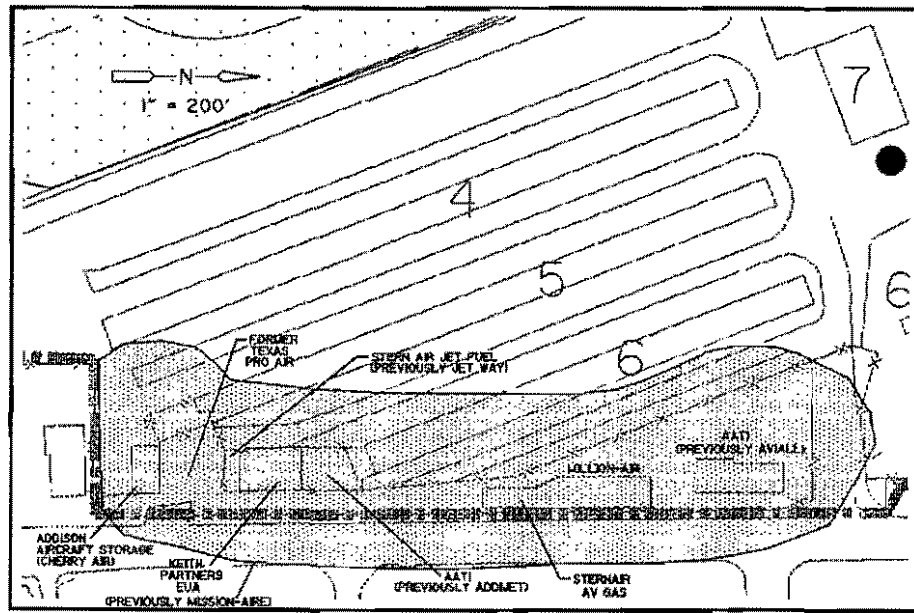
FIG4-4

HISTORICAL AREAS OF ENVIRONMENTAL CONCERN

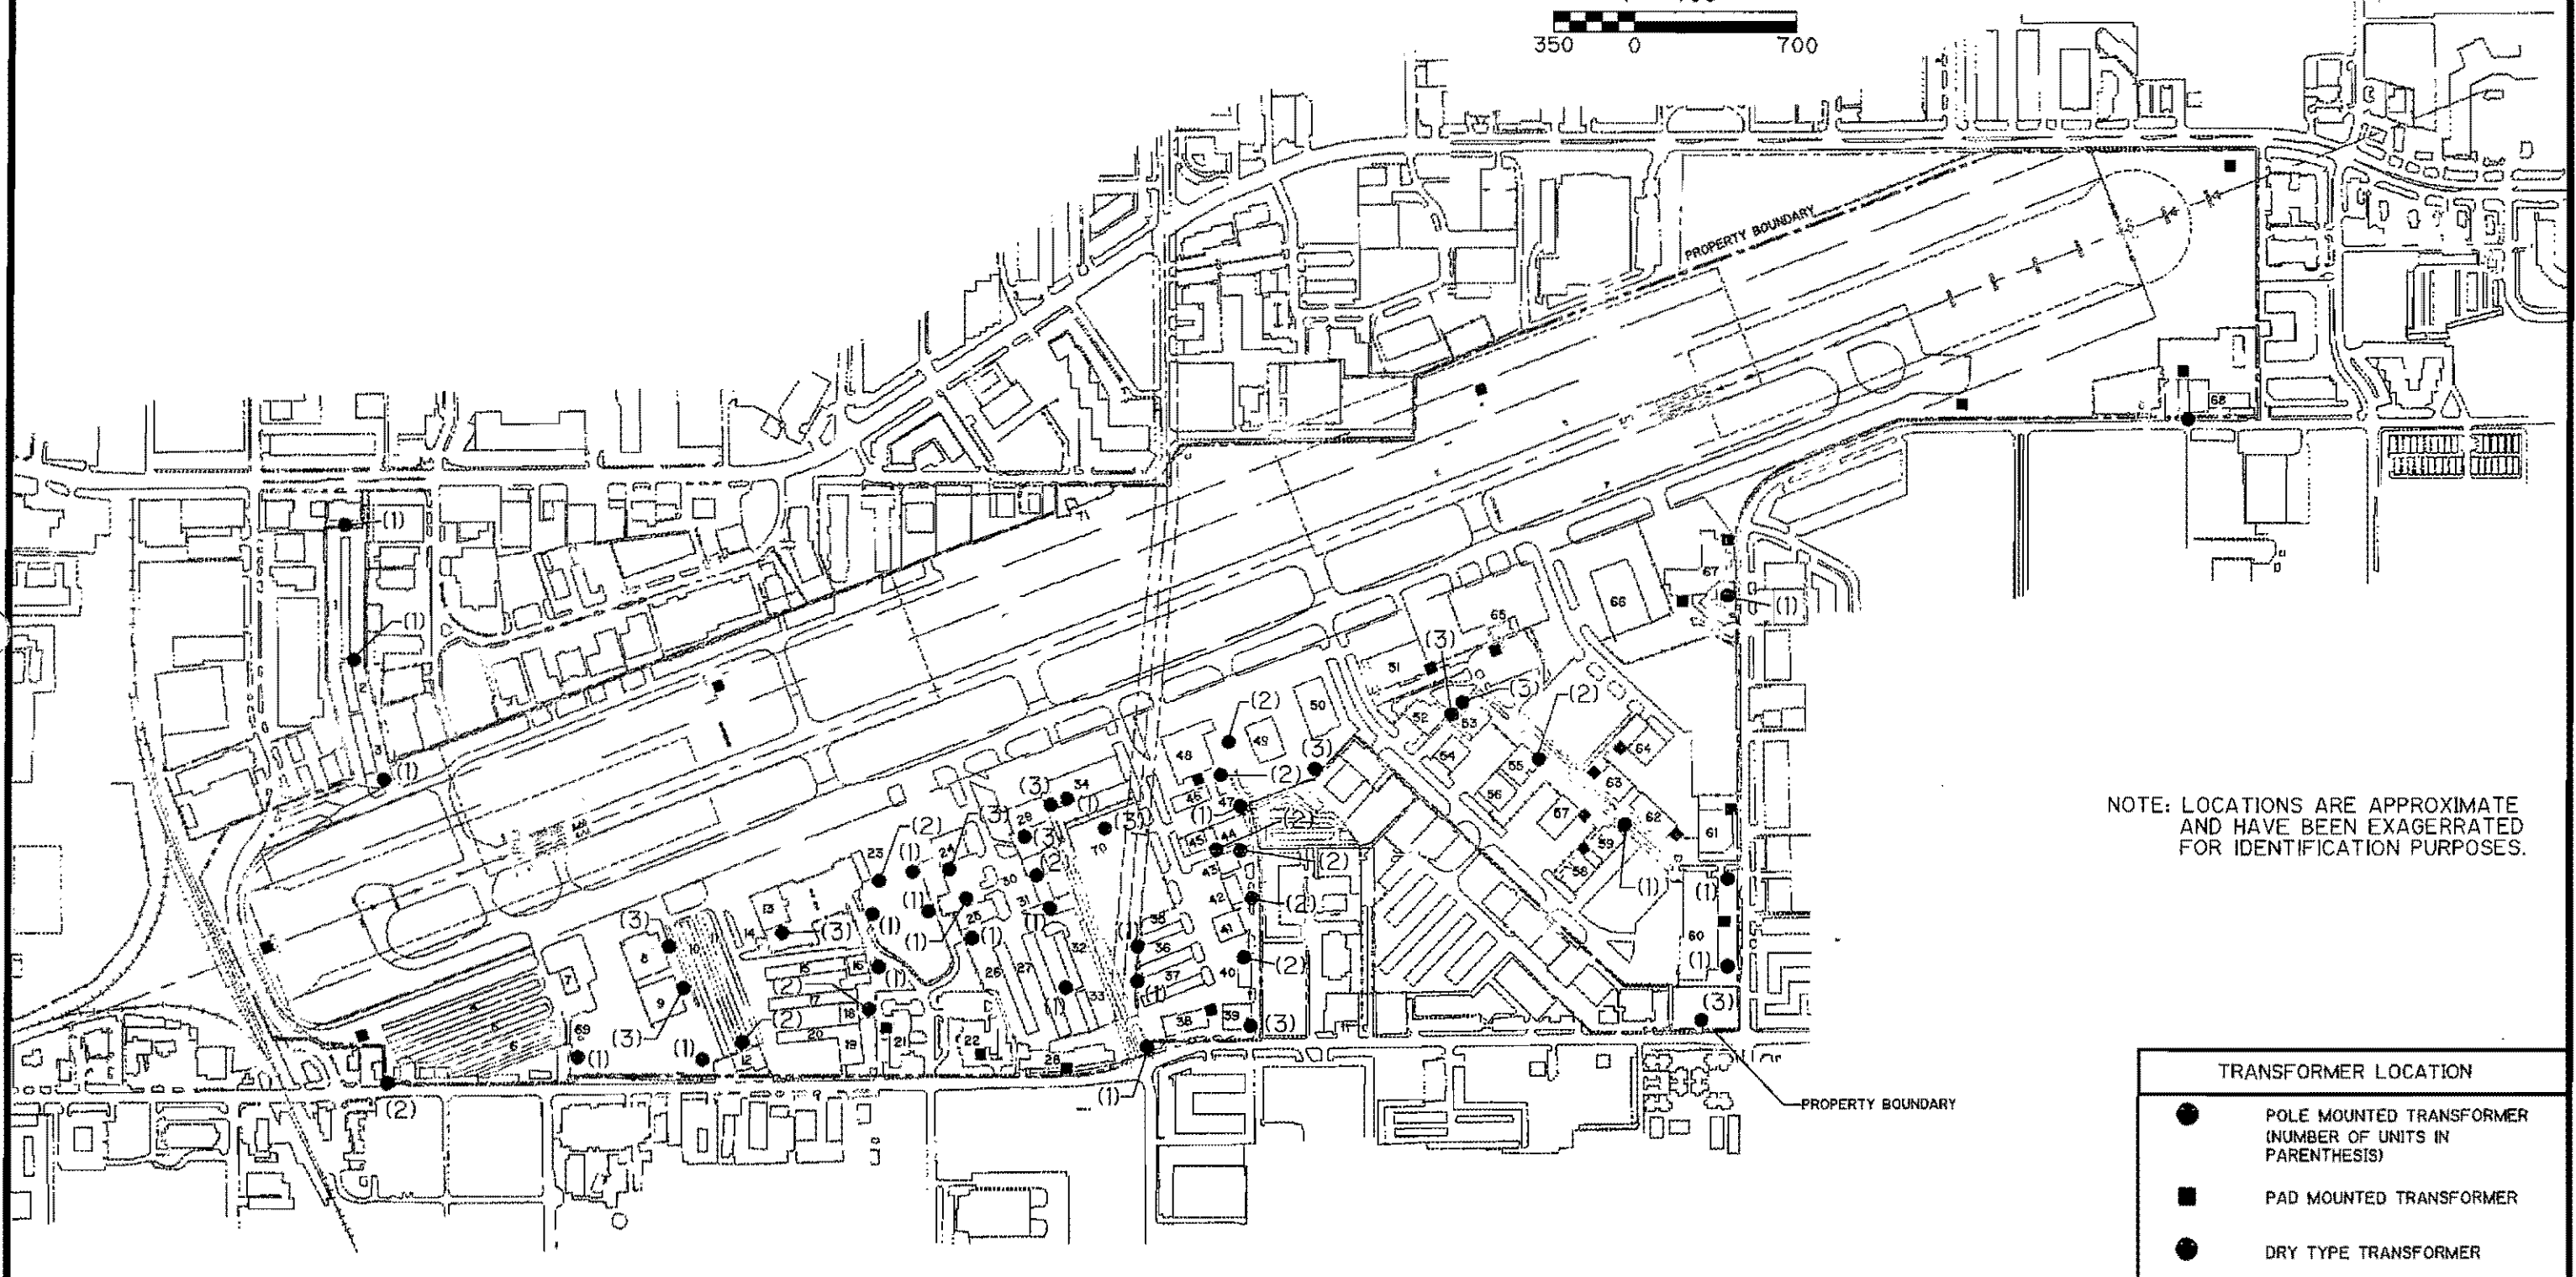
TRANSFORMER LOCATIONS

TRANSFORMER LOCATION	
● (with number in parenthesis)	POLE MOUNTED TRANSFORMER (NUMBER OF UNITS IN PARENTHESIS)
■	PAD MOUNTED TRANSFORMER
●	DRY TYPE TRANSFORMER

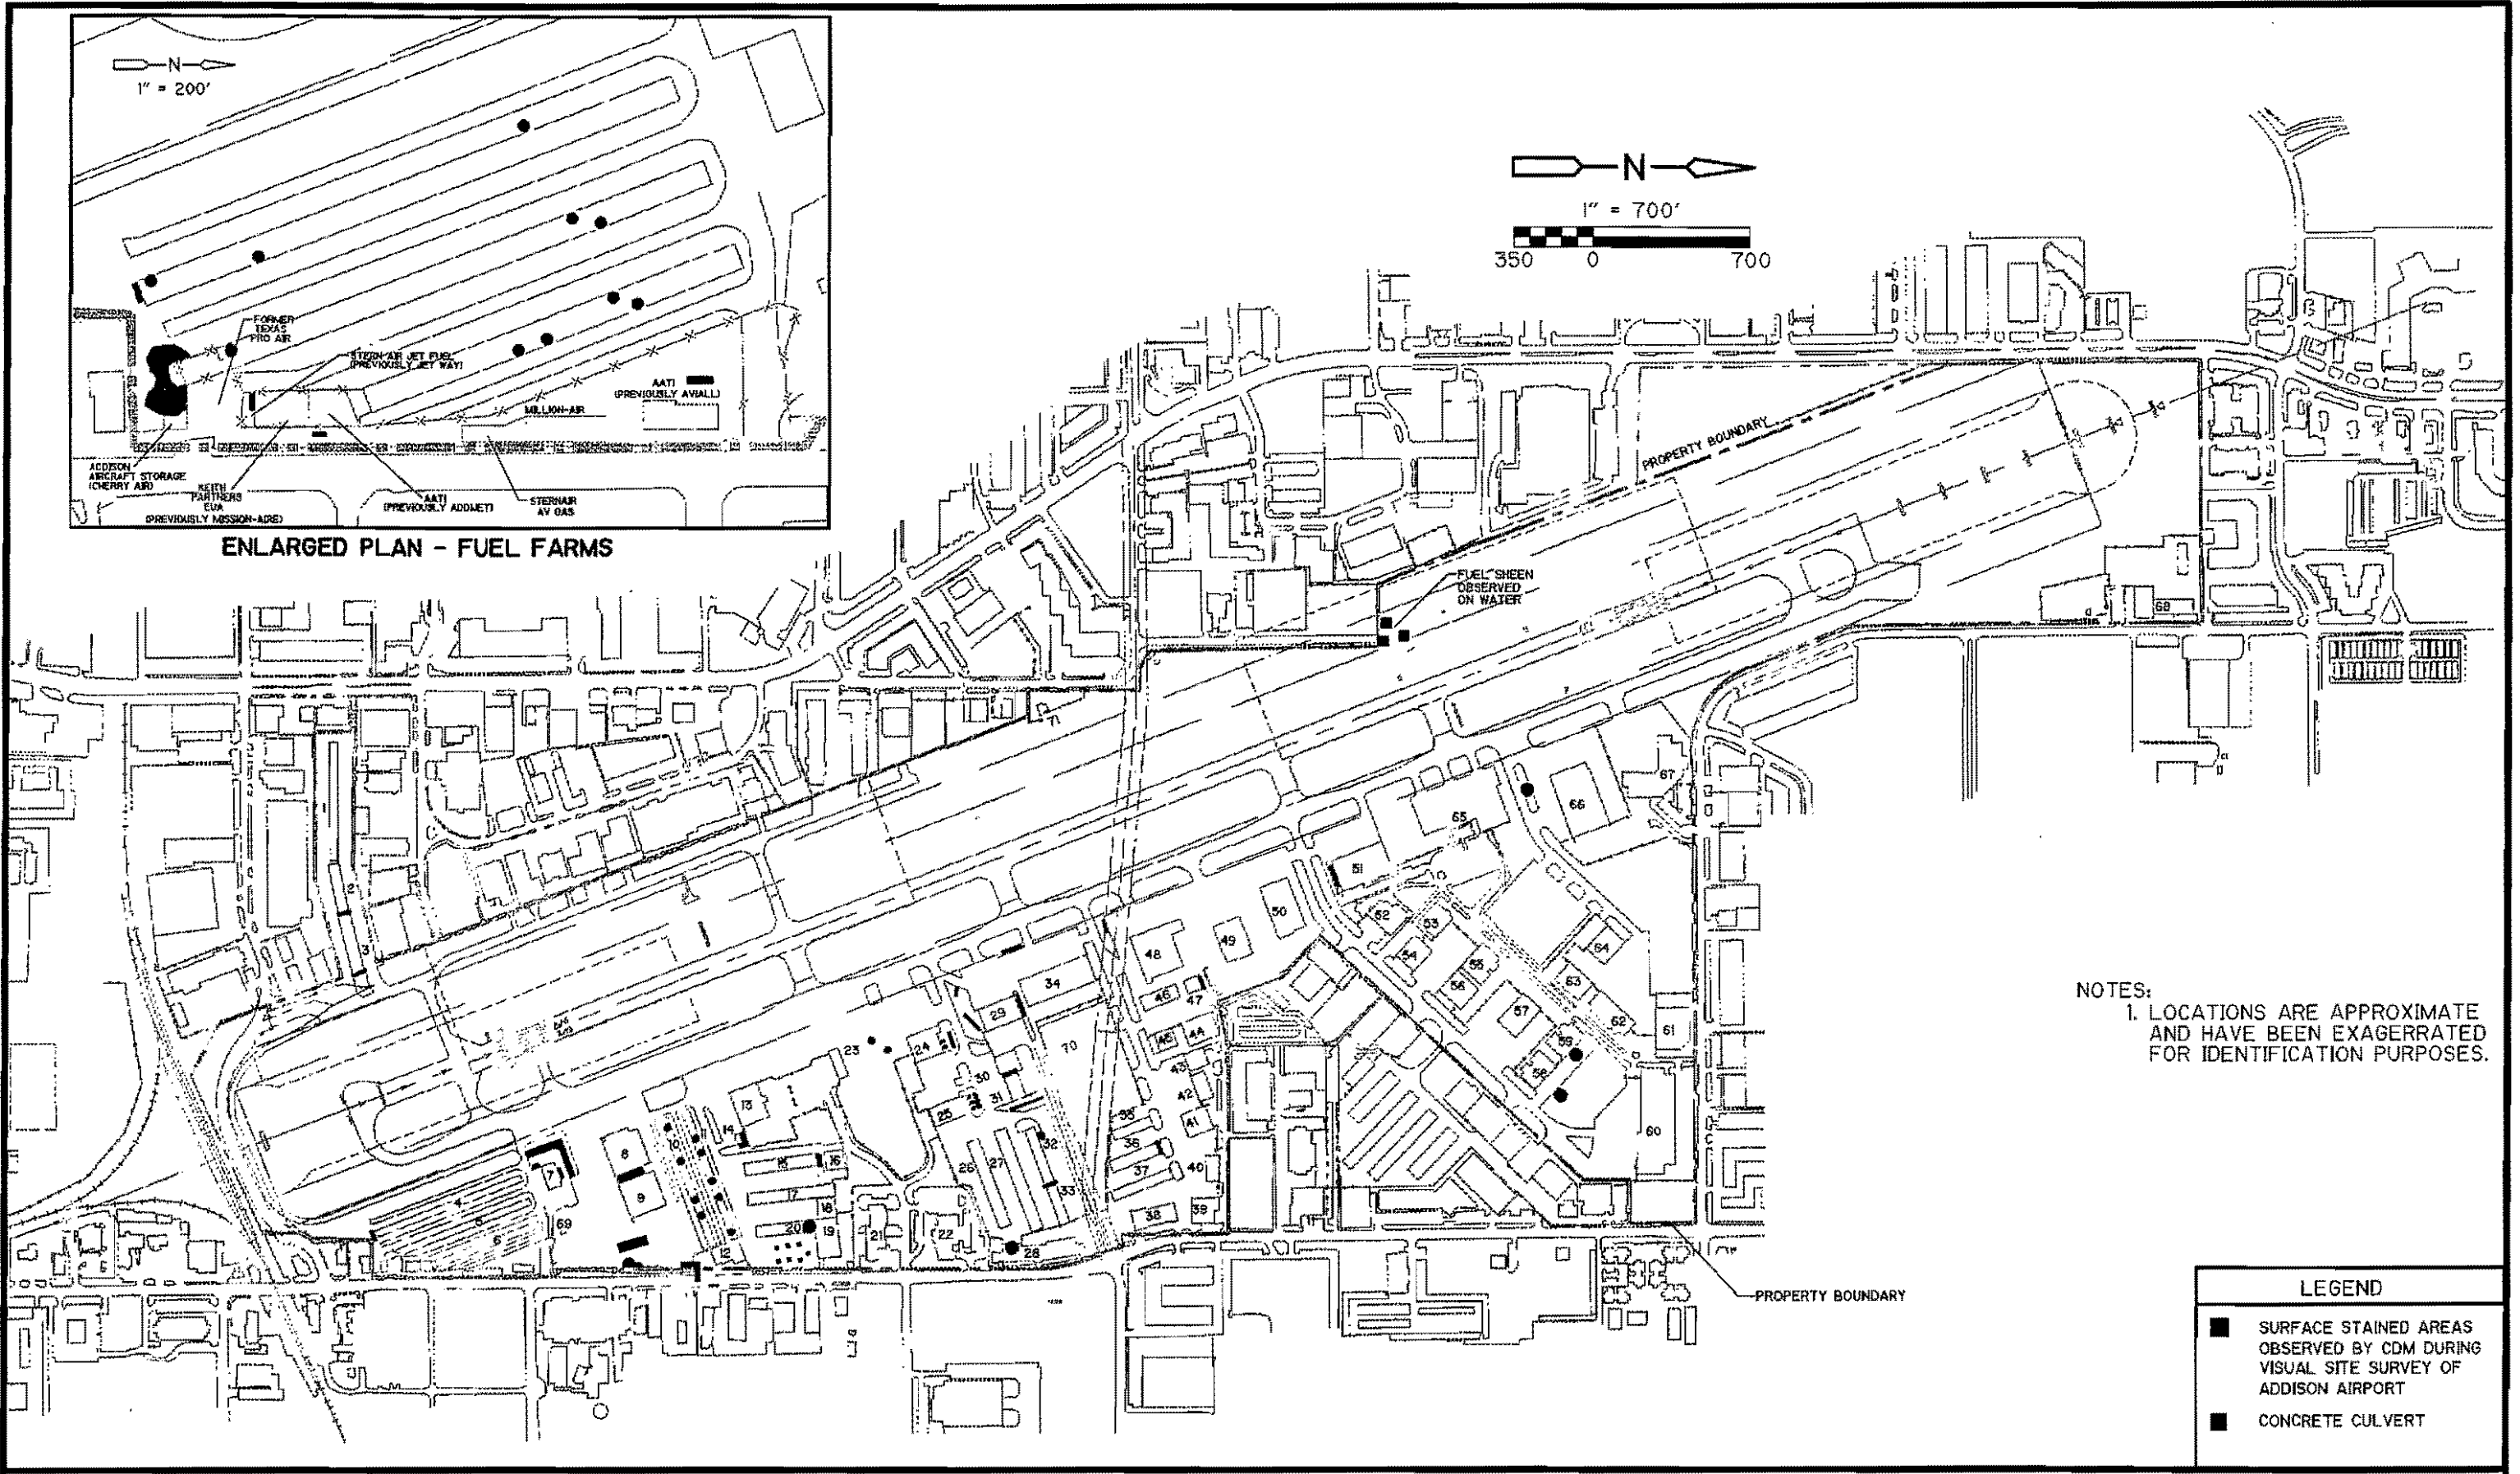
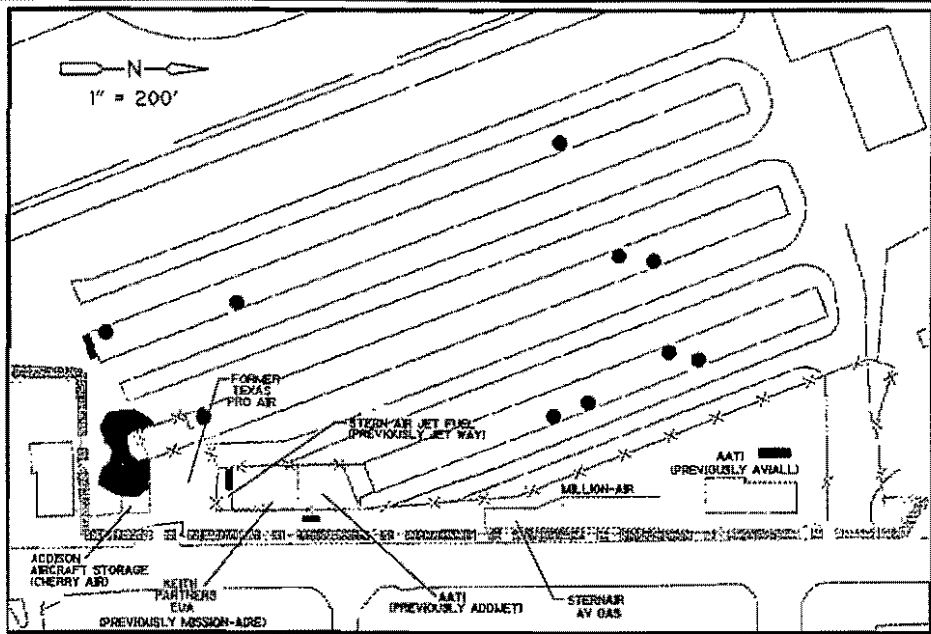
STAINED SURFACE AREAS

LEGEND	
■	SURFACE STAINED AREAS OBSERVED BY CDM DURING VISUAL SITE SURVEY OF ADDISON AIRPORT
■	CONCRETE CULVERT

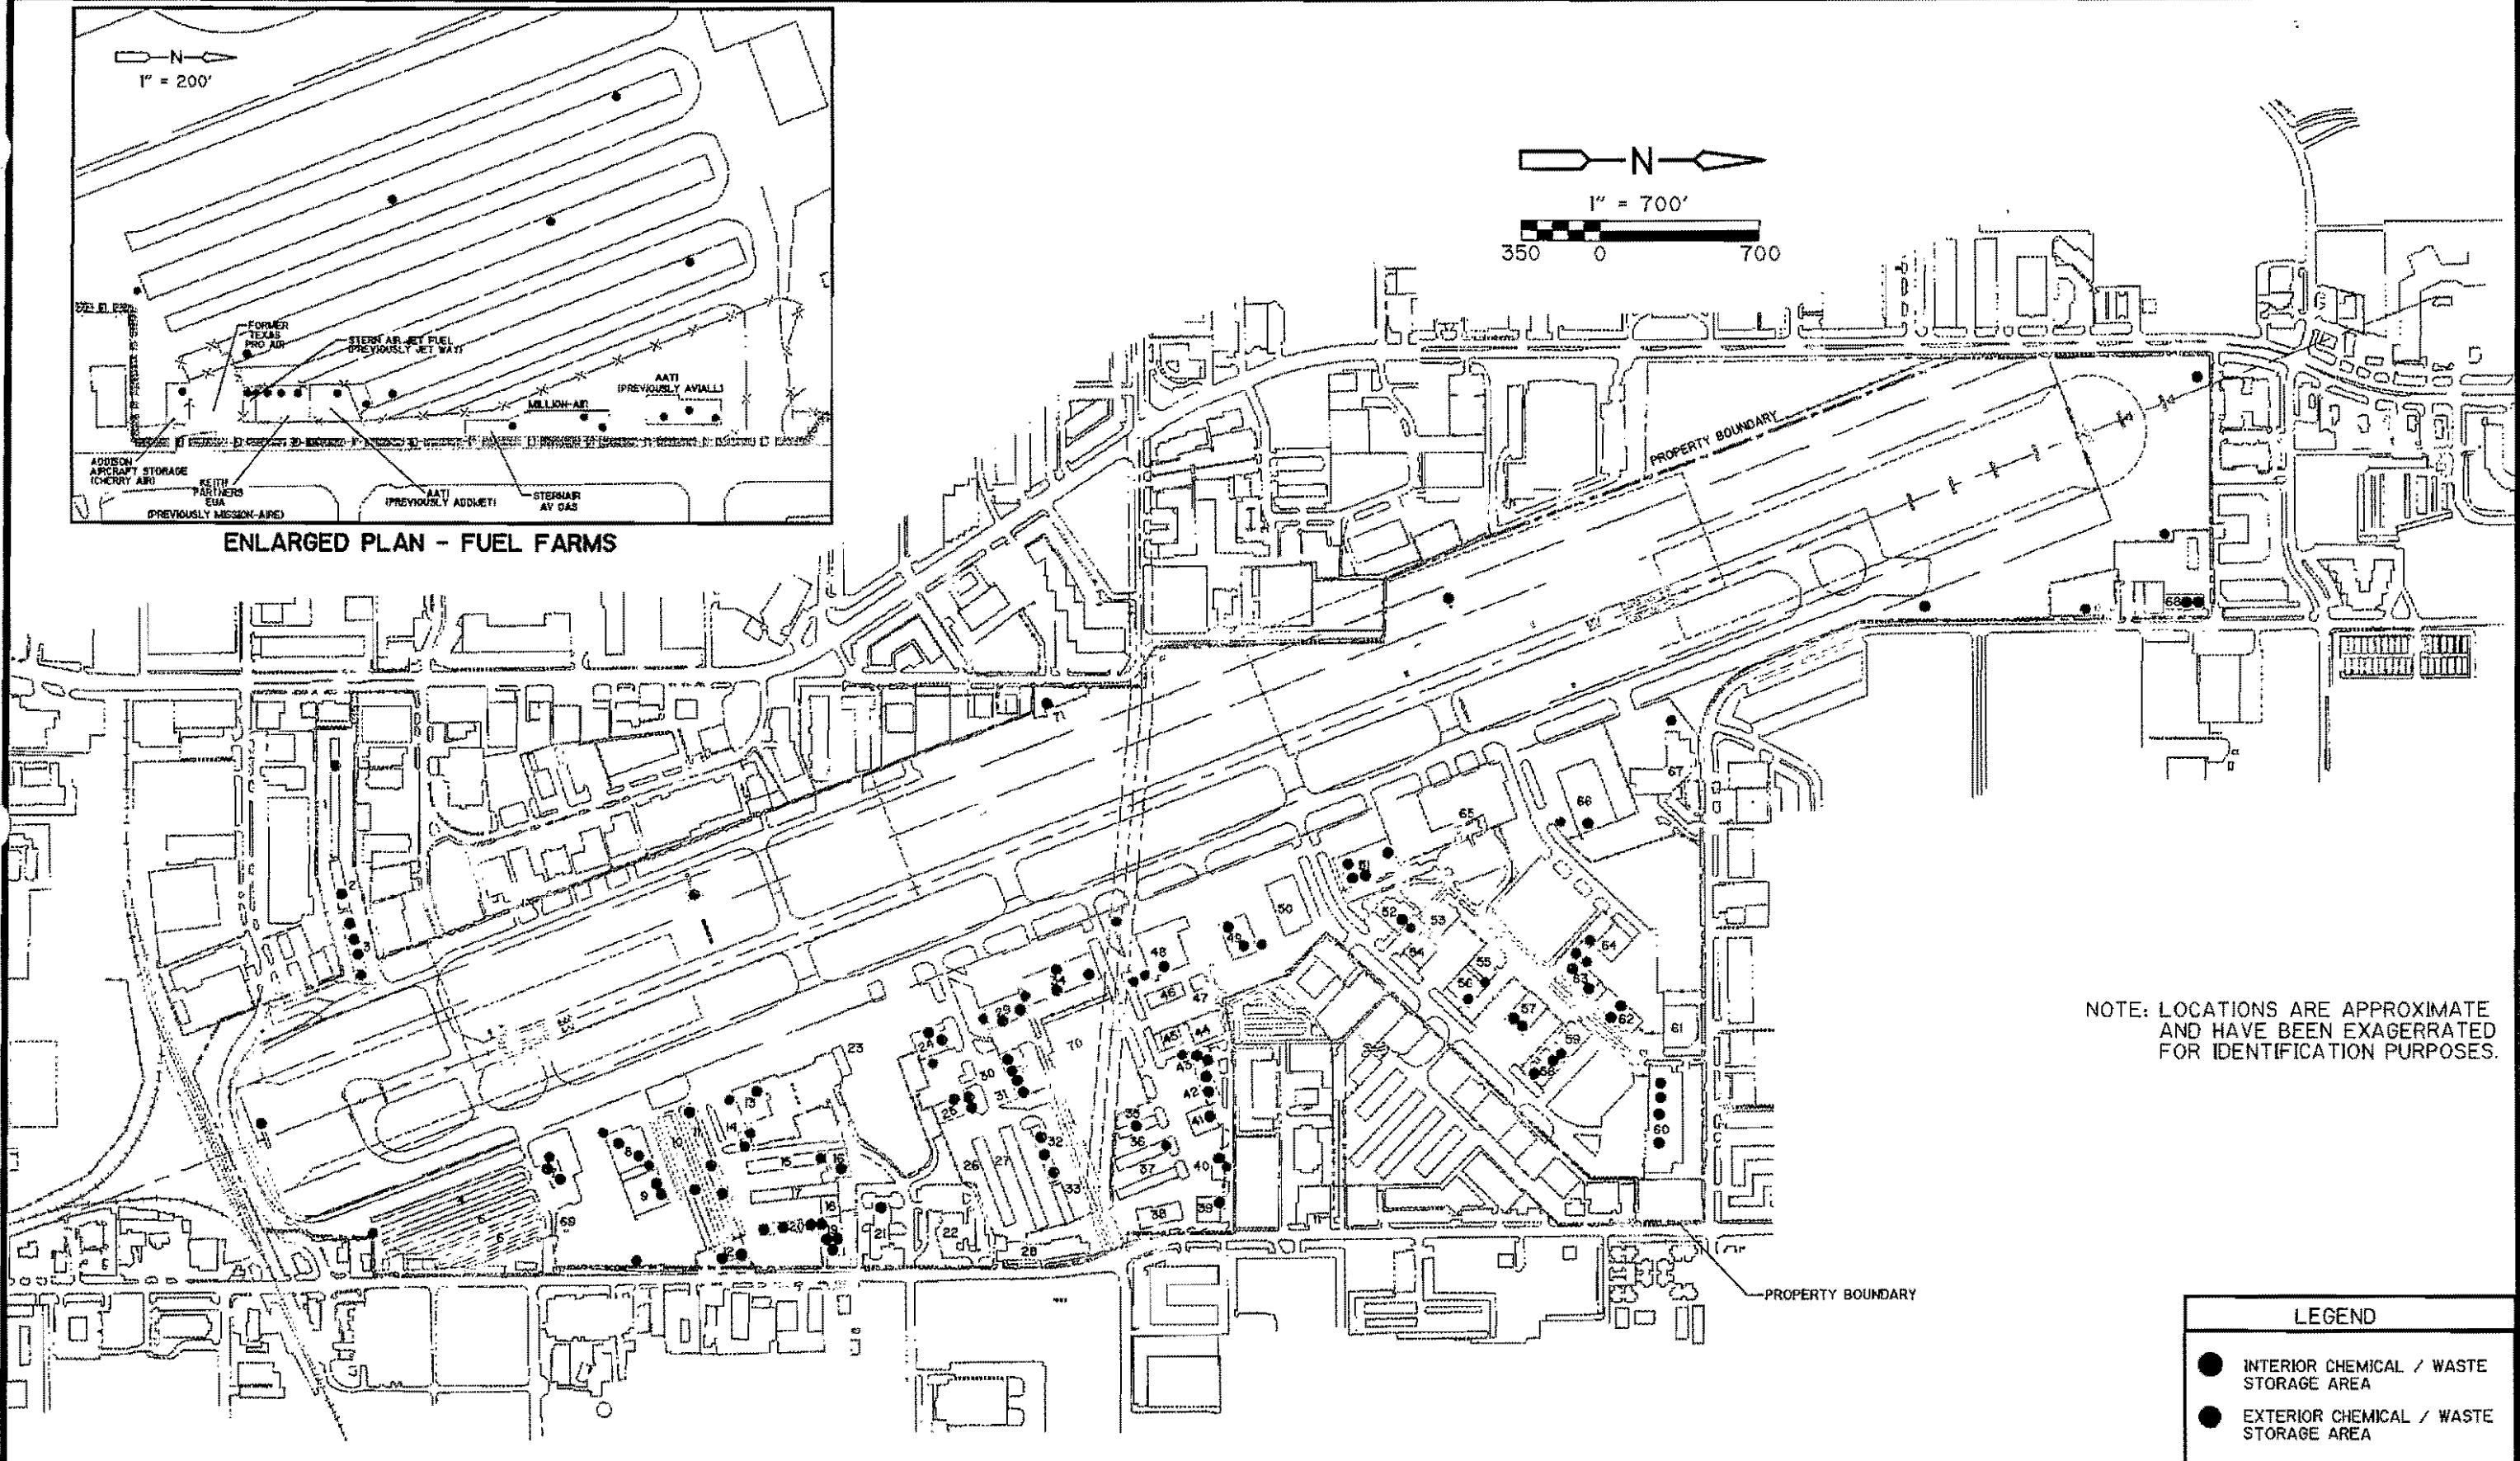
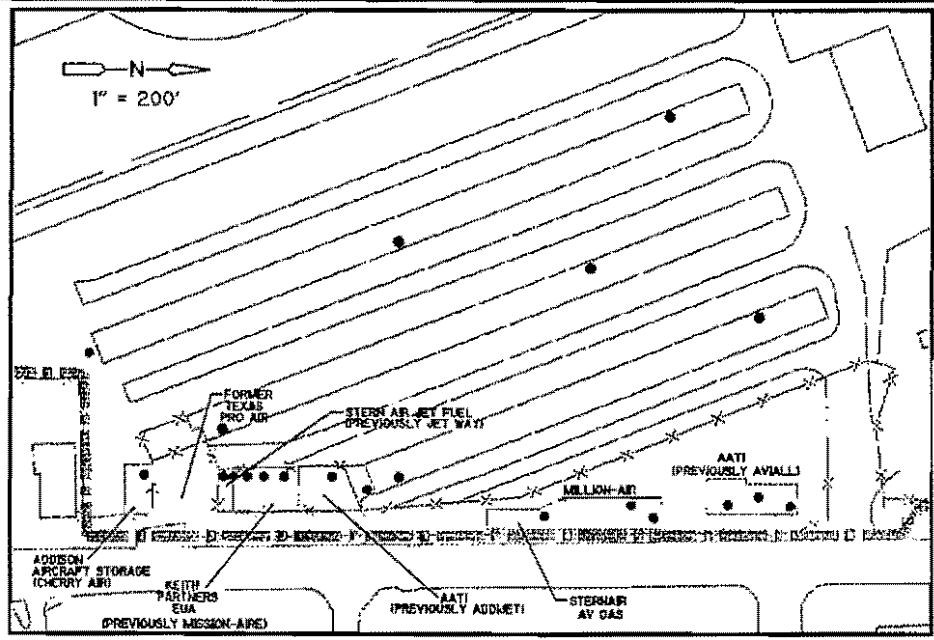
CHEMICAL AND WASTE STORAGE AREAS

LEGEND	
●	INTERIOR CHEMICAL / WASTE STORAGE AREA
●	EXTERIOR CHEMICAL / WASTE STORAGE AREA

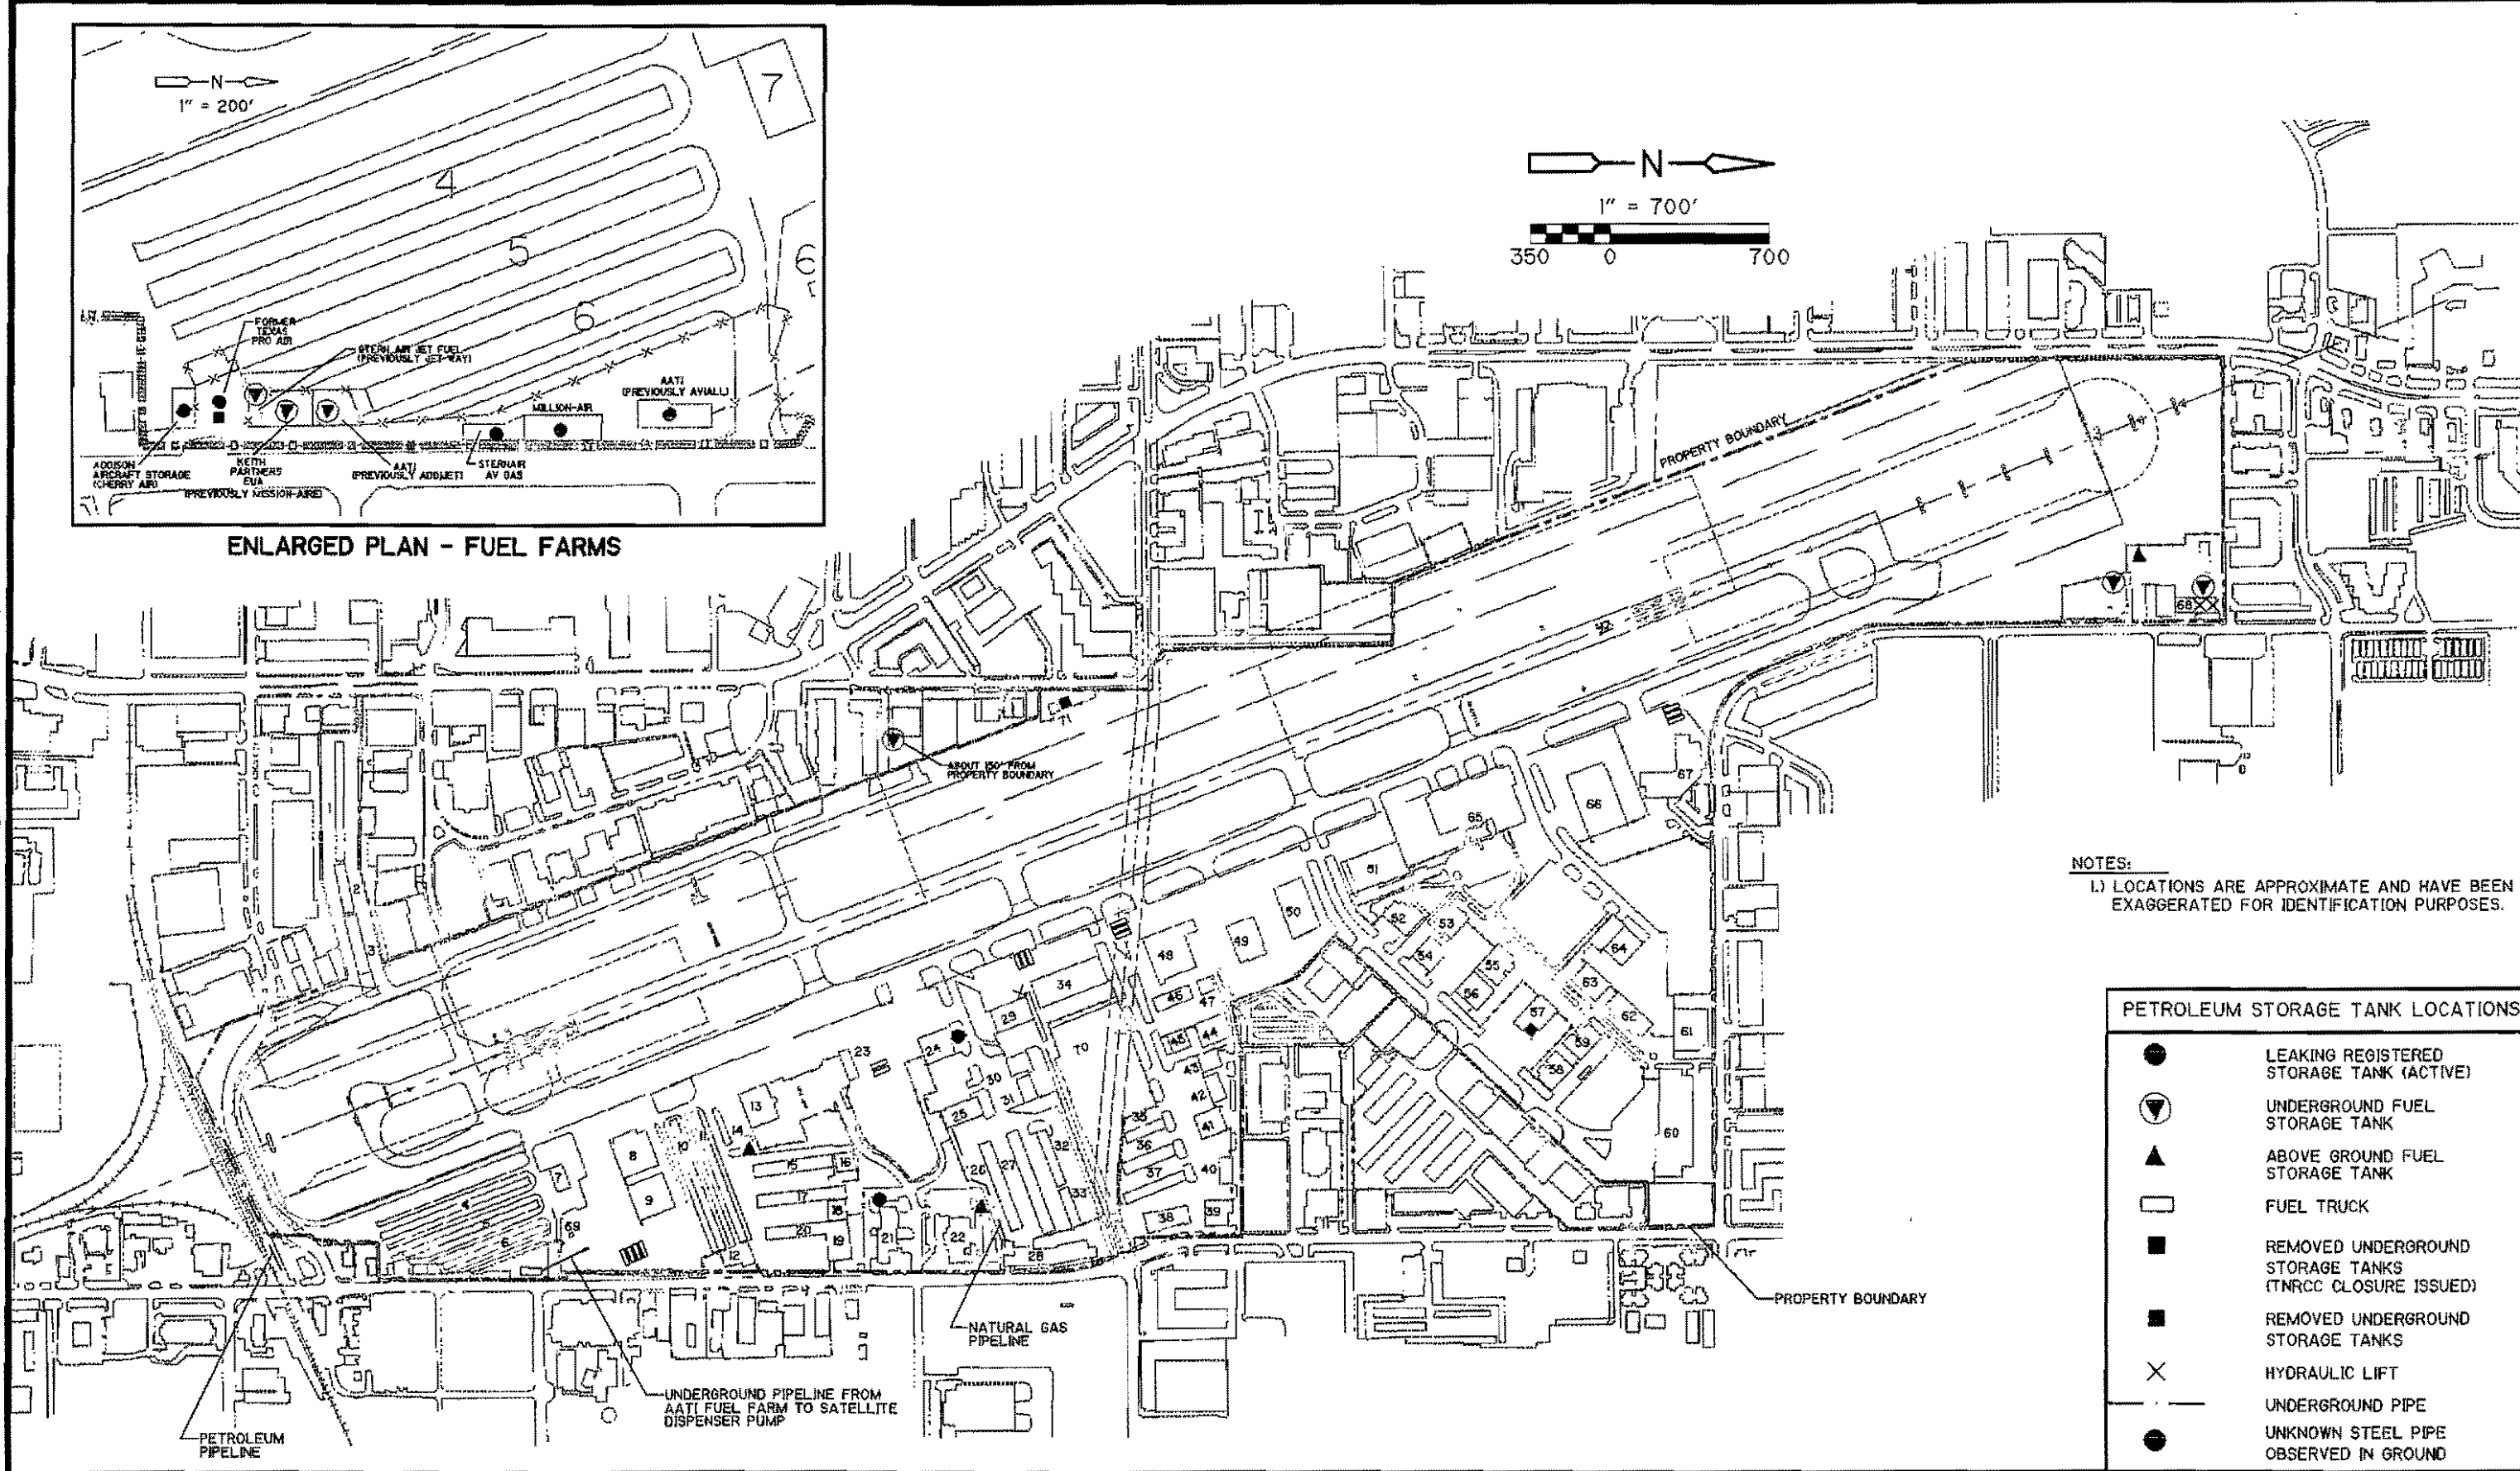
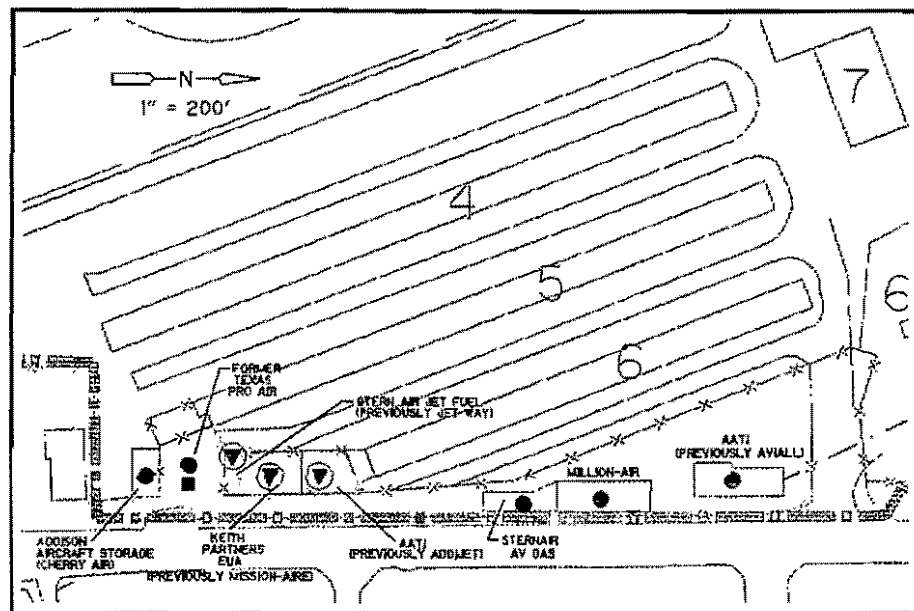
HISTORICAL AND EXISTING PETROLEUM STORAGE TANK LOCATIONS

PETROLEUM STORAGE TANK LOCATIONS	
●	LEAKING REGISTERED STORAGE TANK (ACTIVE)
▼	UNDERGROUND FUEL STORAGE TANK
▲	ABOVE GROUND FUEL STORAGE TANK
□	FUEL TRUCK
■	REMOVED UNDERGROUND STORAGE TANKS (TNRCC CLOSURE ISSUED)
■	REMOVED UNDERGROUND STORAGE TANKS
×	HYDRAULIC LIFT
—	UNDERGROUND PIPE
●	UNKNOWN STEEL PIPE OBSERVED IN GROUND
