AIRPORT ESA EXTRA CODE FIGURES

ADDISON AIRPORT
ADDISON, TEXAS

STAINED SURFACE AREAS

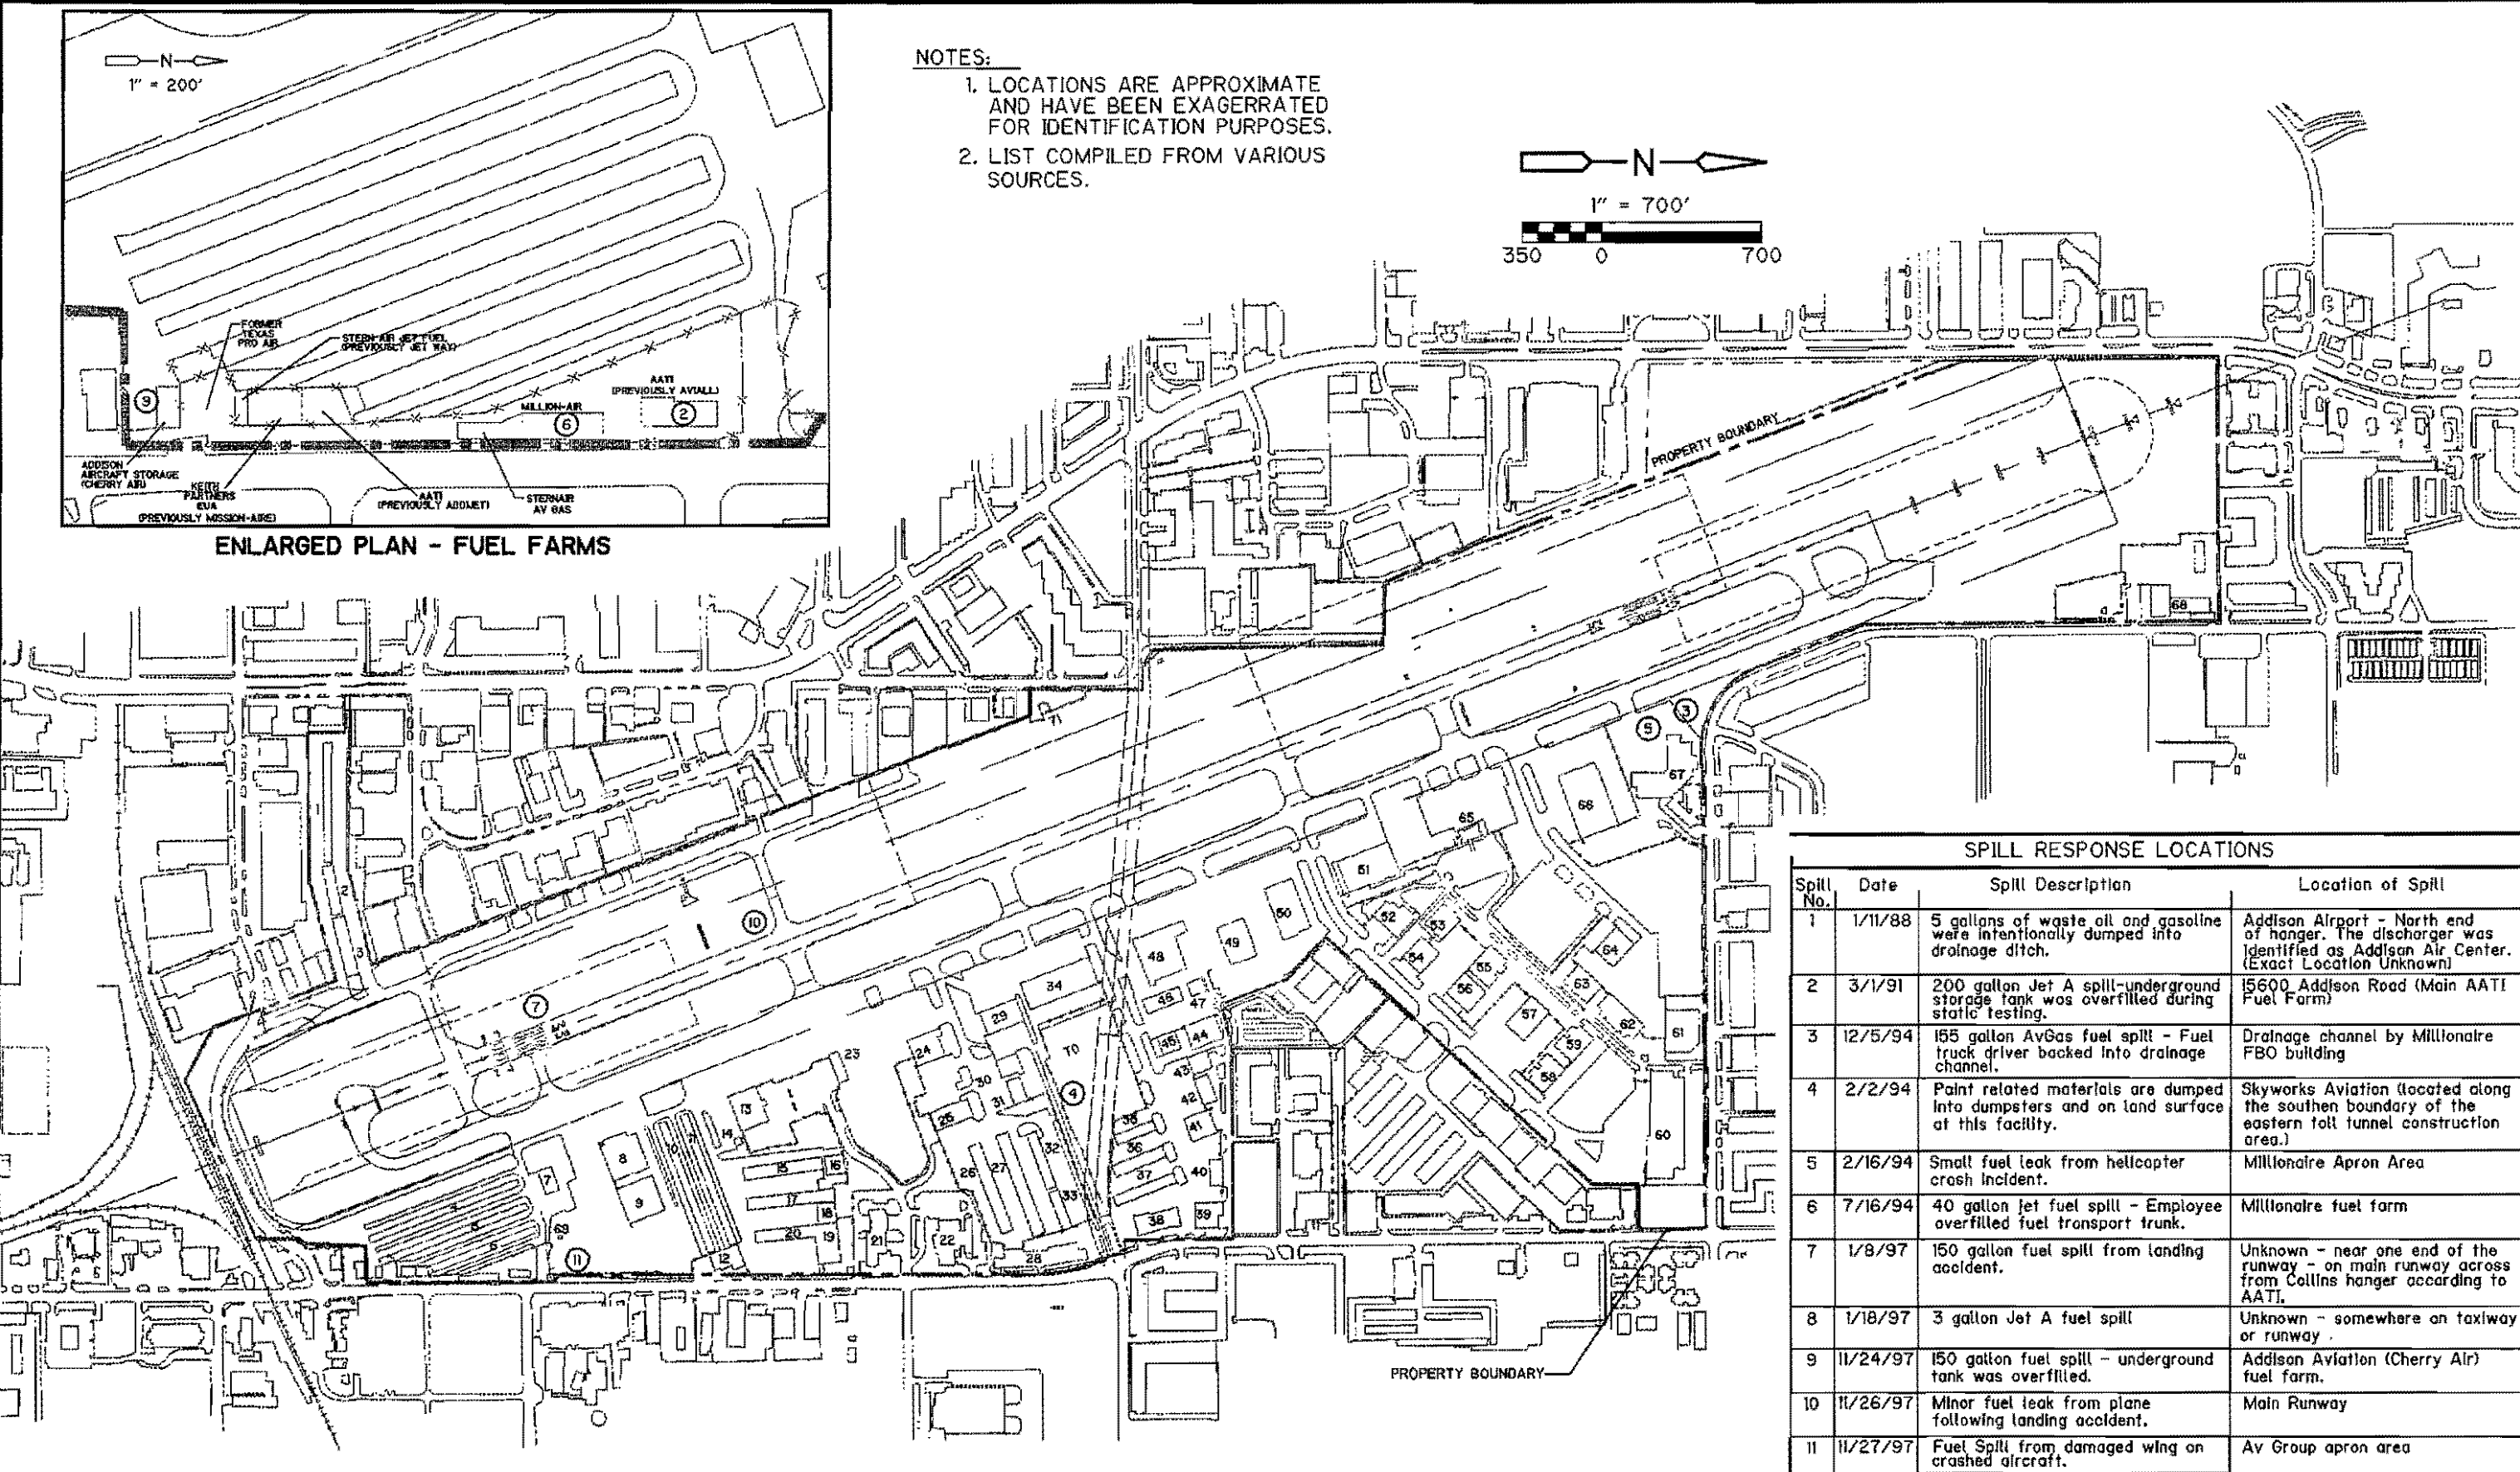
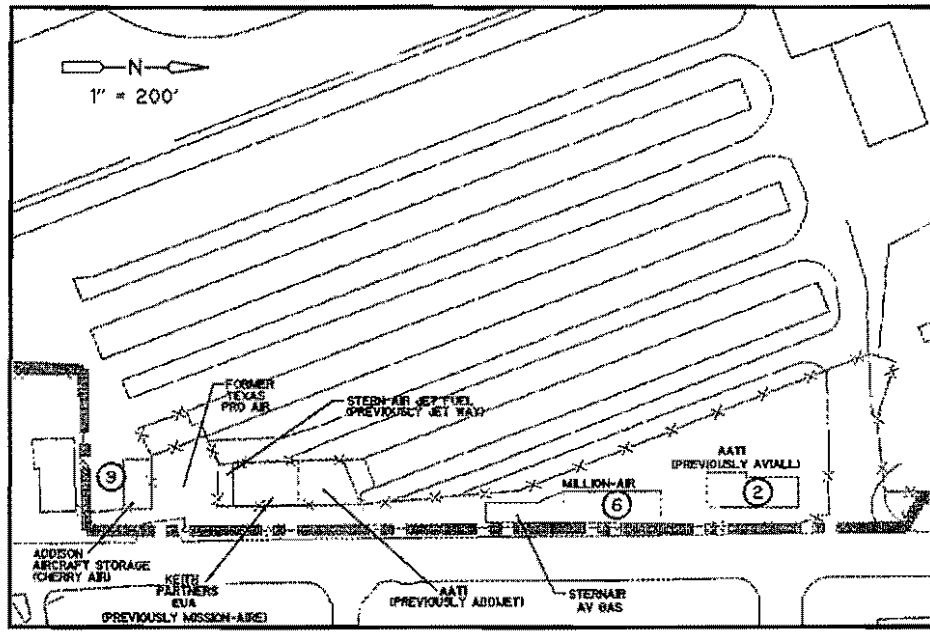
SPILL RESPONSE LOCATIONS

Spill No.	Date	Spill Description	Location of Spill
1	1/11/88	5 gallons of waste oil and gasoline were intentionally dumped into drainage ditch.	Addison Airport - North end of hanger. The discharger was identified as Addison Air Center. (Exact Location Unknown)
2	3/1/91	200 gallon Jet A spill - underground storage tank was overfilled during static testing.	15600 Addison Road (Main AATI Fuel Farm)
3	12/5/94	155 gallon AvGas fuel spill - Fuel truck driver backed into drainage channel.	Drainage channel by Millonaire FBO building
4	2/2/94	Paint related materials are dumped into dumpsters and on land surface at this facility.	Skyworks Aviation (located along the southern boundary of the eastern toll tunnel construction area.)
5	2/16/94	Small fuel leak from helicopter crash incident.	Millonaire Apron Area
6	7/16/94	40 gallon Jet fuel spill - Employee overfilled fuel transport trunk.	Millonaire fuel farm

7	1/8/97	150 gallon fuel spill from landing accident.	Unknown - near one end of the runway - on main runway across from Collins hanger according to AATI.
8	1/18/97	3 gallon Jet A fuel spill	Unknown - somewhere on taxiway or runway
9	11/24/97	150 gallon fuel spill - underground tank was overfilled.	Addison Aviation (Cherry Air) fuel farm.
10	11/26/97	Minor fuel leak from plane following landing accident.	Main Runway
11	11/27/97	Fuel Spill from damaged wing on crashed aircraft.	Av Group apron area
